Deying Li · Liangxuan Yan · Li Wu · Kunlong Yin · Chin Leo

The Hejiapingzi landslide in Weining County, Guizhou Province, Southwest China: a recent slow-moving landslide triggered by reservoir drawdown

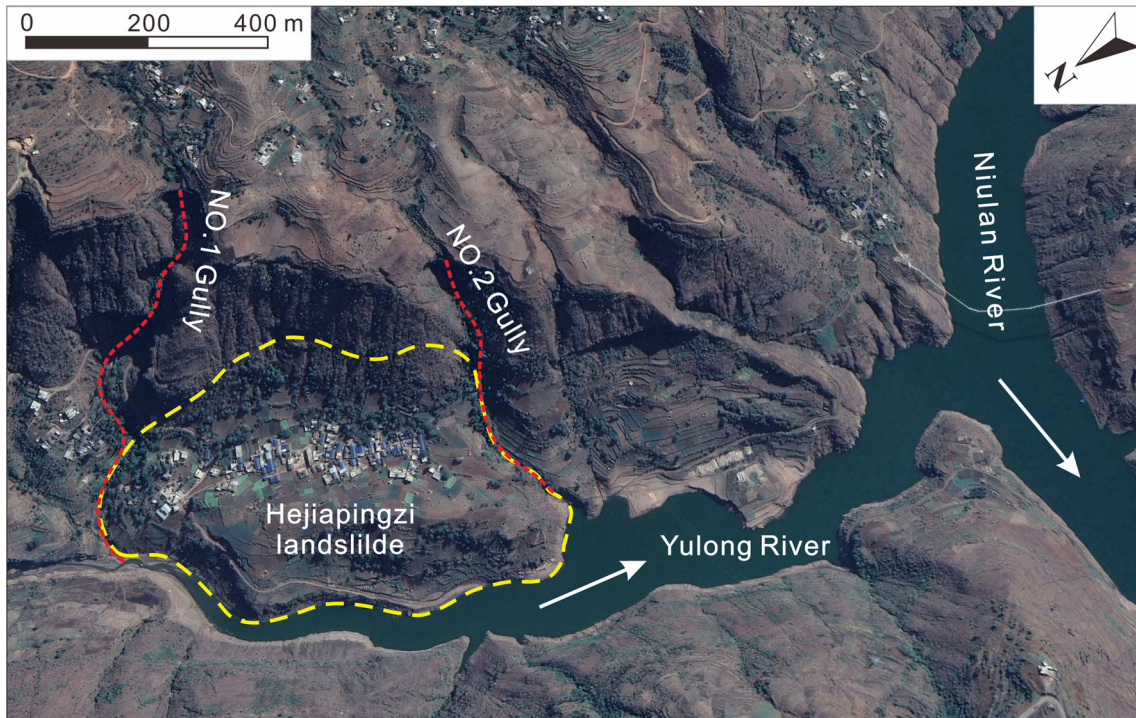
Fig. 3 Overall view of the landslide (from Google Earth, 2018)

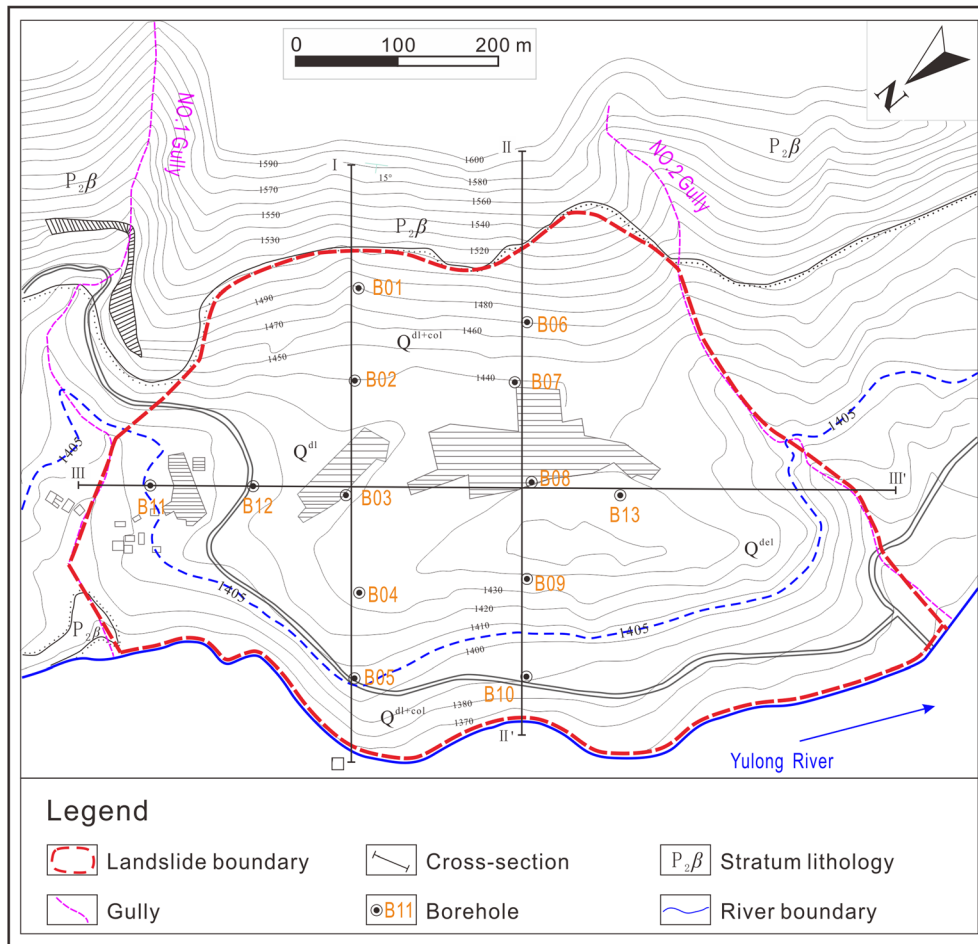
The geological structure of the landslide has been obtained from borehole and field surveys. The borehole locations are shown in Fig. 5. From a geomorphological point of view, the landslide is of a translational and rotational type. The longitudinal profile shows a steeper upper slope and gentler lower slope increasing in thickness toward the toe. The bedrock is mainly basalt, which is overlain by a thinner layer of tuffaceous mudstone. The bedrock is overlain by

Fig. 5 Geomorphological map of the landslide, showing the locations of the cross sections and the boreholes. $P_2\beta$ is the Emeishan basalt of the Permian system, Q^{dl} is a Quaternary diluvial deposit, Q^{dl+col} is a Quaternary diluvial and colluvial deposit, Q^{col} is a Quaternary colluvial deposit, Q^{el} is a Quaternary eluvial deposit, and Q^{del} is the landslide deposit

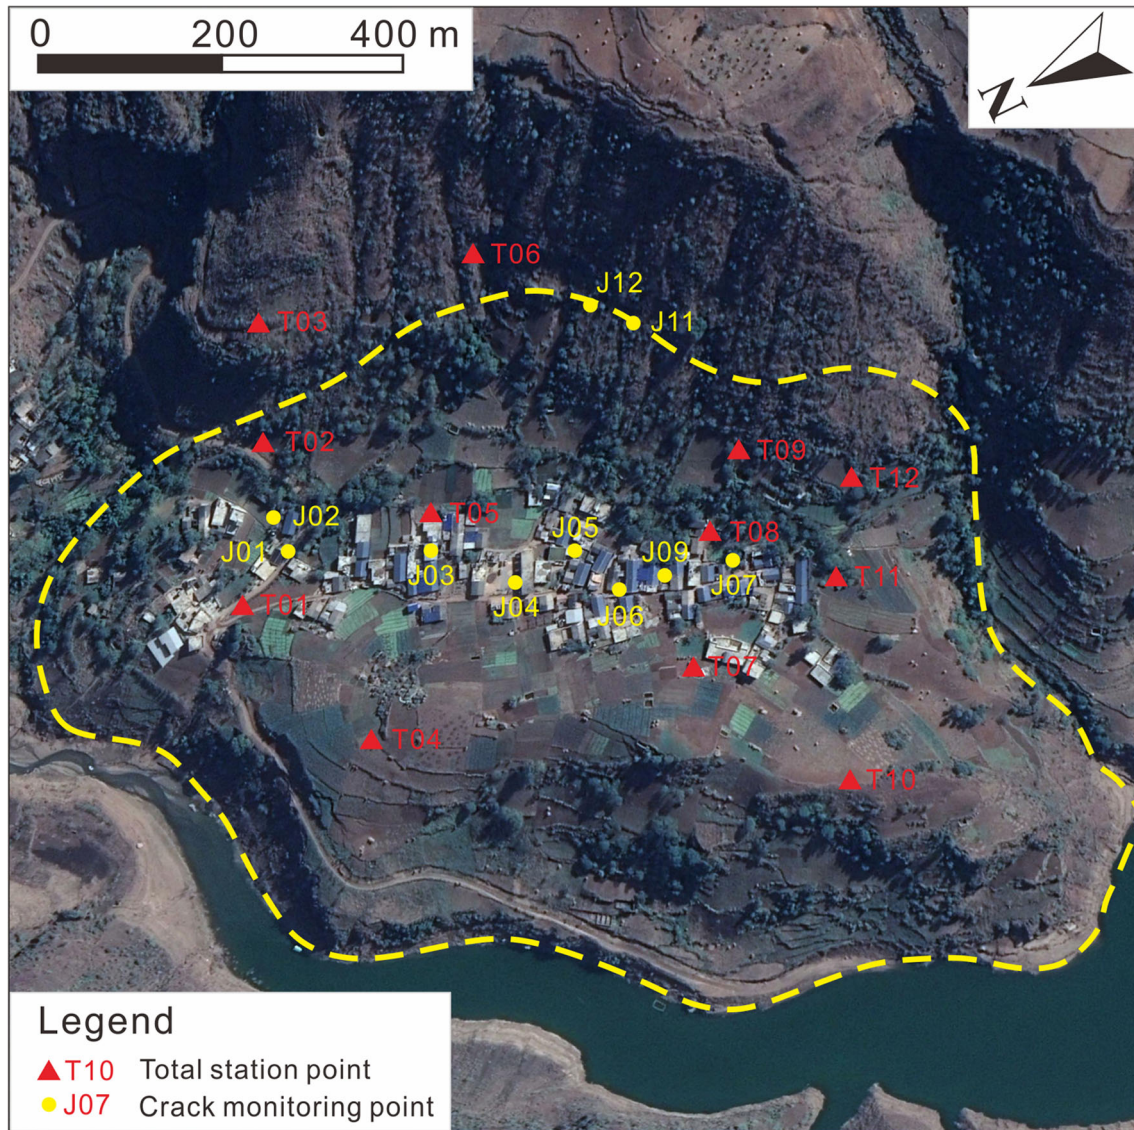
Fig. 11 Map of monitoring points installed in the landslide

To understand the landslide deformation characteristics and their evolution with time, landslide monitoring has been carried out since 28 October 2017. Surface deformation at the landslide site was monitored using a total station and simple crack measurements. Figure 11 shows the locations of the monitoring points. A total of 10 crack monitoring points and 12 survey points using a

total station were progressively positioned for landslide monitoring. Simple crack monitoring points were installed to measure changes in the width of surface cracks since 28 October 2017. Monitoring points using a total station have been installed since 24 June 2018. The monitoring points were measured every 1 day or 4 days, depending on the landslide deformation situation.
