Landslides (2019) 16:2247–2258
 DOI 10.1007/s10346-019-01254-z
 Received: 20 December 2018
 Accepted: 7 August 2019
 Published online: 16 August 2019
 © Springer-Verlag GmbH Germany
 part of Springer Nature 2019

Mass movement and formation process analysis of the two sequential landslide dam events in Jinsha River, Southwest China

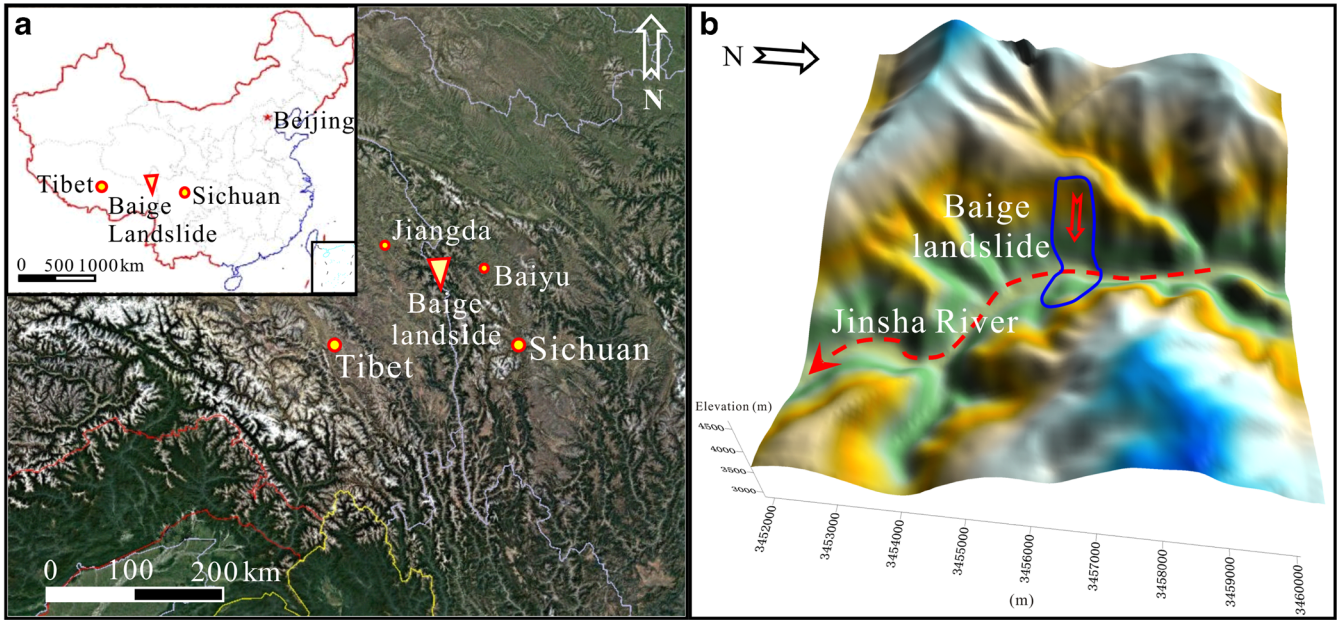
Fig. 1 Location of the Baige landslide: **a** location of the study area and **b** 3D view of the Baige landslide

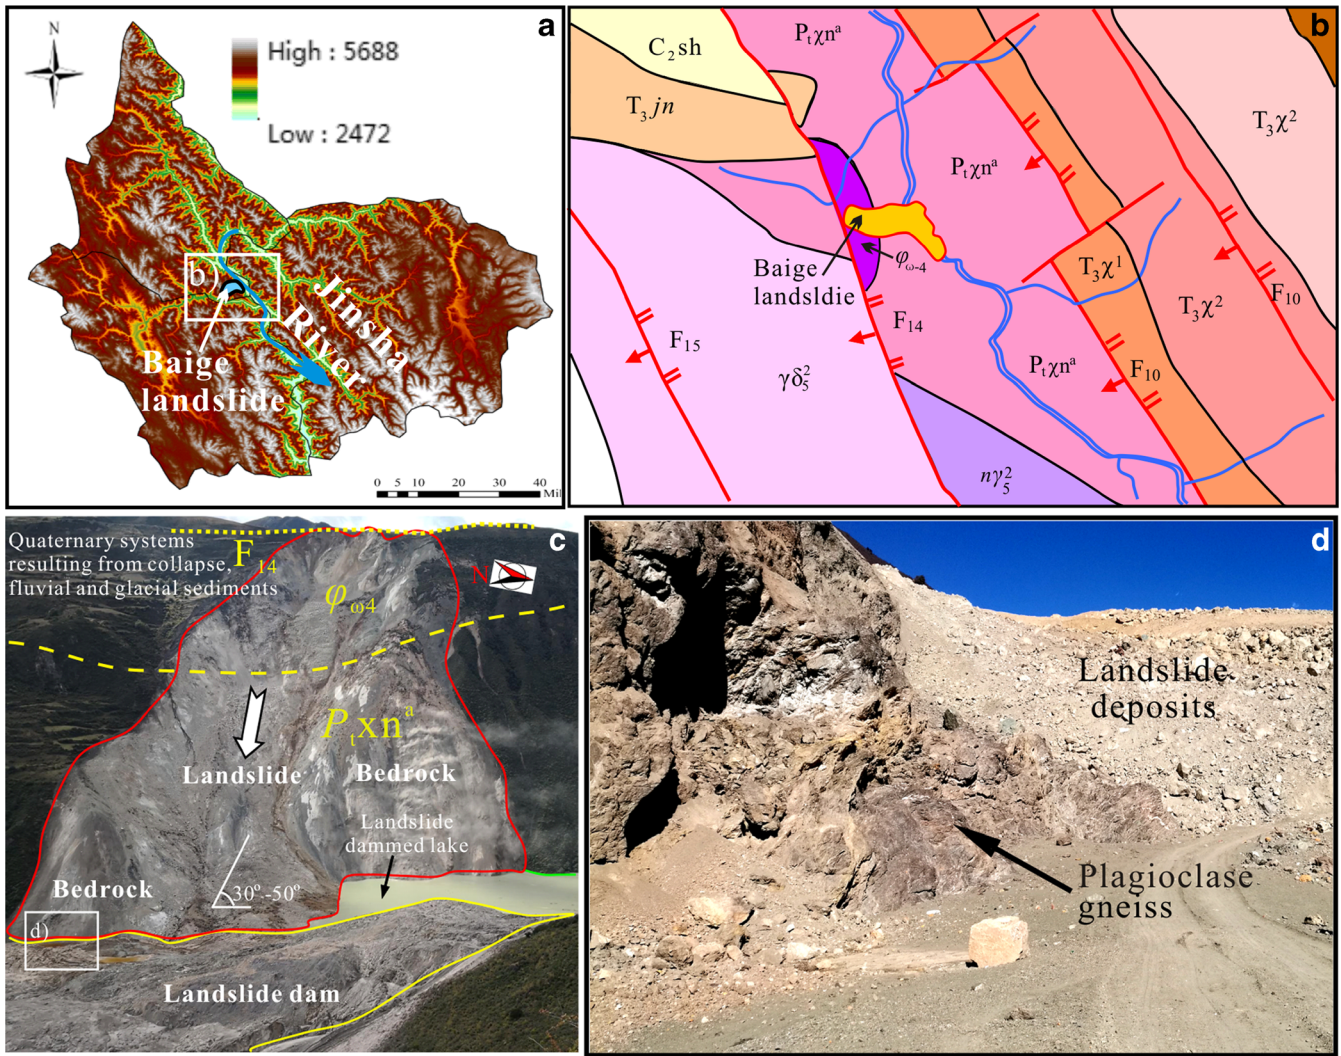
The slopes at both banks are quite steep, with the slope gradient estimated at $30^\circ-50^\circ$ in the landslide area (Fig. 3c). The sloping area is covered with several to tens of meters of Quaternary loose accumulation bodies resulting from collapses, fluvial sediments and glacial deposits. The landslide area has outcrops of mainly plagioclase gneiss (P_{1xn}^a) and serpentine (ϕ_{w4}). The rock strata

mainly dip towards the mountain and downstream side, with a strike of $N40^\circ-50^\circ W$, a dip direction of SW and a dip angle of $45^\circ-60^\circ$. Under long-term geological effects, the rock mass is characterized by low-angle folds or flexural deformation (Fig. 3d). Cracks are well developed because of weathering and unloading and are dominated by two groups of joints: group I is approximately parallel to the landslide surface with a strike of $N330^\circ-380^\circ W$, a dip direction of NE and a dip angle of $75^\circ-85^\circ$; and group II is approximately vertical to the ridge line with a strike of $N10^\circ-25^\circ W$, a dip direction of SE and a dip angle of 80° .

Fig. 3 Geomorphological and geological setting of the Baige landslide: **a** regional geomorphological setting; **b** geological map of the study area (after Xu et al. 2018); **c** field geology investigation result of the Baige landslide; and **d** local view of the landslide dam

The Baige landslide was located in a typical freeze-thaw plateau area, and the steep slope angle (30°–50°), strongly weathered rock mass, glaciers, and thick Quaternary deposits under the original ground surface were quite unfavorable to the stability of the slope. As shown in Fig. 3, the bedrock was mainly composed of plagioclase gneiss and serpentine, which are characterized by a relatively low mechanical strength and intense ductile shearing deformation behavior. Fault F₁₄ and the intensely developed cracks had a great impact on slope stability and promoted the deformation and cracking of the slope and facilitated the

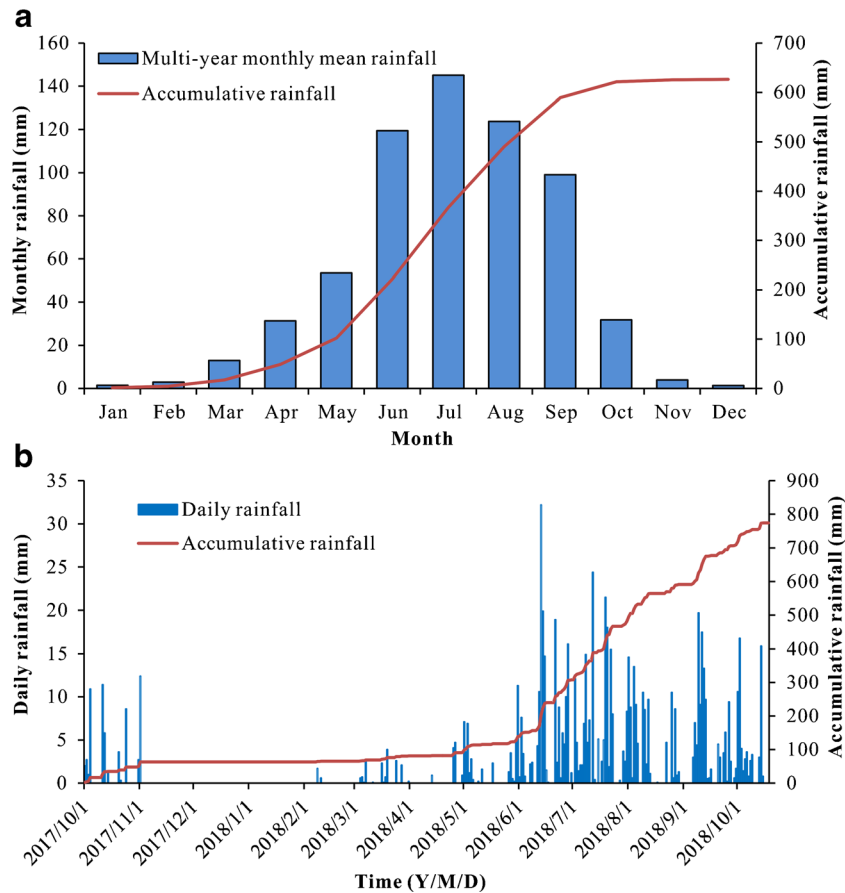
Persistent rain was the primary triggering factor for dramatic failure. As shown in Fig. 7, the Baige landslide area belongs to a typical mainland monsoon climate, and the

rainfall displayed an uneven distribution over a year, mainly concentrated in the summer. Figure 7a shows that the mean annual precipitation was 626.6 mm, while almost 78% of precipitation occurred from June to September (487.5 mm). According to the nearby Baiyu National General Meteorological Station (approximately 20 km away from the site of the landslides), the accumulated rainfall over the past 4 months before the slide exceeded 590 mm, and the precipitation over the 10 days before the slide (in early October 2018) reached a value of 45.9 mm, which was obviously higher than the average rainfall rate observed over the same period in previous years (Fig. 7b). The Baige landslide was not induced by one particular heavy rainfall event but rather by the combination of the complex gravitational and hydrological effects over a relatively long time period. Regarding the long-term effect, prolonged rainfall infiltration would cause a slow but progressive build-up of hydrostatic pressures in the cracks, which might induce crack propagation and creep deformation (Fan et al. 2017). This effect led to crack propagation, which finally accelerated the infiltration rate as well as the creep deformation. In addition, persistent rainfall infiltration softens the rock mass and reduces the mechanical strength of both covering deposits and bedrock (Qi and Vanapalli 2015; Li et al. 2018). For the short-term effects, heavy rainfall resulted in the saturation of loose deposits on the surface and increasing pore water pressure on the structural surfaces. This effect led to crack propagation and accelerated deformation, which finally triggered catastrophic failure.

Fig. 7 Precipitation data of the study area (Baiyu National General Meteorological Station): a multiyear mean rainfall and b daily rainfall before the landslide
