## Deformation characteristics and failure mechanisms of a rainfall-induced complex landslide in Wanzhou County, Three Gorges Reservoir, China

**Abstract** A rainfall-induced complex landslide occurred on April 4, 2013, in Wanzhou County, Three Gorges Reservoir, China. Approximately  $1.5 \times 10^6$  m<sup>3</sup> of earth and rock mass slid over a distance of ~ 30 m, destroying residential buildings and rural roads. We perform a comprehensive assessment of the cause of this landslide using field surveys, borehole drillings, and interpretations of aerial photographs. This landslide exhibited a complex failure mode in which the upper part of the earth slope first deformed and slid along geotechnical interfaces. This then triggered the slide of the lower part of the flysch bedding rock. In this study, the landslide mass was divided into nine separate blocks considering their internal geological features and movements. The study also shows that antecedent rainfall, in association with the geological and morphological features of the steep slope, the presence of weak interlayers, and human interventions such as slope excavations, jointly caused this disaster. This well-observed even

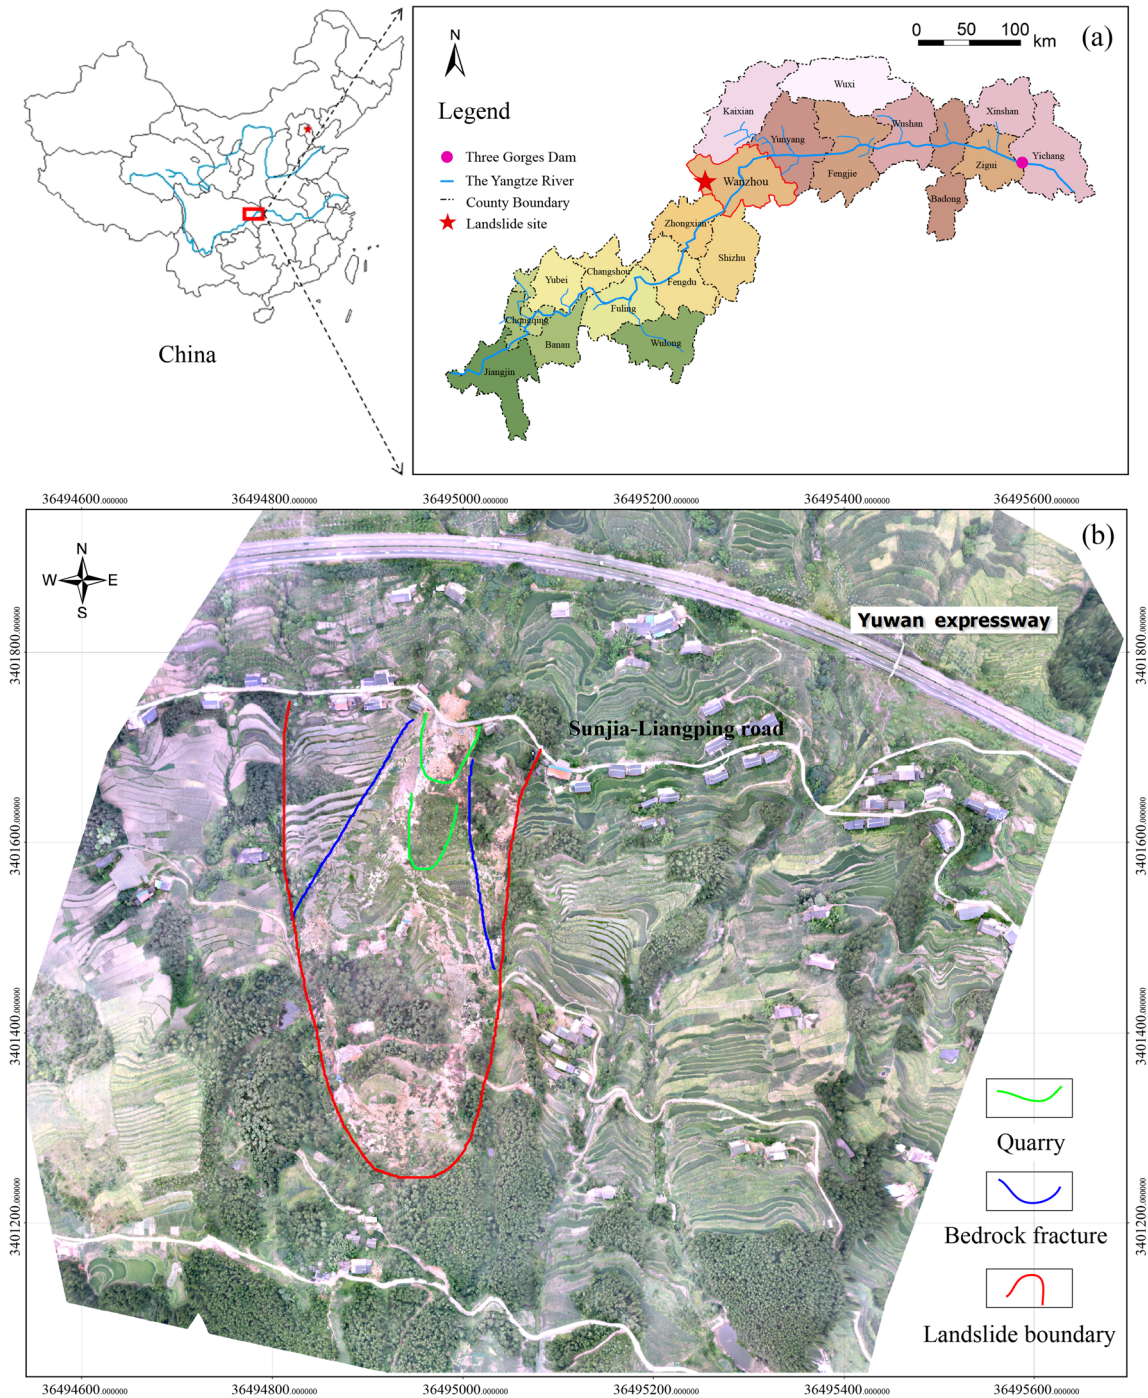
**Fig. 1** Location of the study site. a The Three Gorges Reservoir area. b A post-event aerial image of the landslide site collected from the Nanjiang Hydrogeological Engineering Geological Team

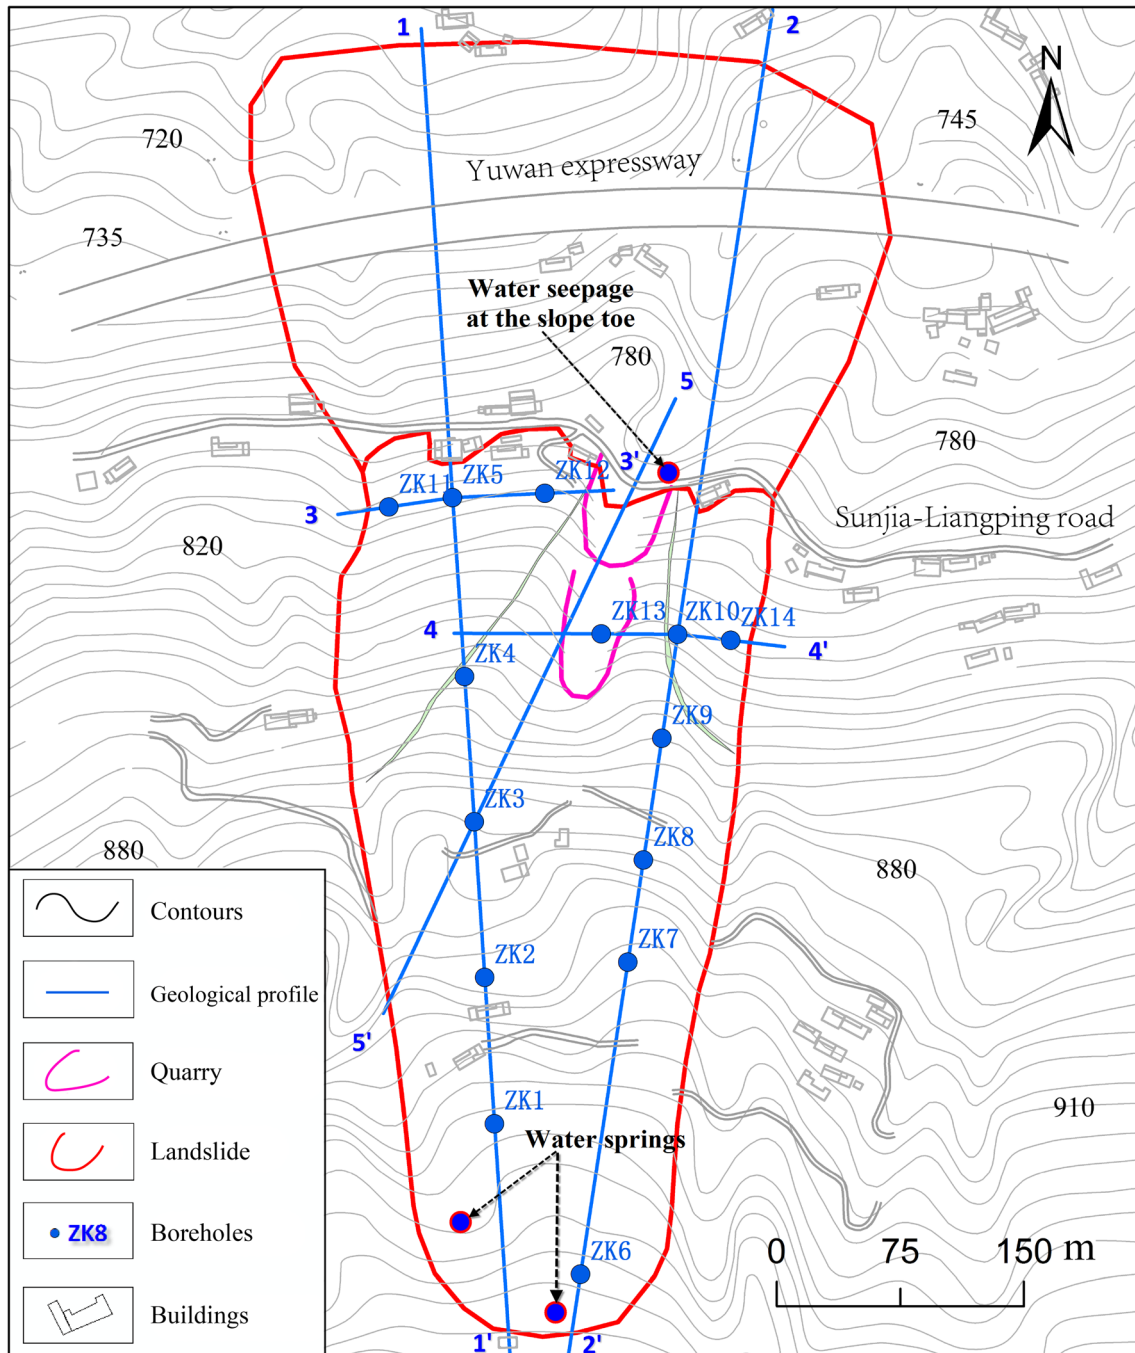
**Fig. 2** Geological ichnography of the Sunjia landslide. The blue numbers are the serial numbers of the boreholes. The black numbers mark the elevations of the contours (5 m)

back margin of the landslide and other seeps at the foot of the steep slope at the front edge of the landslide (Fig. 4). Figure 2 shows the locations of the water springs and water seepage.

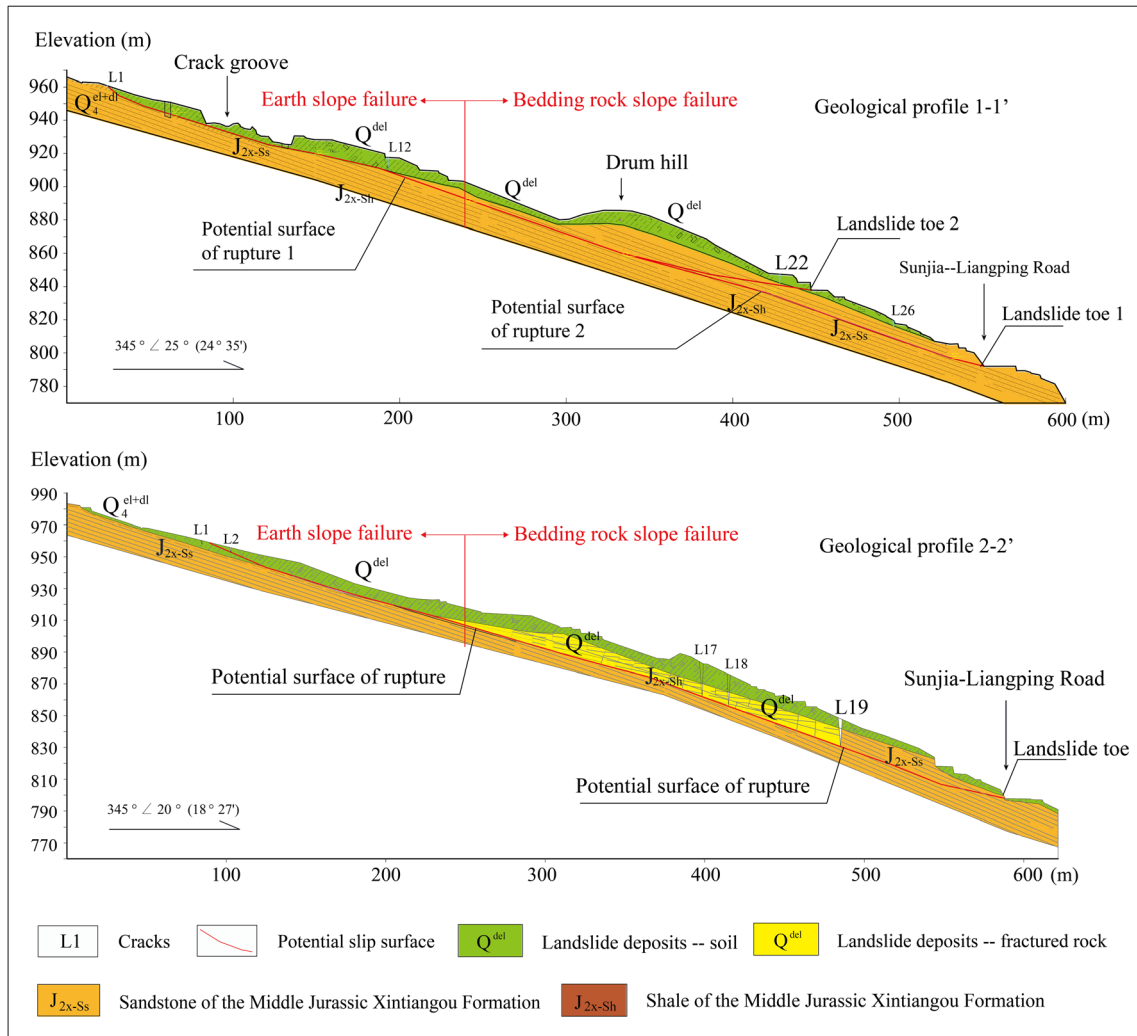
**Fig. 3** Geological profile 1-1' and 2-2' of the Sunjia landslide (see Fig. 2 for the locations of the profiles)

As for the lower bedding rockslide, the flysch bedding planes comprising the overlying hard rock and underlying soft rock provided a slope structure with a tendency for sliding (Figs. 3 and 10). More precisely, a shear sliding surface can easily form along the bedding planes that could be ultimately responsible for the formation of the rockslide (Luo et al. 2012, 2017). Also, rainwater infiltration led to a reduction of the shear strength of the impermeable interlayer of the shale with a muddy structure due to long-term immersion. In addition, the free surface at the toe of the rock slope formed by the previous open-pit excavations had an adverse impact

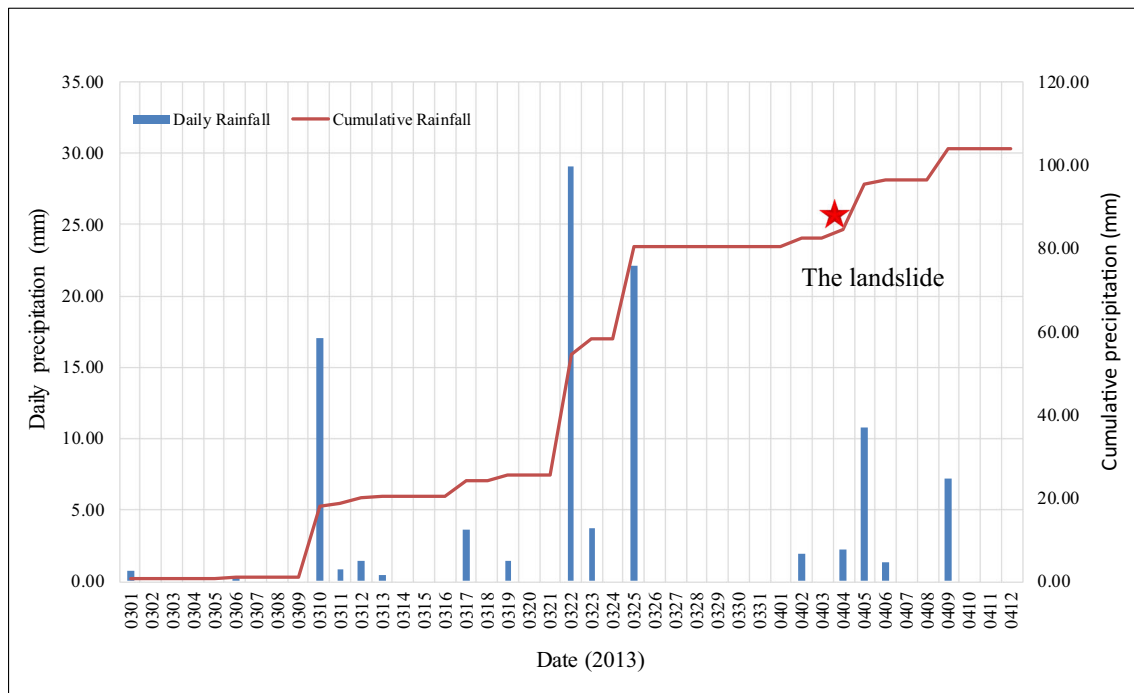
and the maximum daily rainfall reached over 30 mm. The antecedent rainfall at that time could be the main factor that induced the failure of the Sunjia slope (Fig. 5).

**Fig. 5** Distribution of daily average precipitation from March 1 to April 12. The red star marks when the Sunjia landslide occurred (data collected from the Wanzhou Geological Environment Monitoring Station)
