Landslides (2020) 17:1935–1949
 DOI 10.1007/s10346-020-01394-7
 Received: 21 January 2020
 Accepted: 11 March 2020
 Published online: 8 April 2020
 © Springer-Verlag GmbH Germany
 part of Springer Nature 2020

Yueping Yin · Bolin Huang · Quan Zhang · Guoqiang Yan · Zhenwei Dai

Research on recently occurred reservoir-induced Kamenziwan rockslide in Three Gorges Reservoir, China

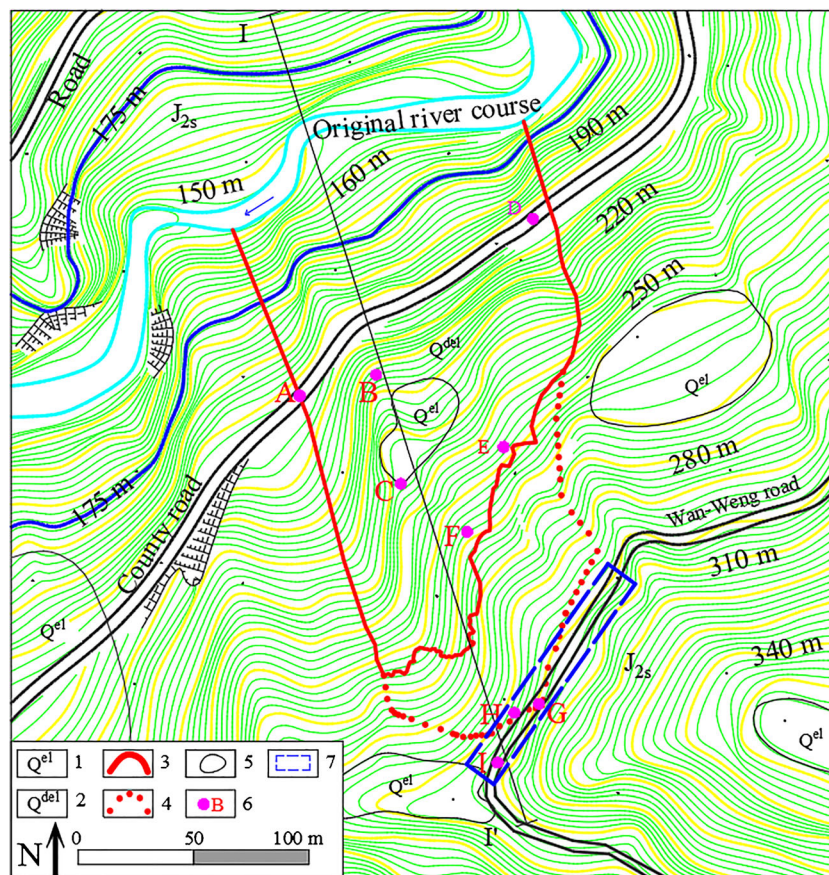
Fig. 2 The geological plan of Kamenziwan landslide. The landslide terrain is pre-destruction terrain. 1, residual deposit; 2, landslide; 3, the boundary of landslide; 4, the boundary of retrogressive zone; 5, geological boundary; 6 A–F are simple monitoring points for cracks before landslide; G–I are simple monitoring points for cracks after landslide; 7, landslide bedrock outcrop observation zone

On November 20, 2019, some cracks on the highway were reported by villagers, which is to the location of the Kamenziwan landslide. During the investigation at that time, cracks were found in many places on the slope (see Fig. 2A–D), which were caused by slope sliding. According to the Three Gorges geological disaster monitoring and early warning network system requirements, simple monitoring points and corresponding inspection-monitoring system were established on the Kamenziwan landslide, in an early stage.

After the deformation on November 20, the relative displacement monitoring of the A–F crack points (Fig. 2) was conducted. Figure 21 shows the relative displacement time curves of crack measuring points. Point A is located in the highway at the leading edge of the landslide, while points E and F are located in the trailing edge of the landslide. In terms of relative displacement, the relative deformation of point E exceeds the relative deformation of point A, in a later stage. On December 10, rapid deformation was observed at point A. Based on the relative deformation rate of cracks (Fig. 22), point A has the highest deformation rate at first. After point E started to deform, its deformation rate exceeds the deformation of point A. In the afternoon of the landslide occurrence, the deformation rate at point A accelerated clearly.

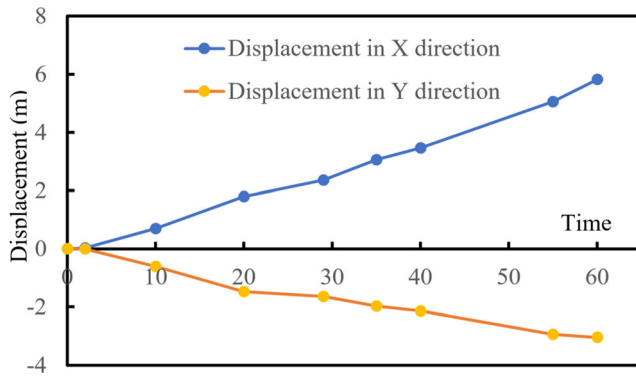
Based on Fig. 8, considering the road and sandstone cliff as the reference, the velocity and acceleration of the landslide in the overall sliding can be roughly obtained, using the relation of displacement, velocity, and time in Newton's law (Huang et al. 2012). At about 20 s, the sliding velocity reached its maximum, i.e. about 0.15 m/s (Figs. 9 and 10). During the 58 s, the average velocity of the landslide reached about 0.1 m/s. At about 60 s, the acceleration of landslide reached the maximum, i.e. about 0.1 m/s². From 16:18, the landslide began to move, and the landslide did not slow down until 16:31. Therefore, it can be estimated

Fig. 9 Displacement time curve of the steep cliff on the highway. According to Fig. 8, the displacement of the steep cliff on the highway in the X and Y directions of the landslide is analysed. X and Y direction refers to the horizontal direction and vertical direction of the sliding direction. The negative displacement means the direction of motion is down

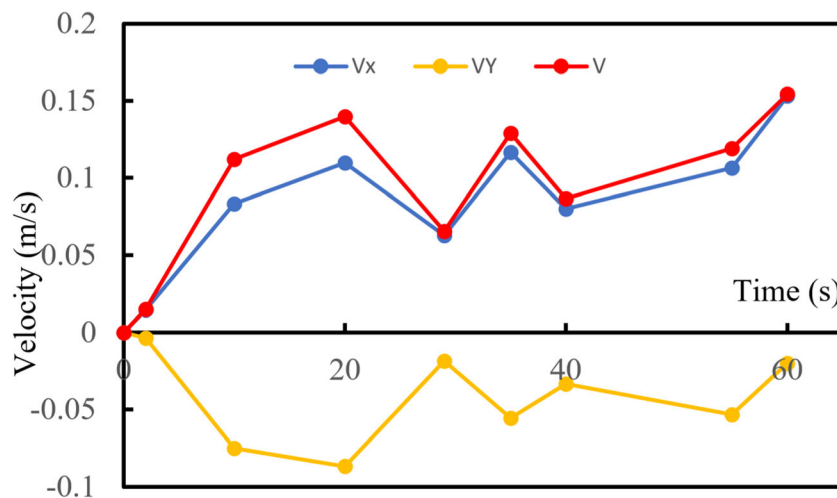
Fig. 10 The velocity process of landslide. According to Fig. 8, the slip displacement and time are analysed, and the instantaneous slip velocity can be obtained by calculating Newton's law of motion. V refers to the sliding velocity, and Vx and Vy refer to the horizontal and the vertical velocity of V, respectively. The negative velocity of Vy means the direction of motion is down

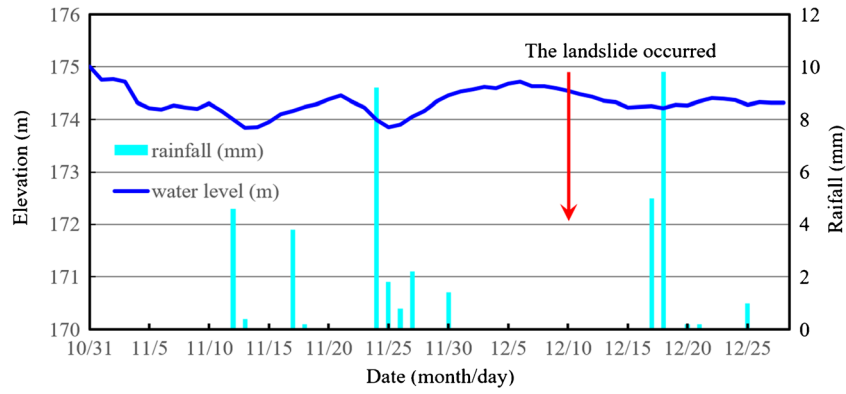
On the day of the landslide, the water level in the Three Gorges Reservoir was 174.6 m asl. Since October 31, 2019, the water level in the Three Gorges Reservoir has been slowly falling from 175 m asl. and fluctuating between 173.8 and 174.8 m asl. (Fig. 11). During this period, the maximum rate of water level rise was 0.17 m/day (occurred on November 29), while the maximum water level declining rate was 0.39 m/day (occurred on November 4). The average declining rate during the last 5 days before the landslide was 0.04 m/day. Based on the current literature, the rate of fluctuation of water level should not be enough to induce landslide (Tang et al. 2019; Yin et al. 2016). From November 30 to the day of landslide occurrence, the weather was sunny for 10 consecutive days, and no rain was reported in the area (Fig. 11). Moreover, the cumulative rainfall in the last 40 days before the landslide occurrence was only 24.4 mm, suggesting the low possibility of rain-induced landslides (Brooks et al. 1993; He et al. 2010; Xia et al. 2013; Yang et al. 2017). Consequently, it is very unlikely that the Kamenziwan landslide was triggered by the water level fluctuation and rainfall. In other words, no immediate and obvious triggering factors can be considered for this reservoir landslide.

Fig. 11 Changes in water levels and rainfall, since October 31. Since November, the water level has been fluctuating slightly between 173.8 and 174.8 m, with the occurrence of mostly sunny days and limited rainfall, during this period

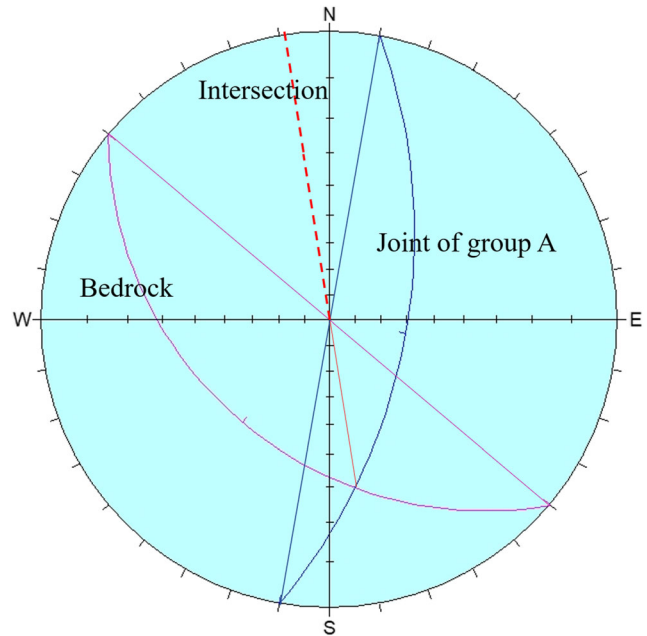
Obviously, this sliding direction (340°) is approximately 55° from the rock strata tendency ($30\text{--}45^\circ$), with an angle of approximately 70° from the structural plane of group A ($270\text{--}290^\circ$). Based on the stereographic projection analysis (Fig. 15), the sliding direction falls within the intersection line between the rock layer and the structure plane of group A (Stead et al. 2006). The Kamenziwan landslide is controlled by two sets of sliding surfaces of rock strata and the structural surface of group A; hence, the real sliding direction is the intersection line of these two sets of sliding surfaces (Fig. 15). Therefore, the Kamenziwan landslide is indeed a wedge sliding, controlled by two sets of sliding surfaces (Stead et al. 2006).

Fig. 15 Stereographic projection analysis of the double sliding surfaces of Kamenziwan landslide. The red line demonstrates the intersection of two sets of sliding surfaces, and the dotted line represents the actual sliding direction

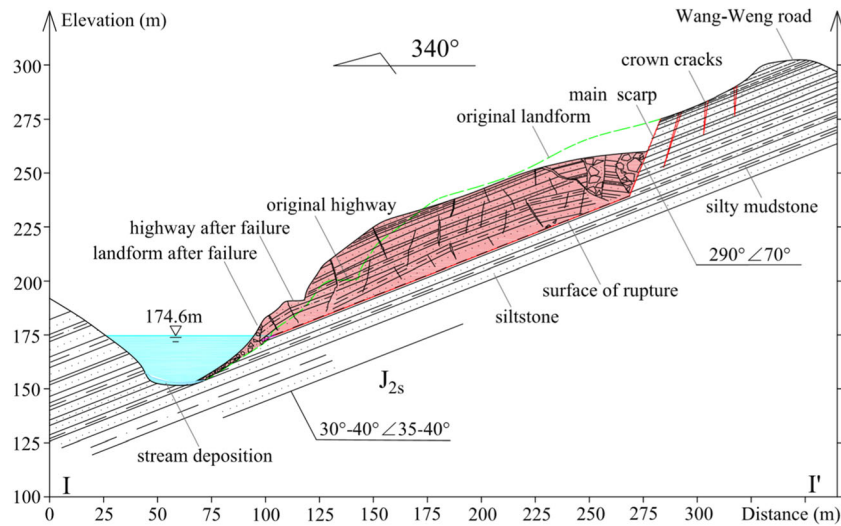
Although the slide mass slides in a wedge-shaped flume, formed in the structural surface and bedding of group A, it still slides along the bedding (Fig. 16) from the longitudinal profile, similar to the apparent dip slide. Based on the sliding bed and outcrop of underlying bedrock strata, it can be concluded that the shear outlet of the Kamenziwan landslide is located near the elevation of 174 m (Fig. 17). According to the profile estimation, the thickest part of the slide mass is about 30 m, and the average thickness is about 20 m. Therefore, the sliding area on December 10 can be calculated as $2.1 \times 10^4 \text{ m}^2$, with the landslide volume of about $42 \times 10^4 \text{ m}^3$.

Fig. 16 Engineering geological profile of Kamenziwan landslide. The water level on the day of the landslide is 174.6 m

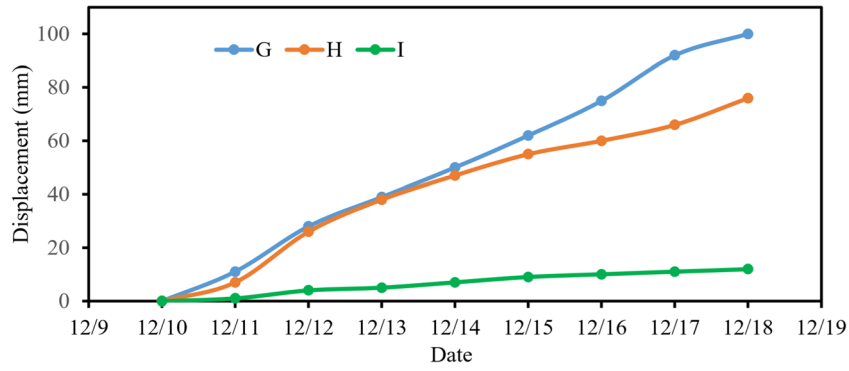
After landslide, the relative displacement of G, H, and I crack points (Fig. 2) at the trailing edge is monitored (Fig. 19). According to the daily relative displacement, G and H cracks (Fig. 18) have been expanded and deformed rapidly every day, with the average deformation between 9.5 and 12.5 mm. The deformation of crack I is small, with an average deformation of 1.5 mm. The maximum

Fig. 19 Relative displacement time curve of the cracks on retrogressive zone

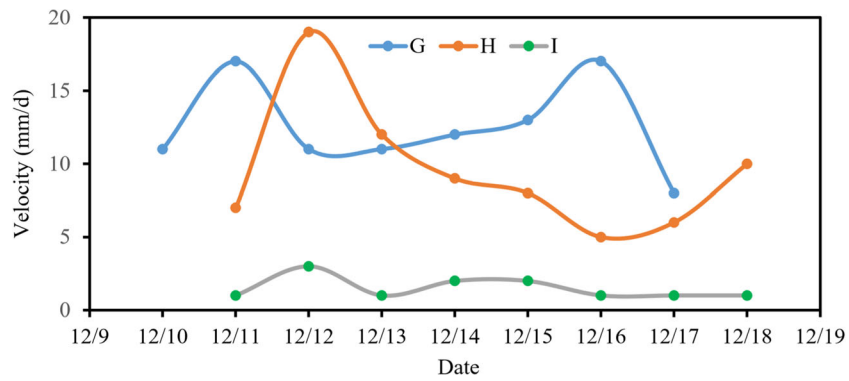
relative deformation rate of these three cracks has reached up to 17 mm/day, on December 12 (Fig. 20). However, due to the short monitoring time and only relative displacement monitoring, the stability trend of the retrogressive zone cannot be determined.

Fig. 20 Relative deformation rate time curve of the cracks on retrogressive zone

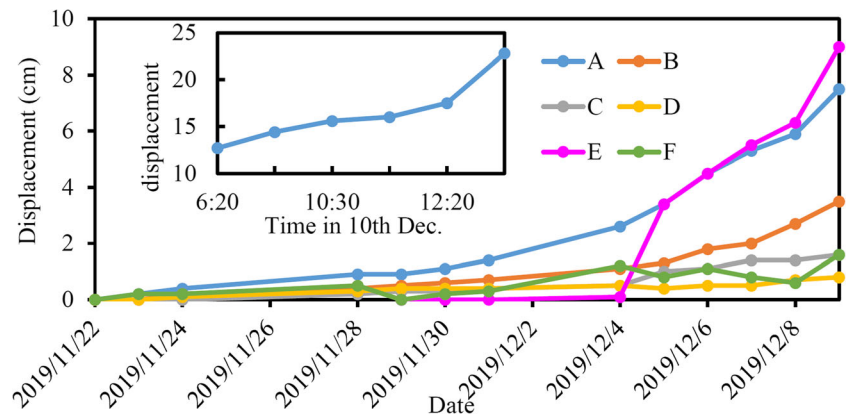
Fig. 21 The relative displacement time curve of A-F monitoring points. The small figure shows the deformation of crack A monitoring point before sliding on December 10

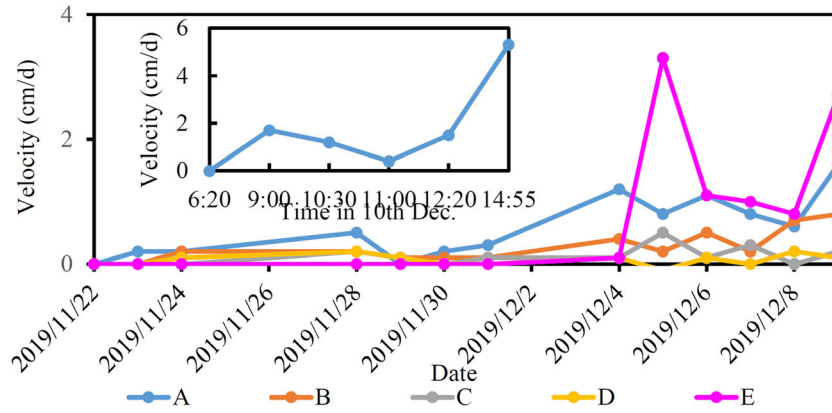
As it is very dangerous, only point A was monitored on December 10, the day the landslide failed.

From the above analysis, the relative displacement monitoring can also reflect the deformation process of the landslide. In consideration of the spatio-temporal location of the crack, the landslide deformation occurred first at the leading edge, followed by its occurrence at the middle and trailing edges. In terms of the deformation extent, the deformation of the trailing edge exceeds that of the leading edge. Therefore, the sliding of Kamenziwan landslide is caused by the traction of the leading edge and the thrust of the middle-rear part. Indeed, the leading-edge traction is crucial to the landslide initiation. It took 8 days from November 20 until the cracks appeared on the highway at point E of the trailing edge, which was the crucial period for the traction-type process. After the formation of cracks at the trailing edge, the gravity shift in the middle-rear parts began to play a major role.

Fig. 22 The relative displacement velocity time curve of A-F monitoring points. The small figure shows the deformation of crack A monitoring point before sliding on December 10

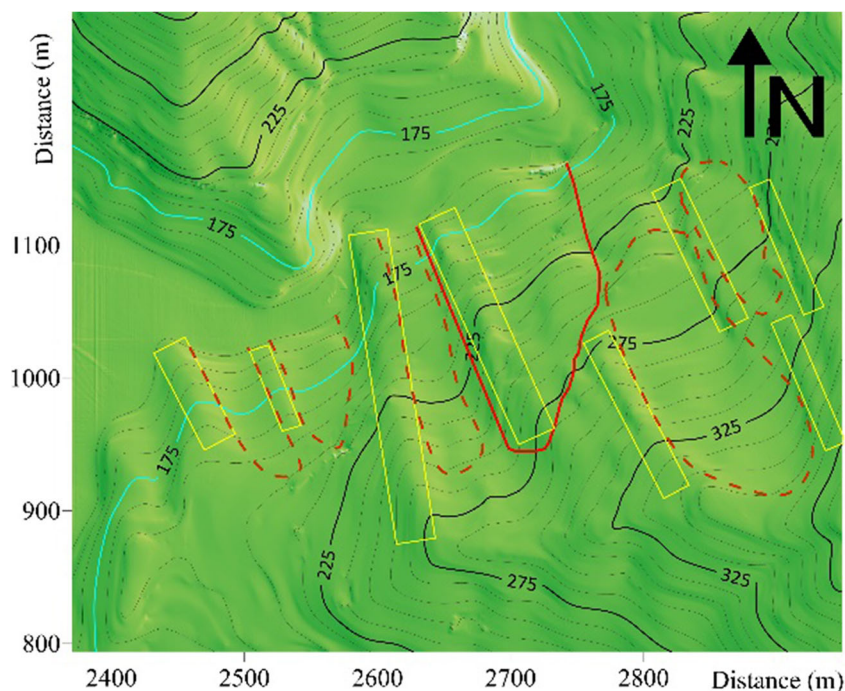
ancient landslides, such as gentle leading-edge platforms and chair-like geomorphology at the trailing edges (Ahmed and Rogers 2016), suggesting they were formed by historical landslides. Because this accumulation slope, formed by the historical failure of rock landslide, is gentle, and the loose accumulation thickness is not large and the stability is good, these historical landslides have not been identified yet. After the occurrence of multi-layered rock landslide, the stepped geomorphology will be formed (Xu et al. 2015). Therefore, in this area or similar areas, features such as near-parallel stepped geomorphology, bedding, oblique bedding, or apparent dip bedding geomorphology in the area cause potential geohazards in the adjacent bedrock mountains on both sides

of the area, similar to Kamenziwan. When the slope base of these potential geohazards is located in the water level fluctuation zone, further investigation and monitoring are required, in order to minimise the impacts of such a hazard on the environment and society.

Fig. 26 Identification instructions of Kamenziwan landslide. Topographic map and shadow image, before sliding. The yellow frame represents the ridgeline, the red solid line demonstrates the Kamenziwan landslide, and the red dashed line refers to the grooved landform, which may represent the history rocky landslide area
