Landslides (2021)18:3577–3597
 DOI 10.1007/s10346-021-01741-2
 Received: 31 December 2020
 Accepted: 12 July 2021
 Published online: 5 September 2021
 © Springer-Verlag GmbH Germany,
 part of Springer Nature 2021

Geo-structures and deformation-failure characteristics of rockslide areas near the Baige landslide scar in the Jinsha River tectonic suture zone

Abstract After two successive Baige landslides in the Jinsha River tectonic suture zone, a landslide scar with three steep free surfaces has been exposed in the source area, where three concomitant sliding blocks (K₁, K₂, and K₃) have been identified as continuously moving at high rates, suggesting further potential failures within these areas. This study focused on structural geology and conducted a comprehensive multidisciplinary analysis to understand the active features and geological evolution models for these sliding blocks. Results showed that the three rockslides can be further subdivided into eleven subdomains. The revealed rock masses are likely to be affected by faults, fracture zones, and folds, and are featured by widely distributed and variable interbedded lithology with heterogeneous qualities combined with fragme

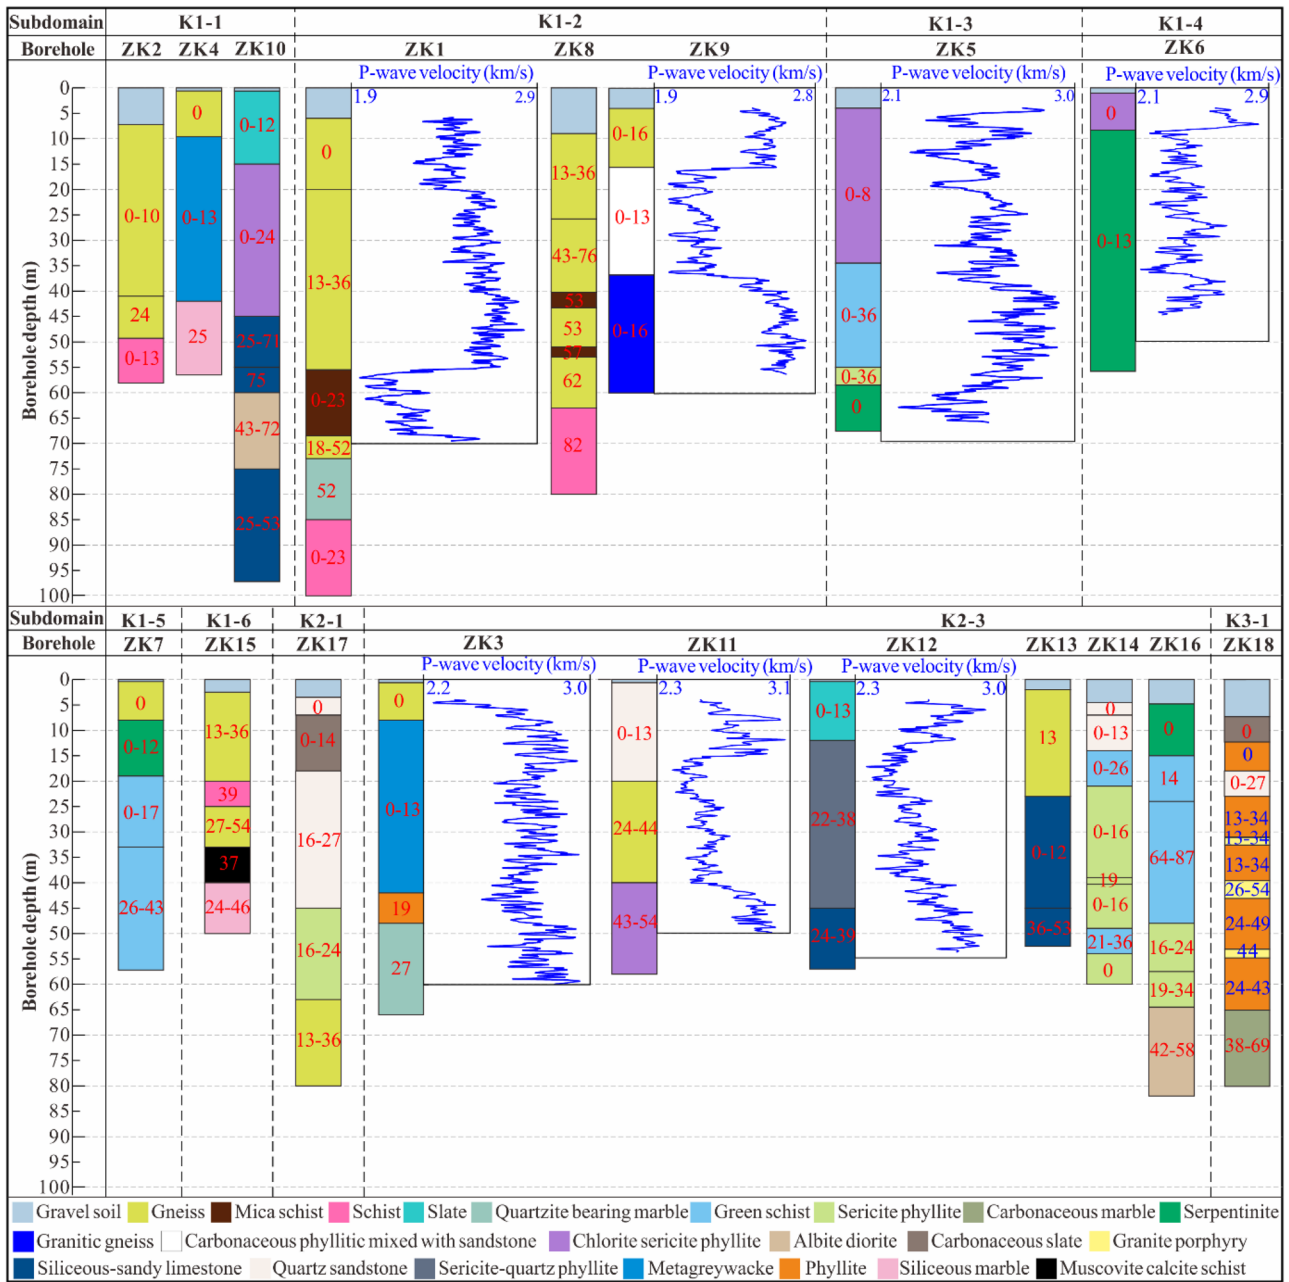
The cores logged in the boreholes are shown in Fig. 7. Some typical rock exposures observed in the boreholes of the first stage can be found in Zhang et al. (2020b). As shown in Fig. 7, complex lithologic distribution is the primary feature. First, the rocks forming P₁xn^a are dramatically diverse, consisting of twenty-one lithologies. In addition to widely distributed gneiss, other lithologies are sporadically exposed. Mylonite, shear zones, and faults are the main contact types between the lithologies. The rocks behind the landslide scar (including K1-1, K1-2, K1-3, and K1-6) are mainly gneiss and schist. On the north side of the landslide scar, K1-4 primarily consists of serpentinite, while the serpentinite in K1-5 presents a concave vein-like distribution, and the front part of K1-5 is especially mingled with relatively intact gneiss (Fig. 8a). However, K3 mainly consists of phyllite without serpentinite, and gneiss is exposed on its lower part (Fig. 8a). Furthermore, in ZK18, we found that the granite porphyry, which is clearly distinguished above the serpentinite on the outcrops of the landslide deposit according to Zhang et al. (2020a), is interbedded with phyllite and is intermittently outcropped with a maximum thickness of ~3.5 m (Figs. 7 and 8b). Additionally, the predominate features of the lithologic distribution on the south side include the extensive exposure of carbonaceous rock, as shown in ZK17, where the thickness of such rock is more than 10 m (Fig. 7), and daylighting highly weathered carbonaceous slate is distributed on the lower part of K2-1 (Fig. 8a). In addition, serpentinite exposes ~380 m away from Scarp-2 on the right side of the landslide scar according to the logging results of ZK16 (Figs. 7 and 8c), which updates the previous finding that serpentinite is only distributed on the left side of the landslide (Zhang et al. 2020a).

Fig. 7 Characteristics of the rock masses in the boreholes. The values of RQD are marked in the catalog of each core (unit: %). The sonic logging of P-wave for ZK1, ZK3, ZK5, ZK6, ZK9, and ZK11 is illustrated on the right side of the borehole catalog

From the lithology and rock fracture data shown in Fig. 7, it can be concluded that due to the varying degree of metamorphism, deformation, and weathering extent, the rock masses in the rockslide areas can be characterized by the wide and interbedded spatial distribution of various lithologies with extremely heterogeneous qualities. Such mutually embedded structures lead to many blocks not sliding despite apparent deformation, such as K1-5, because the front parts of these blocks are supported by better quality rock masses. Furthermore, according to our investigation results of the characteristics of rock masses (“Characteristics of rock masses” section)

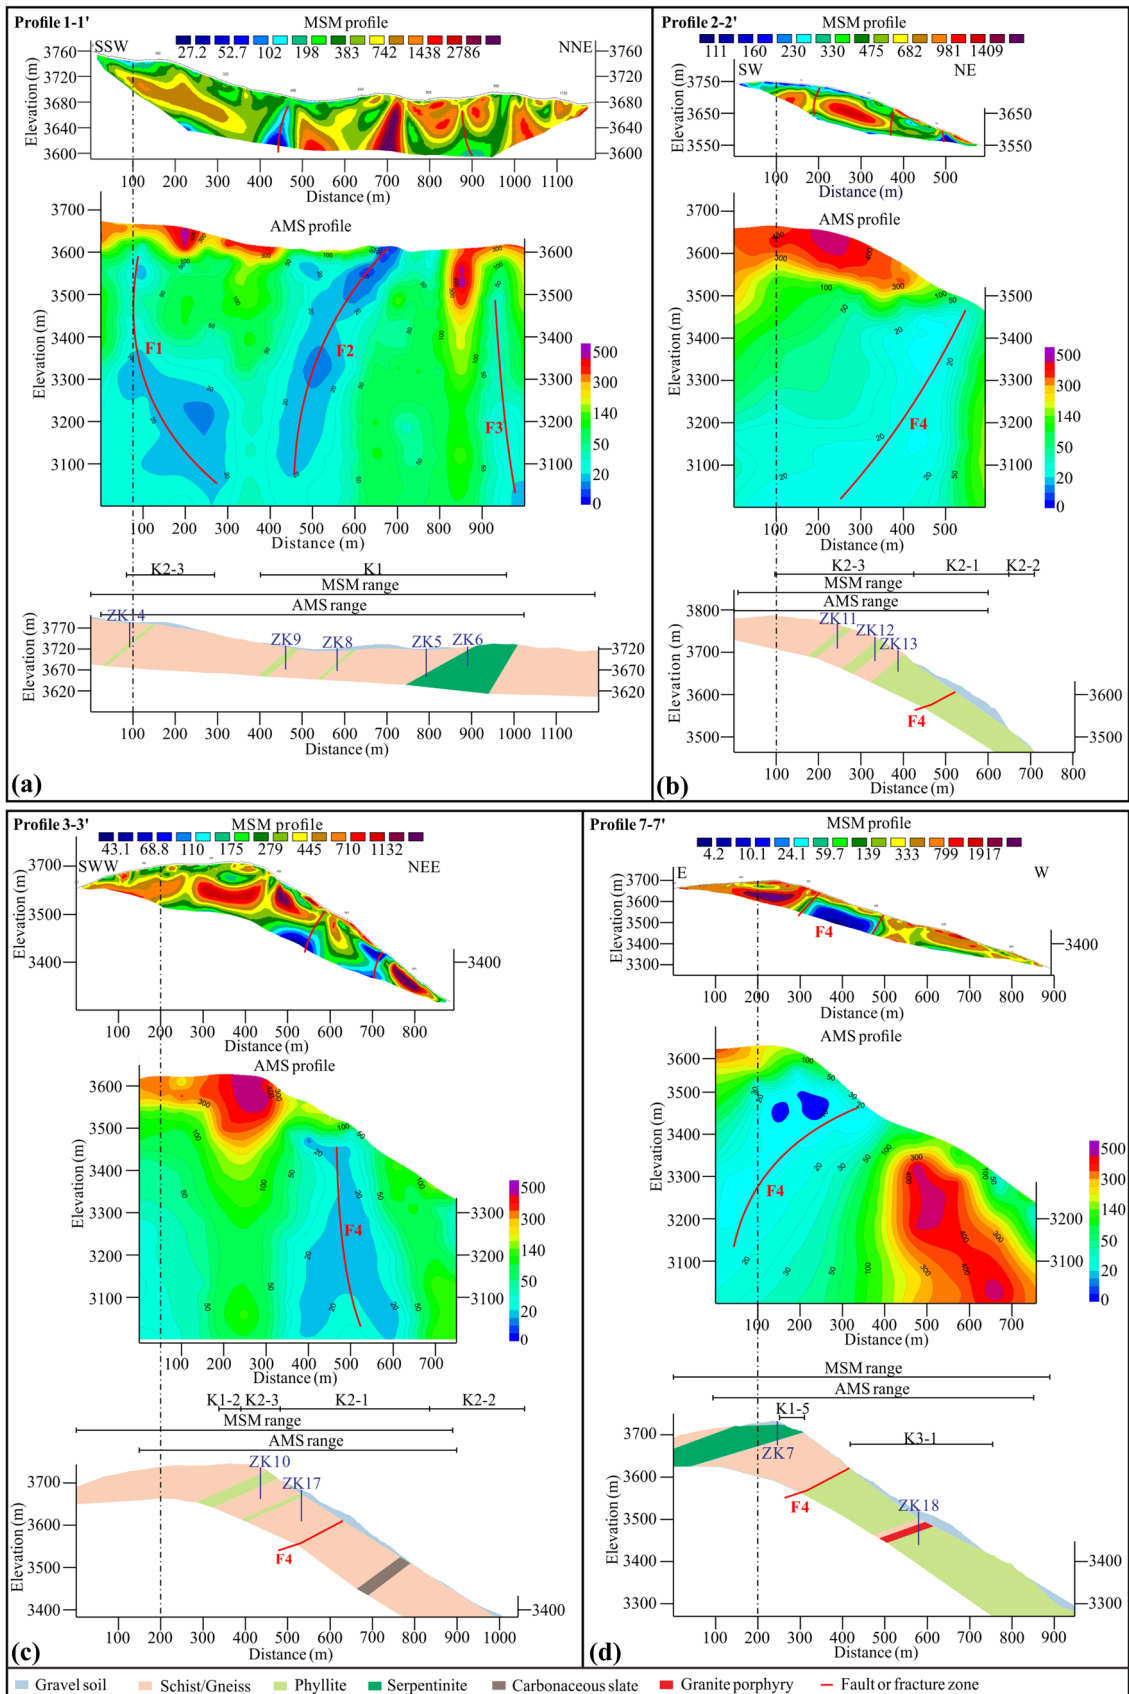
In addition to regional fault F1 (as shown in Fig. 1), a series of local geological structures that are otherwise difficult to detect on the surface can be determined near the rockslide areas by the geophysical survey. As shown in Fig. 9, several representative profiles obtained by the geophysical survey (MSM and AMS) have been made. Several faults or fracture zones can be inferred from the MSM profiles shown in Fig. 9. Reflectors approximately oriented to S–N (i.e., profile 1–1' in Fig. 9), consisting of one segment of lower resistivity and two segments of lowest resistivity as indicated by blue and light green colors, respectively, in the AMS profile (Fig. 9a), are

interpreted to be three steep faults or fracture zones that are named as F1, F2, and F3. In particular, F2 daylight at the surface in the same area (Fig. 10a) as a mapable feature of the AMS profile and field investigation. Among these faults or fracture zones in profile 1–1', F3 is relatively small in scale and exhibits a trend of northward dip, while F1, dipping to N, and F2, dipping to S, are larger in scale, thereby causing a wider range of heavily fractured rock on the south side of F2 (Fig. 9a). Other, lower resistivity zones, shown in light green along profile 2–2' by AMS, indicate that K2 is located in an area with larger-scale steep faults or fracture zones (named F4), mainly dipping to W (Fig. 9b). Moreover, on the right side of profile 2–2',

several lower resistivity zones, such as zones in profiles 3-3' (Fig. 9c) and 7-7' (Fig. 9d), are also interpreted as faults/fracture zones. These faults/fracture zones have similar distribution characteristics to F4, and therefore are inferred as a northward extension of F4.

Fig. 9 Geophysical survey results by MSM and AMS and related geological profiles for **a** profile line 1-1', **b** profile line 2-2', **c** profile line 3-3', and **d** profile line 7-7'. The profile lines are taken from Fig. 7

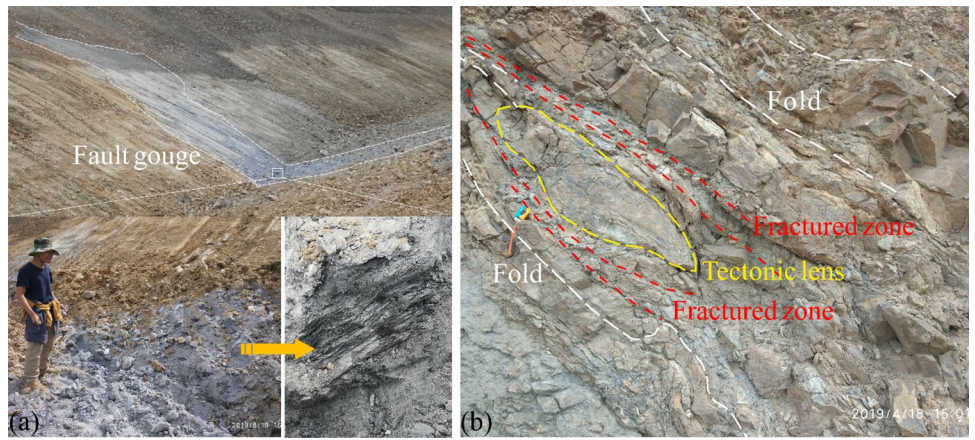
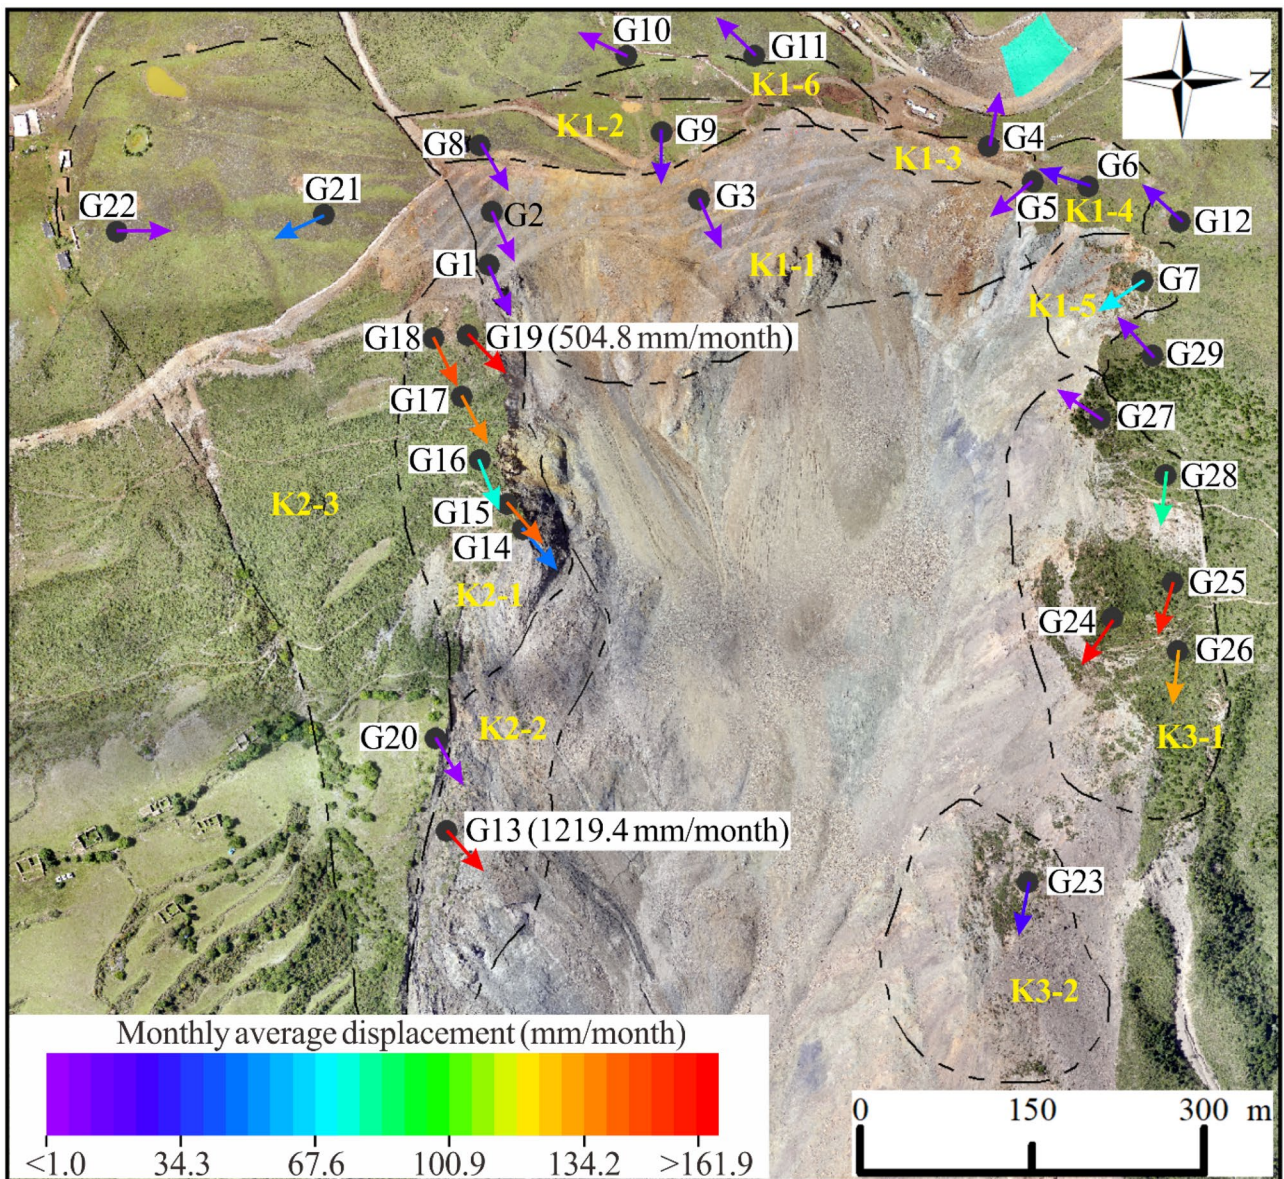
Fig. 11 Monthly average displacement recorded by GNSS

As for K2-1, combined with the overall deformation feature that gradually increases from the toe to the top (Fig. 11 and Table 2) and the observed bulging crack at its front part (Fig. 16), we can infer that the deformation–failure behavior, with bearing on these features, is characterized by “back–pushing” of an *en masse* slide. This implies that the front part of K2-1 is able to act as the locking section and thereby likely to both support the overlying rock mass and synchronously impede the deformation of the upper part of K2-1. Further, the extremely “mature” boundary and dramatic groundwater seepage indicate that this subdomain has the potential to fail.

For K3-1, due to the better rock mass integrity existed in the deeper layers (Figs. 7 and 8b), the gradually decreasing overall deformation trend is illustrated from the toe toward the top of the unstable block (Fig. 11 and Table 2), thereby showing multistage superficial collapse. The underlying evolution model is proposed to be “fore-pulling” of retrogressive superficial collapse in a progressive way with a lesser possibility of deep-seated failure.

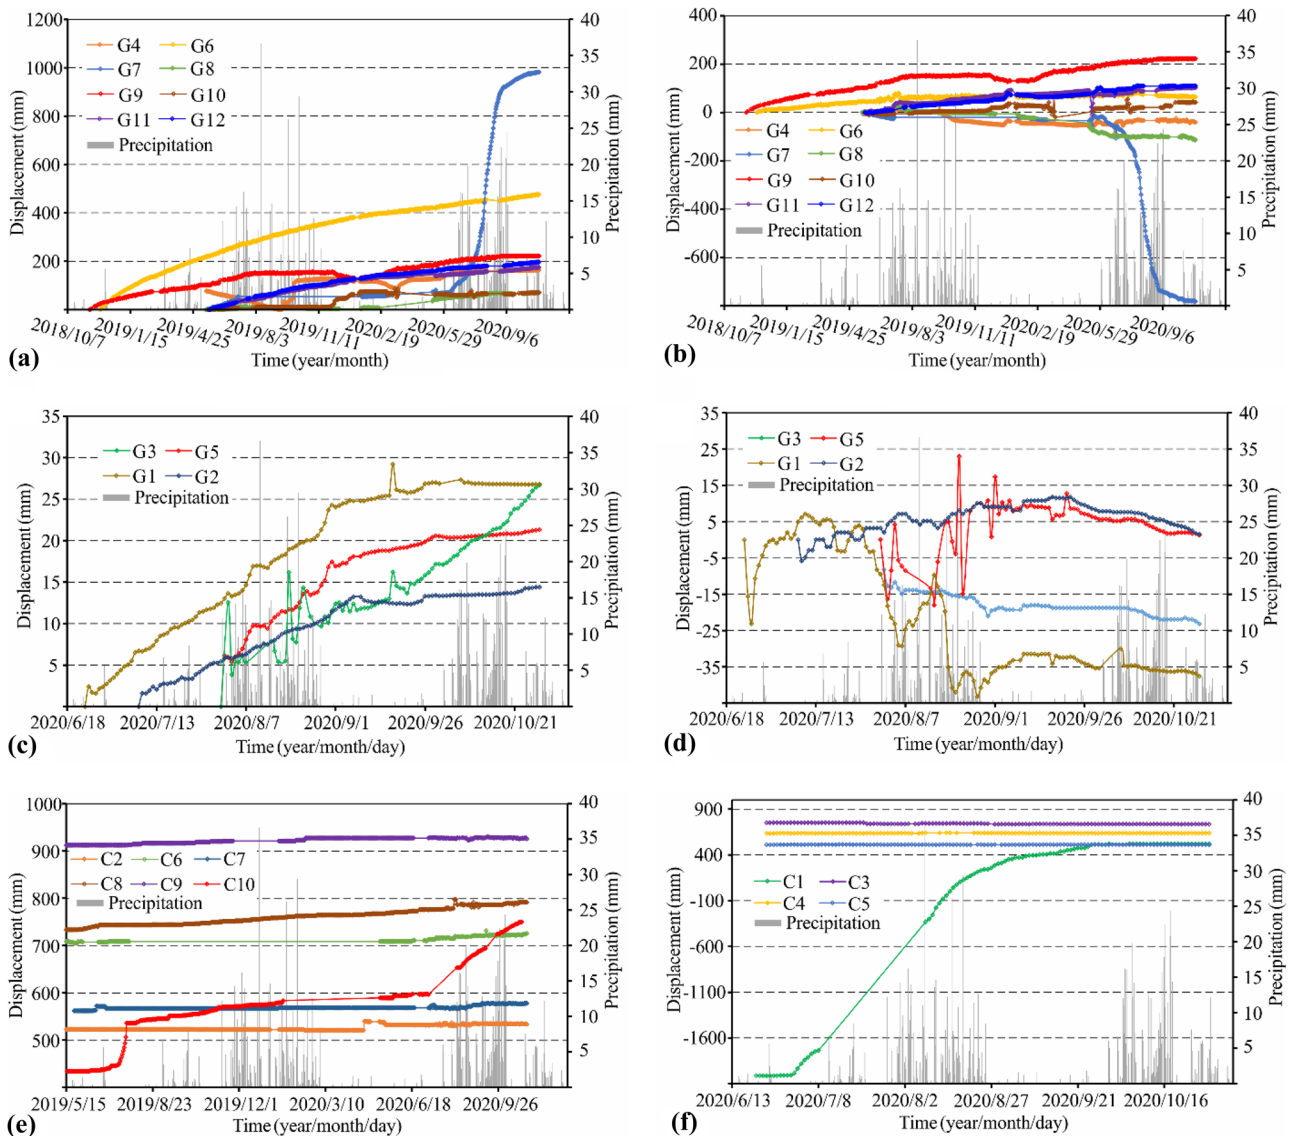
the monitoring curves with periods of short-lived yet very rapid deformation for several monitoring points installed immediately after the second rockslide event, including G6, G9, G18, and G24 (Figs. 12–14). However, the subsequent development and evolution of the unstable rock blocks are intensely related to the daylighting geo-structure. In this section, the influence of geo-structures on deformation and failure of rockslide areas are discussed.

Fig. 12 Displacement and precipitation versus time curves on K1: **a** and **c** horizontal displacement versus time monitored by GNSS, **b** and **d** vertical displacement versus time monitored by GNSS, and **e**

and **f** relative displacement–time curves obtained from extensometer. The vertical displacement is positive upward

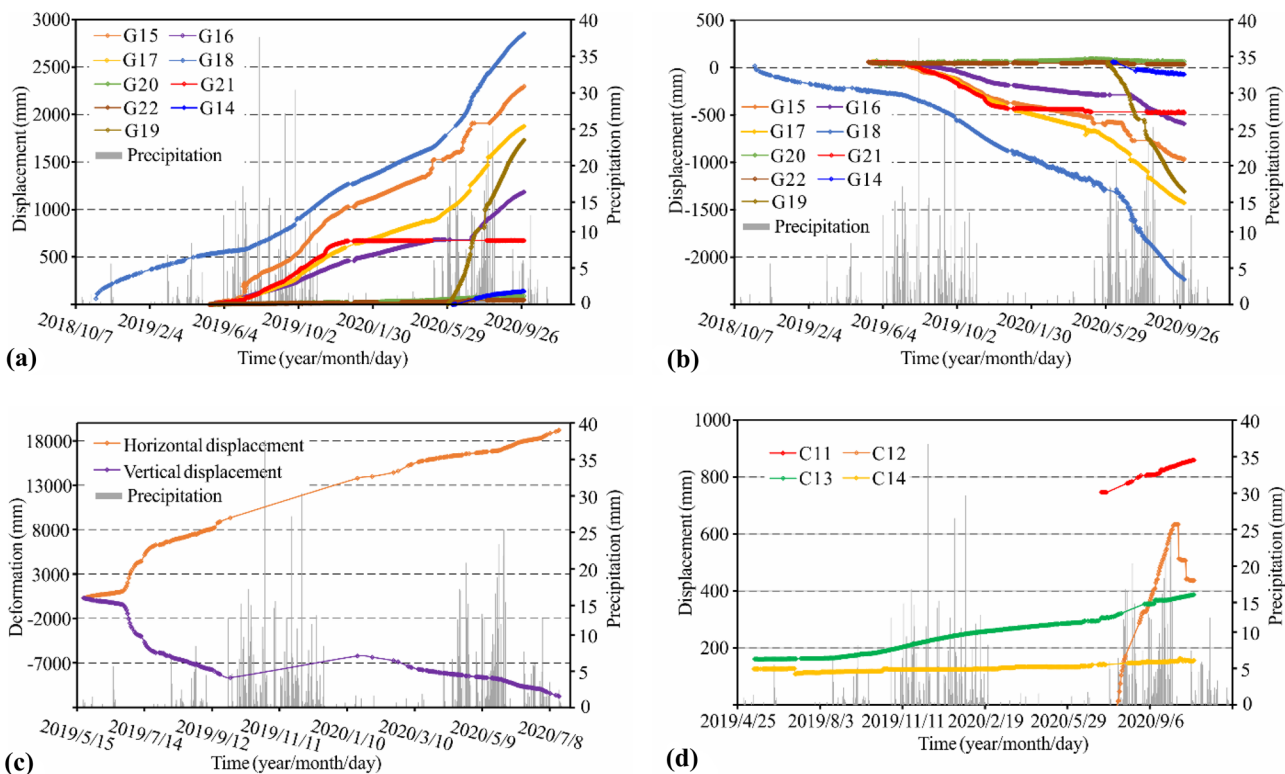
Fig. 13 Displacement and precipitation versus time curves on K2: **a** and **b** horizontal and vertical displacement versus time monitored by GNSS, respectively, **c** displacement–time curves obtained from G13,

and **d** relative displacement–time curves obtained from extensometer. The vertical displacement is positive upward

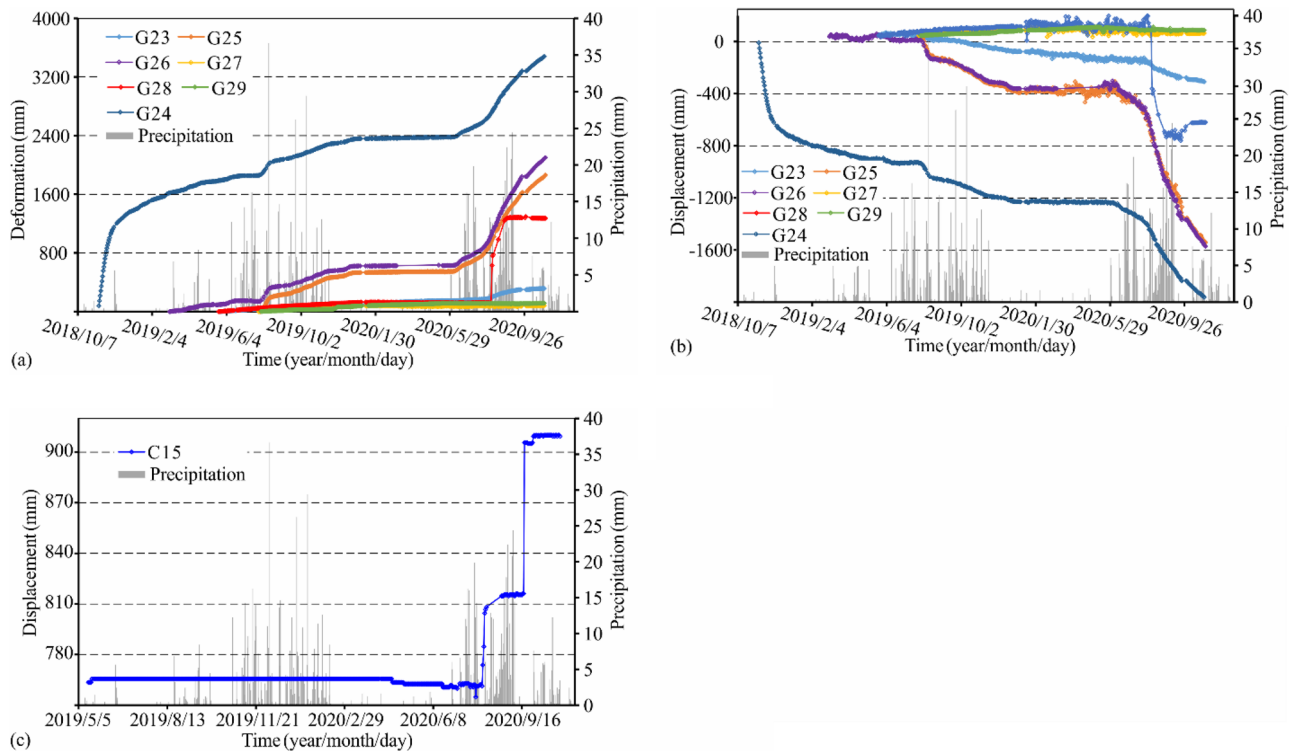
Fig. 14 Displacement and precipitation versus time curves on K3: **a** and **b** horizontal and vertical displacement versus time monitored by GNSS, respectively, and **c** relative displacement–time curves obtained from E15. The vertical displacement is positive upward
