Peculiar earthquake damage on a reinforced concrete building in San Gregorio (L'Aquila, Italy): site effects or building defects?

Abstract In San Gregorio (L'Aquila, Italy) a three-story, reinforced concrete (RC) building had the first floor collapsed following the earthquake of April 6, 2009. The remaining two stories fell with a displacement in the horizontal projection of about 70 cm. This unusual behaviour is made more puzzling by the fact that buildings located at a short distance and with similar features had little or no damage reported. To understand the causes of the collapse we performed strong motion recordings, microtremor measurements, a detailed geological survey, a high-resolution geo-electrical tomography, a borehole with a down-hole test. On the building we performed a geometrical survey and laboratory tests on concrete cores. The acceleration and noise recordings have shown a high amplification with uphill-downhill direction. The geological survey has revealed the presence of co-seismic fractures on stiff soils. Geo-electrical tomography has shown an unexpected, strong discontinuity just below the building. Taking advantage of excavations in adjacent lots, we hav

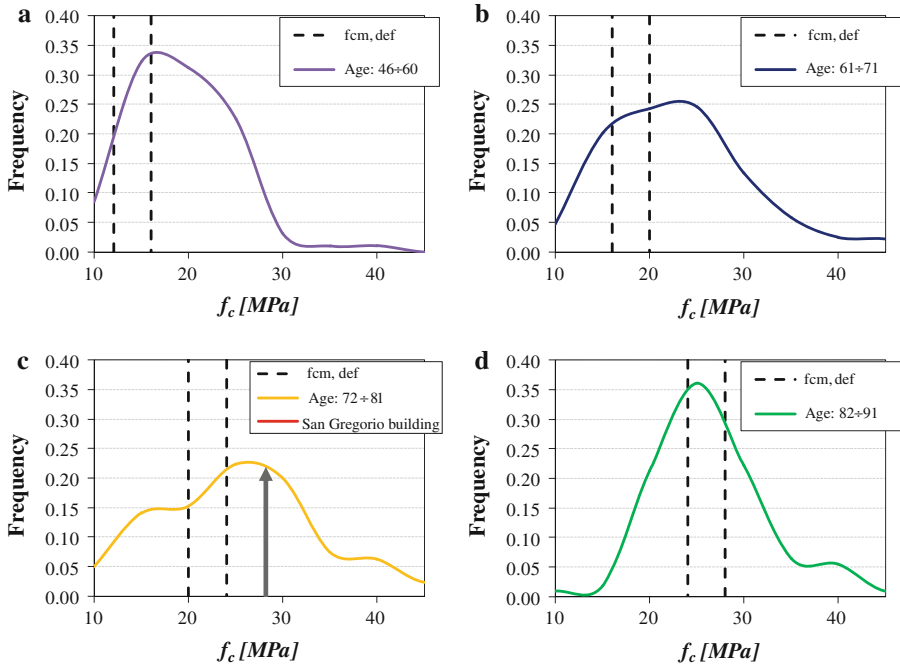
Finally, the average value of the in situ concrete strength was been obtained: $f_{cm} = 28.1$ MPa. This value has been compared with experimental results of in situ concrete strength obtained by existing RC buildings (Masi and Vona 2009). The experimental results show that in situ concrete strength is remarkably dependent on the period of construction (Fig. 5). Average values of f_c are in good agreement with the expected values relevant to the standards of the time of the construction $f_{cm,def}$. Moreover, it is worth noting that the above experimental strength evaluated for the San Gregorio RC building is higher than the

average value of the construction period (Fig. 5c). Finally, considering the global quality of the building, it is possible to exclude detrimental conditions or deterioration of materials.

Fig. 5 Distribution of in situ strength values f_c vs $f_{cm,def}$ (mean default values in various construction periods). In panel c the experimental value for the San Gregorio RC building is reported as a straight line

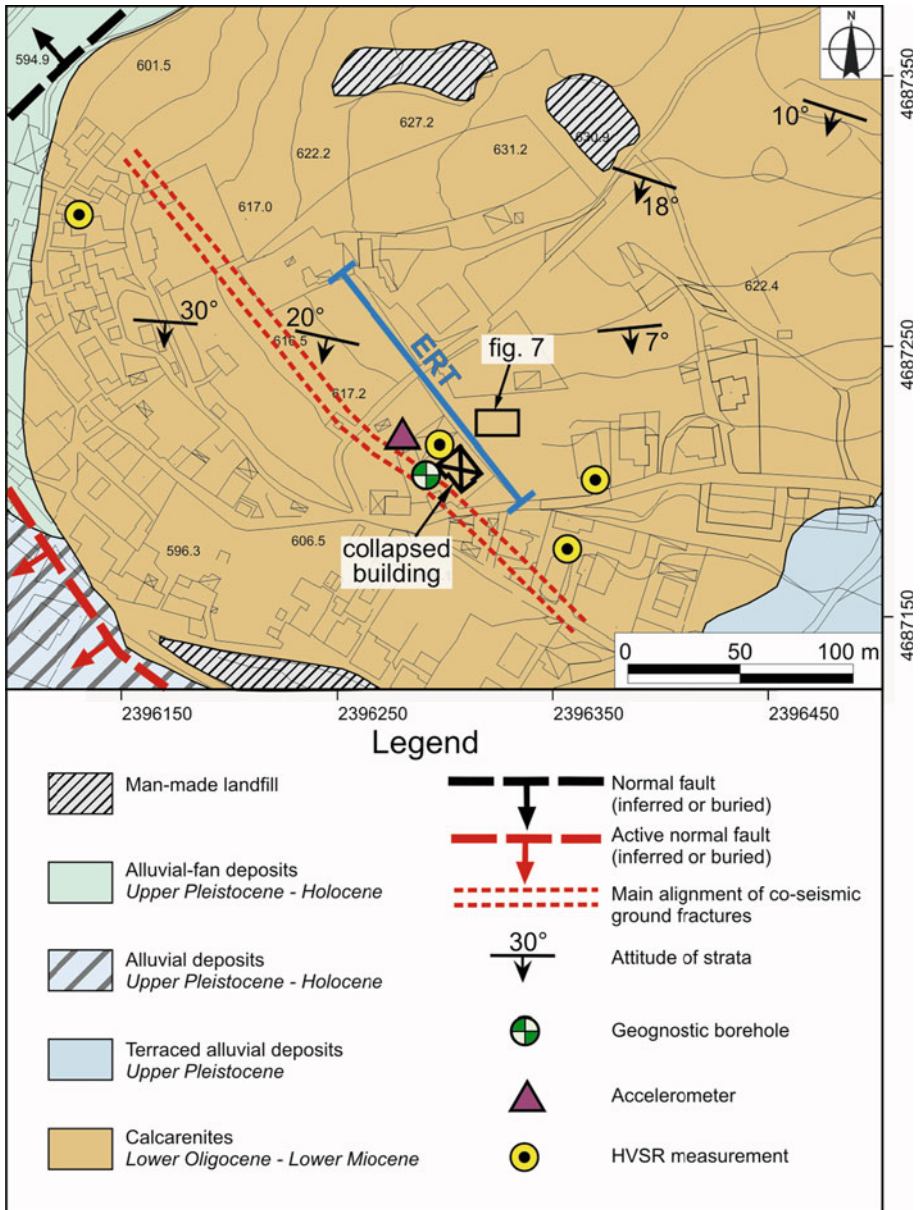
The main structural features in this area are represented by two normal faults, whose surface traces are covered by the Upper Pleistocene-Holocene alluvial deposits (Fig. 6). In particular, the NW-SE trending normal fault (SW edge of the map in Fig. 6) is considered as still active.

In Fig. 6, the alignment of the co-seismic ground fractures detected and mapped in the first days after the mainshock is also reported, which shows the same NW-SE trend of the active normal fault.

Fig. 6 Geological map of the area where the collapsed building stood. The locations of the geophysical tests and the geognostic borehole are also reported

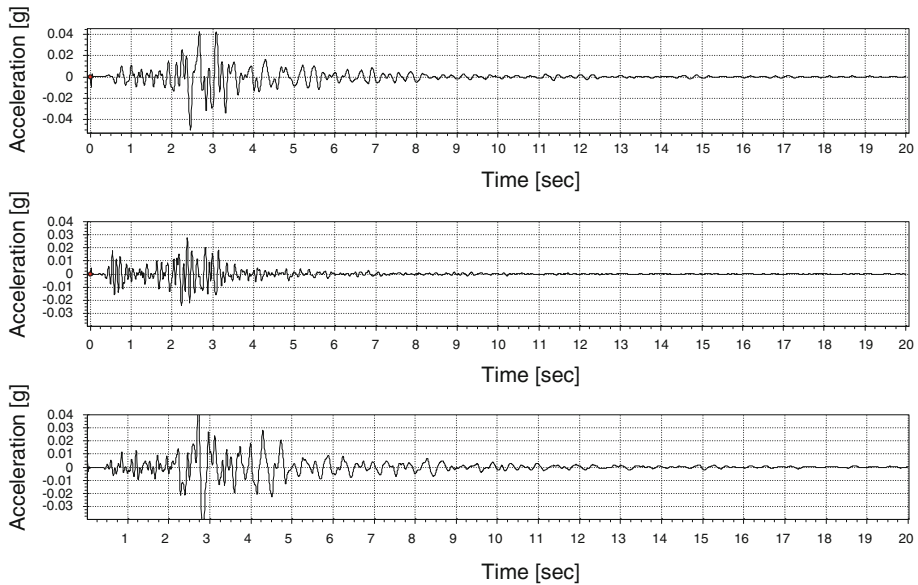
Fig. 10 Acceleration recordings of the $M_I = 4.0$ shock on April, 23rd at 15.14. Components are NS (upper), UD (middle) and EW (lower)

To understand if seismic site amplification could be a possible cause of damage we have performed several ambient noise and earthquake recordings. The aftershocks were recorded by the accelerometer Kinematics Altus K2 installed by German Task Force (GFZ-Potsdam) close to the collapsed building two days after the mainshock and uninstalled on April 26. Figure 6 reports the location of the station. The magnitude of the recorded earthquakes ranges between 3.0 and 4.0MI and the epicentral distance between 10 and 40km. Table 1 reports the principal characteristics of these seismic events, while Fig. 10 reports the acceleration recordings of the strongest aftershock recorded, $M = 4.0$ on April 23rd at 15:14.

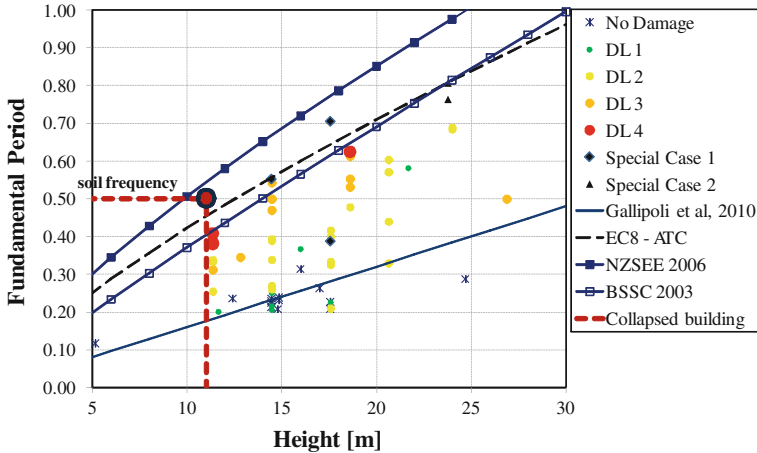
Fig. 14 Correlation among height–period–damage level (modified from [Ditommaso et al. 2010](#))
