Performance of the L'Aquila (central Italy) gas distribution network in the 2009 (M_w 6.3) earthquake

Simona Esposito · Sonia Giovinazzi ·
Ludovica Elefante · Iunio Iervolino

Received: 28 December 2012 / Accepted: 23 June 2013 / Published online: 2 July 2013
© Springer Science+Business Media Dordrecht 2013

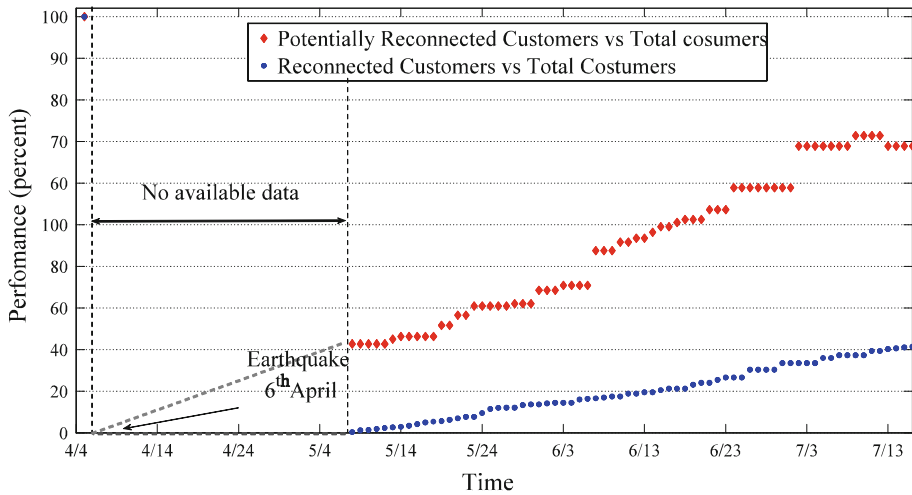
From the figure it also emerges that data on potential reconnection and end-user activation was available only since the 6 of May. In fact, from 6 April 2009 to 6 May 2009, when information was not available, a hypothetical trend for the network performance has been assumed (dashed lines in Fig. 11) considering that, immediately after the earthquake, the entire network was shut off.

The restoration curves in Fig. 11, can lead to some preliminary considerations on the L'Aquila gas system resilience to the 6 April 2009 earthquake. For an infrastructural system, a measure of resilience, R , may be related to the area pertaining to the restoration curve in Fig. 11, from the time of shock to that at which the pre-event level of performance is taken back.

Fig. 11 Observed resilience-related curve for the L'Aquila gas network following the 2009 event
