Performance of buildings with masonry infill walls during the 2011 Lorca earthquake

Lutz Hermanns · Alberto Fraile ·
Enrique Alarcón · Ramón Álvarez

Received: 24 February 2012 / Accepted: 29 July 2013 / Published online: 9 August 2013
© Springer Science+Business Media Dordrecht 2013

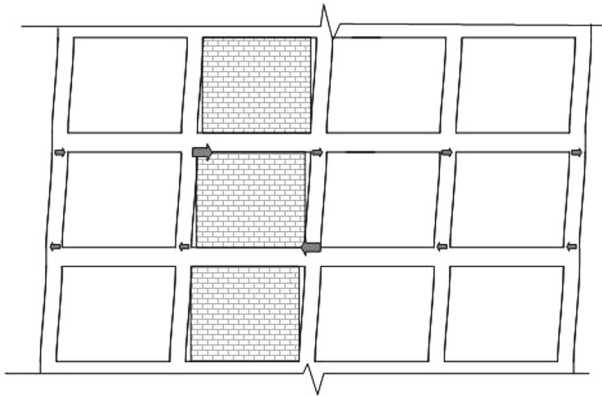
- Shear force concentration in combined systems consisting of RC columns and masonry infill walls (see Fig. 8). In order to estimate realistic shear forces during the design phase it is crucial to take the stiffness of the masonry infill wall into account however, quite often infills are not considered in the structural building model that is used for the seismic response analysis. It is quite common that only one infilled bay exists at ground level. In this case the infill is usually part of the elevator core walls.

Fig. 8 Shear force concentrations at beam–column junctions due to the presence of masonry infill

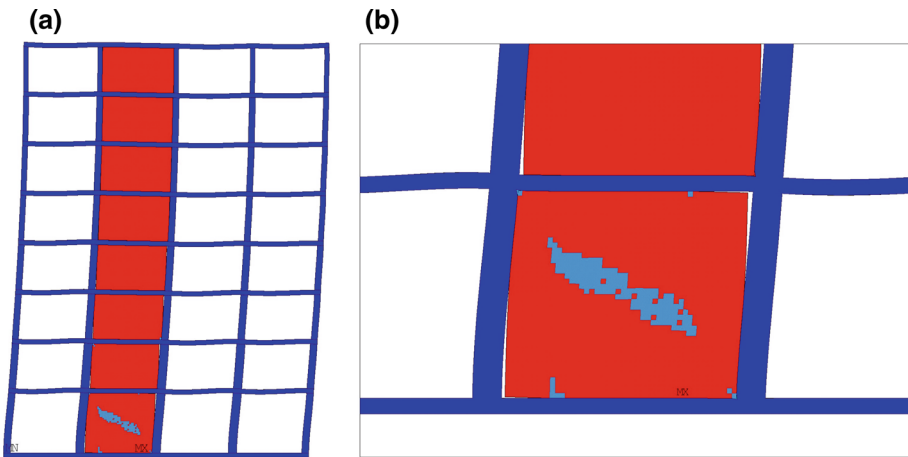
**Fig. 23** Building 1: **a** Front view of the deformed structure; **b** Detail of the infill wall at ground floor level

In Fig. 23 the configuration is shown when a diagonal crack forms in the infill panel. At this stage the relative displacement of the ground-storey is 5.3 mm which corresponds to a lateral drift of 0.12 %.

In Fig. 23b open gaps of up to 1.7 mm between the infill wall and the surrounding frame are clearly visible as well as the diagonal crack that develops in the infill panel. In Fig. 24 the contact pressures between masonry infill and columns are presented.

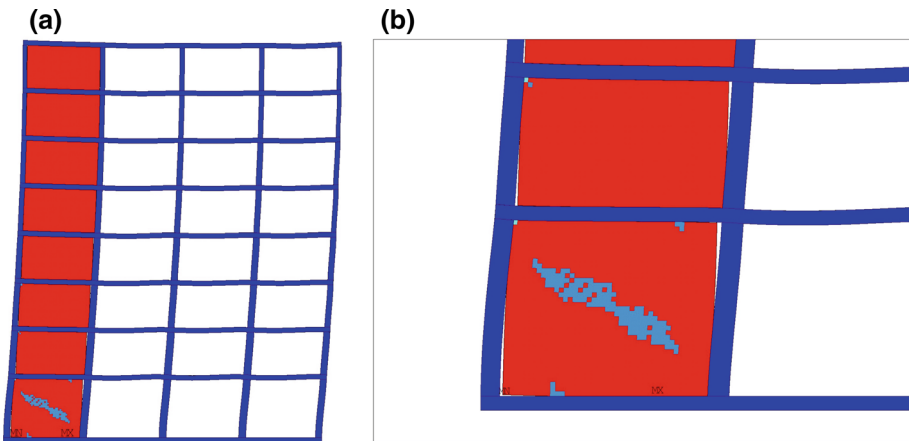
Fig. 26 Building 2: **a** Front view of the deformed structure; **b** Detail of the infill wall at ground floor level

In Fig. 26 the configuration is shown when a diagonal crack forms in the infill panel. Due to the lower stiffness of the lateral resistance system the relative displacement of the ground-storey is higher and reaches 6.3 mm which corresponds to a lateral drift of 0.16 %. In this case open gaps of up to 2 mm form between the infill wall and the surrounding frame.
