Seismic performance of masonry residential buildings in Lorca's city centre, after the 11th May 2011 earthquake

Luisa Basset-Salom · Arianna Guardiola-Víllora

Received: 21 December 2012 / Accepted: 19 November 2013 / Published online: 1 December 2013
© Springer Science+Business Media Dordrecht 2013

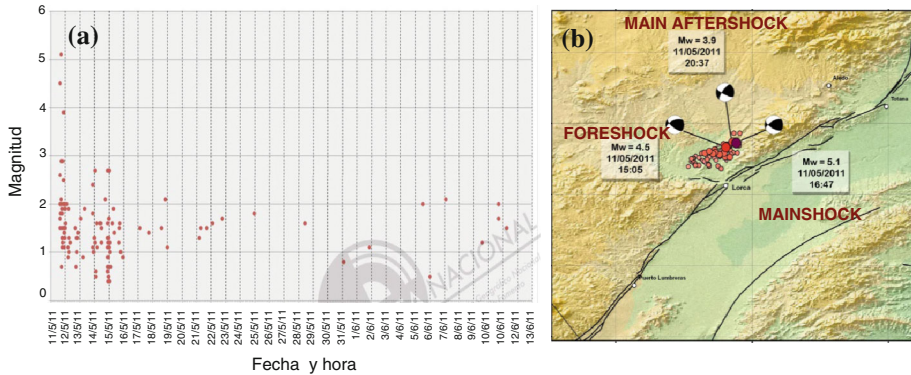
Fig. 2 **a** Earthquake sequence (IGN 2011) and **b** location of the foreshock, mainshock and main aftershock (Cabañas et al. 2011)

Preceded by a $M_w = 4.5$ foreshock at 15:05:13 (lat: 37041 N, long: 16812 W) and six tremors including a $M_w = 2.6$, the $M_w = 5.1$ mainshock (lat: 376946 N, long: 16756 W, 2 km NE historic city centre) was the strongest of a sequence of earthquakes that finished on July 14th, after a distribution of 135 aftershocks (Fig. 2), including a $M_w = 3.9$ and a $M_w = 2.9$ (IGN 2011).

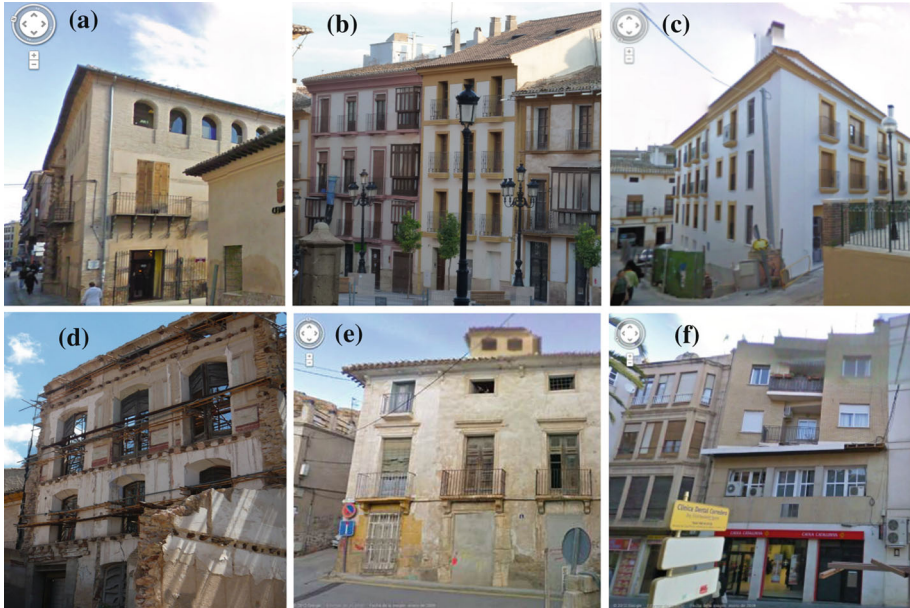
Fig. 5 Buildings in the surveyed area, before the earthquake: **a** fullrestored mansions with residential or administrative use, **b** traditional residential buildings, **c** new apartment dwellings, **d** cleaned up buildings, **e** abandoned buildings and **f** new reinforced concrete buildings (Google Street View)

braced façades, (e) abandoned buildings waiting to be declared ruined and (f) new reinforced concrete buildings built from 1970 to 2000 (see Fig. 5).

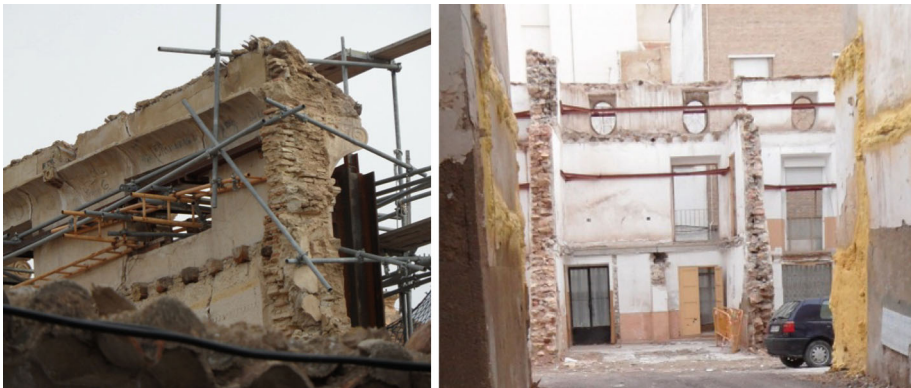
The vertical structural system of traditional URM residential buildings in Lorca consists of load bearing orthogonal walls forming the street façades (or the main façade and the interior courtyard façade) and the party walls (Fig. 6). Sometimes, depending on the building plan, there are interior walls with structural function.

Fig. 6 Vertical load-bearing masonry walls: street façades and party walls

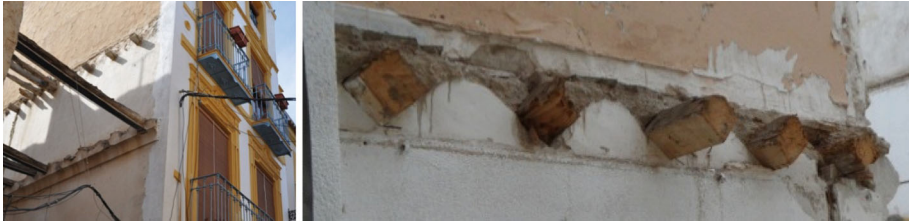
Frequently, buildings in a block share the party walls, presenting also a continuity of the horizontal structure and the roof overhang, either because they were built at the same time or because new buildings in between two older ones used the existing walls (Fig. 8). In these situations attention has been paid to possible coupling effects, considering buildings together instead of individually.

Fig. 8 Shared party walls

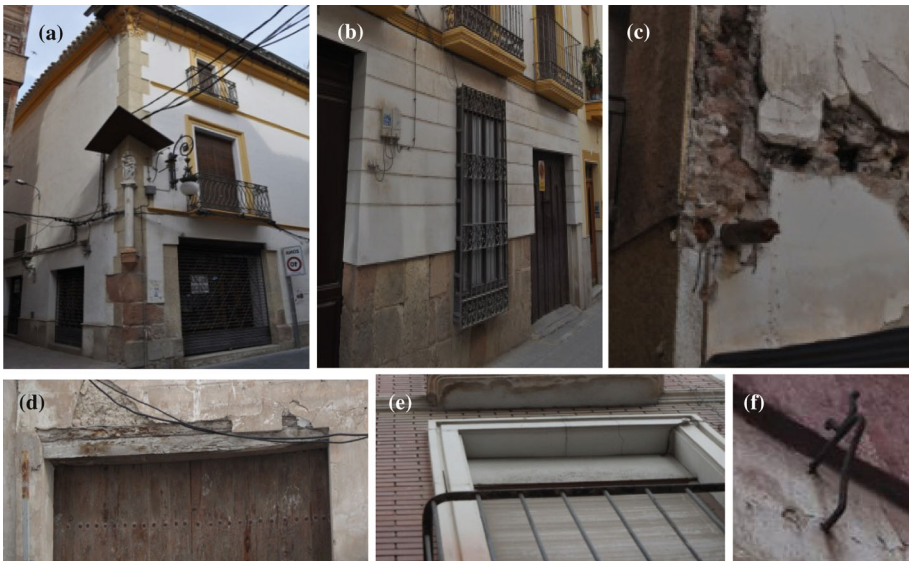
Fig. 9 Reinforcement elements: **a** quoins, **b** plinths, **c** floor and wall timber ties or timber ring beams, **d** timber lintels, **e** stone frames around openings and **f** iron ties

Being Lorca in a region of moderate seismicity, some reinforcement elements can be found: stone quoins in one or more storeys, plinths, floor and wall timber ties or timber ring beams placed horizontally in the middle of the thickness of the wall, timber lintels, stone frames around openings and a few iron ties connecting the façades to the floors or to the orthogonal walls (Fig. 9).

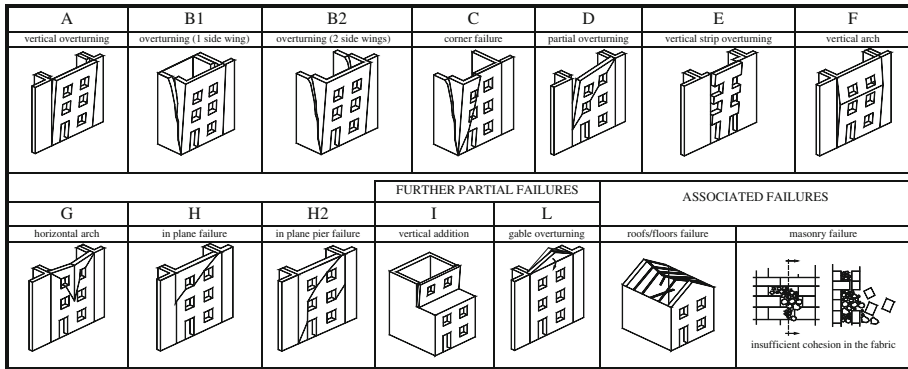
Fig. 11 Sketches corresponding to FaMIVE mechanisms: out-of-plane and in-plane mechanisms, partial failures and associated failures (D’Ayala and Speranza 2002, 2003; D’Ayala and Novelli 2011)

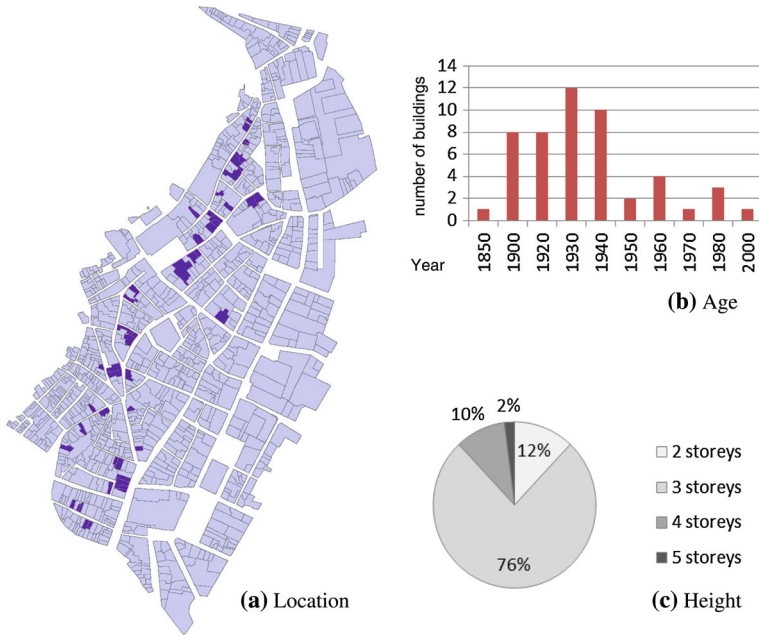
Fig. 13 a Location, b age (buildings from 1980 to 2000 correspond to masonry buildings in which horizontal timber structures have been replaced with RC floors) and c height of the sample façades

The location of surveyed buildings in the target area, their age (78% built before 1940) and the number of storeys are shown in Fig. 13. Although most of the buildings have three storeys, differences up to two storeys are present, with considerable variation across the sample, in floor to floor height, plan shape, street front's dimensions, opening layouts, etc.

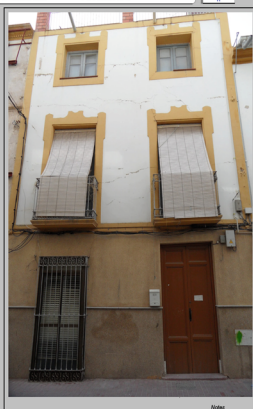
Fig. 14 Famive electronic inspection form (D'Ayala and Novelli 2011). Example of a surveyed façade in Lorca

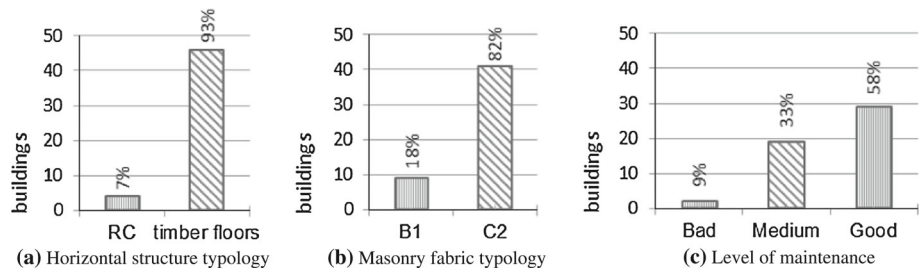
Fig. 15 Sample characteristics in percentages: **a** Horizontal structure typology (RC: RC floors and timber floors: traditional timber beams and joists with lightweight vaults floors), **b** masonry fabric typology (B1: kiln brickwork and C2: poor quality rubble stone, according to FaMIVE description) and **c** level of maintenance (bad, medium and good)

Sample characteristics regarding horizontal structure typology, masonry fabric typology and level of maintenance in percentages are shown in Fig. 15. The percentage of façades with bad level of maintenance is very low because, according to the selection criteria mentioned in this section, ruined buildings have not been included in the sample.
