# Structural damage in the cities of Reggiolo and Carpi after the earthquake on May 2012 in Emilia Romagna

Marco Andreini · Anna De Falco ·  
Linda Giresini · Mauro Sassu

**Abstract** This paper addresses the structural damage to the main buildings of the cities of Reggiolo and Carpi after the primary earthquake shocks on May 20th and 29th, 2012, in Emilia Romagna. The damage survey, performed via form-based methods, highlights the different seismic behaviour of several types of buildings, especially those having historical features, and the consequences of the damage in terms of costs. Moreover, an analysis of some failure mechanisms activated in Reggiolo enables the evaluation of the local peak ground acceleration, due to the soil amplification.

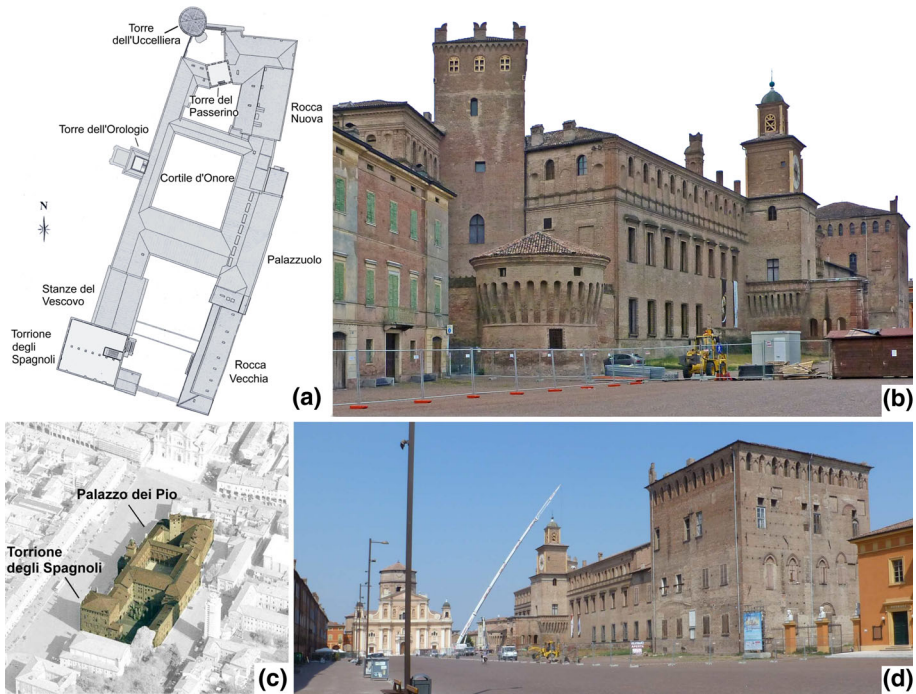
**Fig. 16** *Palazzo dei Pio*—**a** scheme; **b** view from north, in front of the *Torre dell'Uccelliera*, after the earthquakes; **c** axonometric view of the complex **d** view from south, in front of the *Torrione degli Spagnoli* after the earthquakes

This tower was created in 1450 by joining two adjacent towers. It is connected to the *Palazzo dei Pio* (Fig. 16a) along the north-eastern side. The four-storey brick masonry building is rectangular in section, 20m × 23 m. The floors are mainly supported by brick vaults, often decorated, and the roof is sustained by large wooden trusses resting on the outer walls and isolated columns (Fig. 20a). The building has always been state-owned, but it is currently abandoned and in a poor state of maintenance. Only the lower floors were partially consolidated after the 1996 earthquake. During the two shocks of May 2012 the *Torrione* suffered further damage to its interior walls, with some frescoes and vaulted ceilings with decorated plasters. However, few additional diagonal cracks appeared on the walls and vaults: the recently installed tie rods helped to contain out-of-plane mechanisms. The most cracks are located at the top of the building, on the outer walls, particularly vulnerable to the presence of a great number of openings (Fig. 20b). Moreover, the roof trusses (Fig. 20a), some of which were in conditions of incipient collapse, produced local damage to the walls, due to punching actions during the seismic oscillations. Indeed, many out-of-plumb sections are noticeable on the upper part of the walls.

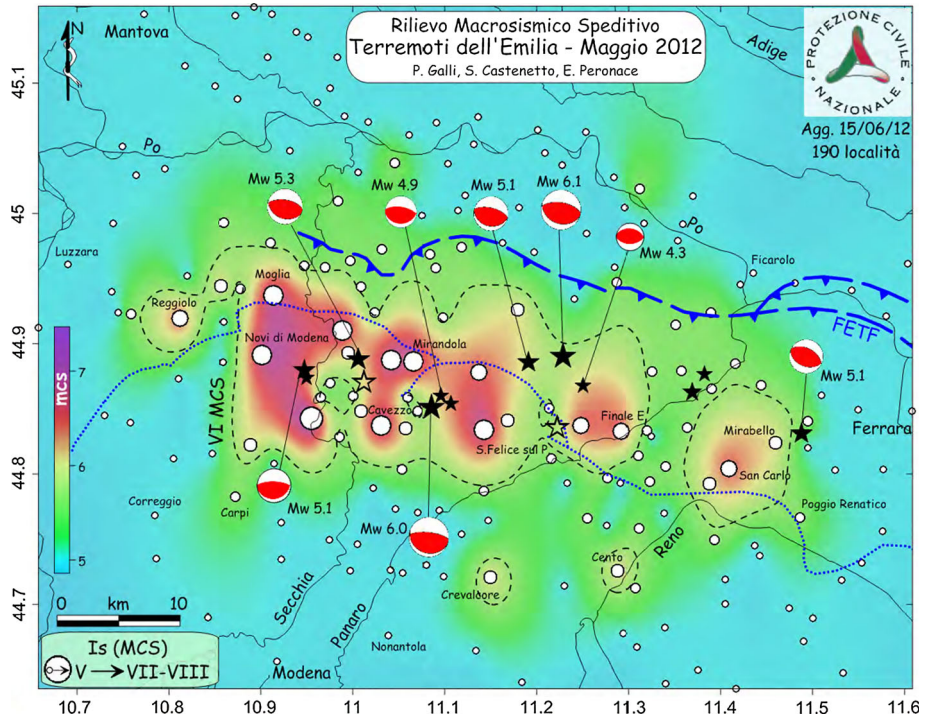
Fig. 27 Macroseismic survey map (Galli et al. 2012)

In addition, it is interesting to note that the damage in Reggiolo was generally greater than in the surrounding municipalities located closer to the epicentre, as shown (Fig. 27) in the map of the macroseismic survey (Galli et al. 2012).

This fact is probably due to local amplification produced by the soil. A well-known fact is that the surface seismic response generally differs from the shaking in the bedrock and varies from one area to the next depending on the specific geological and morphological conditions of the soil. In addition, in the areas prone to producing local effects, the soil response to different shock levels may be different. In this regard, the current Italian Technical Norms on Constructions (NTC 2008) provide a local amplification coefficient  $S$  to take account of both the soil morphology and topographic effects.
