Damage assessment of three medieval churches after the 2012 Emilia earthquake

Abstract The architectural heritage was severely damaged by the seismic sequence that occurred in Emilia (Northern Italy) in May 2012. This paper investigates the seismic behavior of three masonry churches that were damaged by the 2012 Emilia earthquake. The analyzed churches are located in the South-East area of the province of Mantua: they are representative of some churches, denoted as “Matildic churches”, belonging to the territorial area between Lombardia, Emilia Romagna and Toscana and built during the Matilde di Canossa domain, between the X and the XI centuries. The study was based on detailed field surveys, in situ tests, visual inspections and existing archives in order to obtain an accurate knowledge of the churches and a proper evaluation of the damage caused by the earthquake. Then, detailed finite element models of the churches were developed and non-linear dynamic analyses with different peak ground accelerations were performed. The numerical simulations provided a deep insight into the seismic behavior of the analyzed churches, identifying the damage patterns and the main collapse mechani

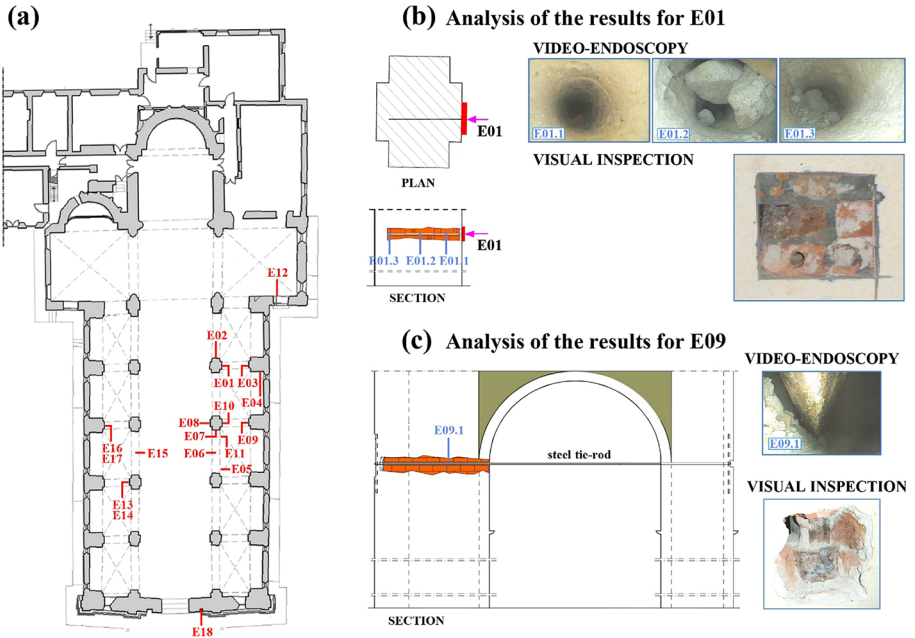
Fig. 11 a Locations of the video-endoscope inspections, b video-endoscope inspection on a column, c video-endoscope inspection in correspondence with a tie-rod

As a result of this qualitative survey, two different typologies of masonry were detected. The oldest Romanesque masonry of the transept and the façade—characterized by a greater thickness—proved to be a multi-wythe masonry made of two exposed faces with square and regular bricks and an inner core filled with irregular material bonded by quite compact mortar; the absence of voids was revealed. The XVI century masonry of the central nave and the aisles proved to be compact and consisting of solid bricks for the entire wall thickness; sporadic discontinuities were observed.

Figure 11 shows the locations and some images of the video-endoscope and visual inspections on a column of the central nave and on an arch of the aisles, in correspondence with a tie-rod.

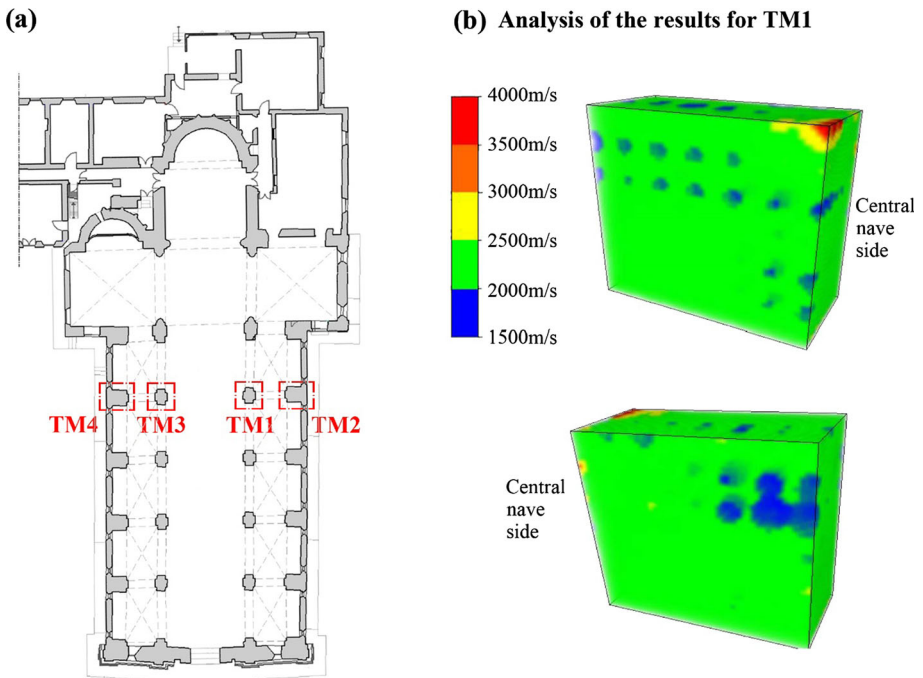
Fig. 12 a Locations of the sonic tests, b tomographic survey on a column

Sonic and tomographic tests were carried out on four elements to verify the density and homogeneity of masonry by means of the sonic speed distribution. The locations of the tests and the results obtained for a column are shown in Fig. 12. Two columns of the central nave and two walls between the chapels of the aisles were selected, so that only the XVI century masonry was tested. The choice of these elements was performed on the basis

From the data processing, it can be noted that the masonry sections investigated by sonic and tomographic tests are characterized by values of sonic speed mainly within 2000 and 2500 m/s. This result indicates a medium-compact masonry of fairly good execution. The absence of very low and heterogeneous speed values indicates that large masonry discontinuities are not present (i.e. internal holes or poor quality units). It has to be noted that, even if any sonic or tomographic test was performed on the Romanesque masonry, not too different findings may be expected on the basis of the outcomes obtained through the endoscopic inspections.

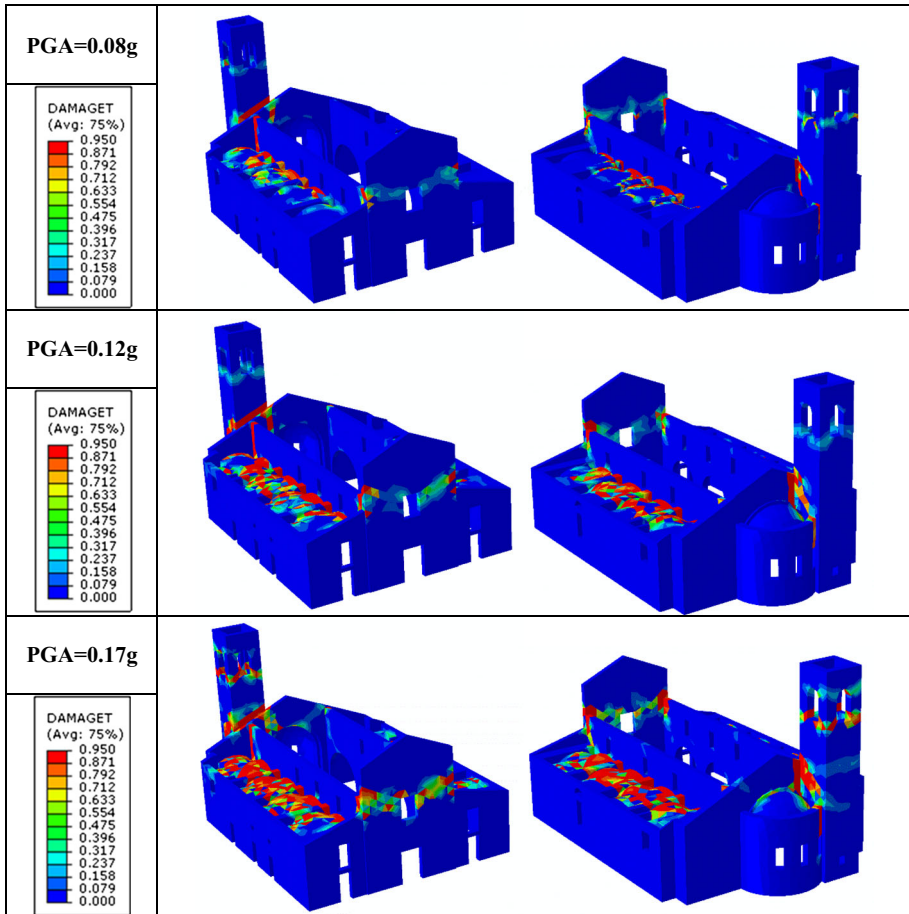
Fig. 29 San Fiorentino Martire church: tensile damage contour plots at the end of the non-linear dynamic analyses for different peak ground accelerations

The non-linear dynamic analysis under $PGA = 0.08\text{ g}$ shows a significant damage in the vaults of the aisles chapels, localized mainly in the connection region with the walls of the central nave and along the arches connecting the different chapels: such damage is consistent with what observed in situ, (Fig. 17e, photos 09–10; Fig. 17f, photos 11–12). A slight damage starting from the central opening is visible on the façade. A vertical damage is registered between the façade and the longitudinal walls of the central nave, as observed during the damage survey, (Fig. 17a, photos 01–02). A localized damage is observed between the bell tower and the hall wall and between the bell tower and the apse wall, as documented by the damage survey, (Fig. 17h, photos 14–15). The bell tower presents a slight damage near the openings of the belfry, as reported by the in situ survey, (Fig. 17h, photos 14–15).

The non-linear dynamic analyses under higher values of PGA show a considerable enlargement of damage, involving the entire vaults system. In particular, it is possible to

observe a widespread damage along the ribs of the vaults of the side chapels, a possible detachment of the aisles vaults from the walls of the central nave and a significant damage in the arches of the masonry vaults. A localized damage can be noted in the contact region between the bell tower and the walls of the church. Furthermore, a clear damage is registered near the connection region between the façade and the walls. The façade presents a significant horizontal damage near the central opening and an extensive damage with sub-horizontal distribution is visible in the belfry, above all in the analysis under $PGA = 0.17$ g. The apse does not present damage in the external wall, but a severe damage can be noted along the contact region between the apse wall and the bell tower, visible also in the analysis under $PGA = 0.08$ g.

A specific evidence has not been found for the damage reported in the walls of the central nave, (Fig. 17b, photos 03–04; Fig. 17g, photos 13–14), of the apse, (Fig. 17c, photos 05–06), and of the transept, (Fig. 17d, photos 07–08). It is worth mentioning that the damage observed in the wall of the central nave from the in situ survey may be related to the Romanesque origin of the macro-element (which may consist of a multi-wythe

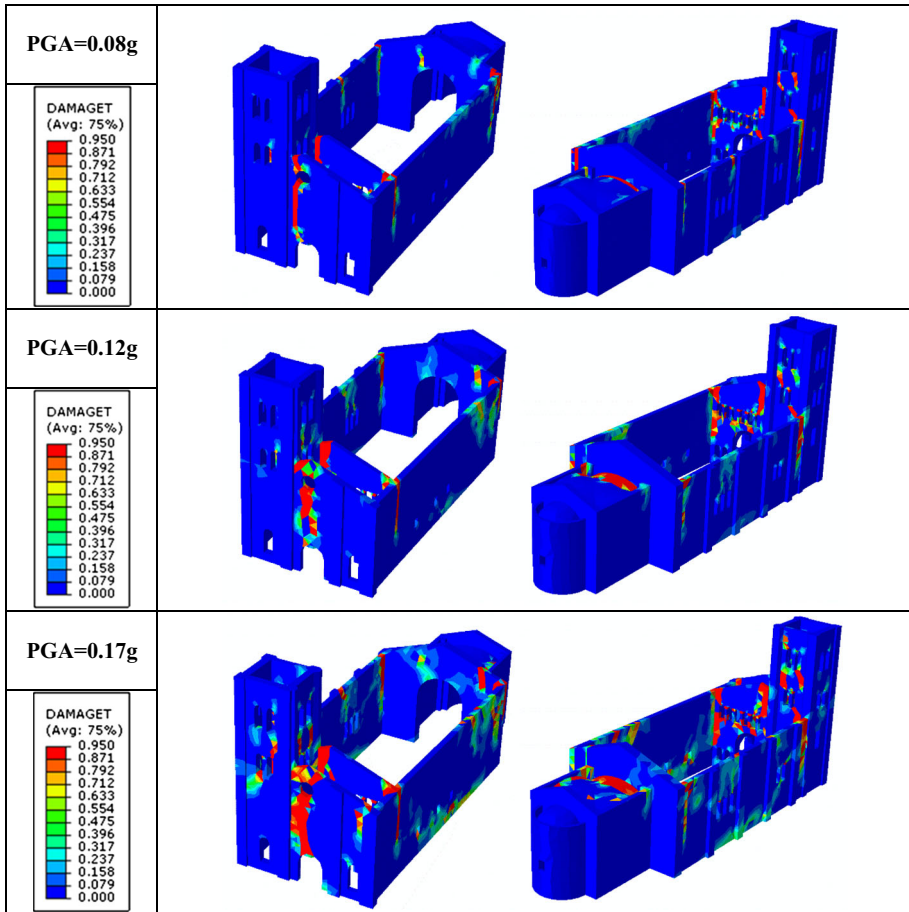
Fig. 30 Santa Maria Assunta church: tensile damage contour plots at the end of the non-linear dynamic analyses for different peak ground accelerations

The non-linear dynamic analysis under $PGA = 0.08$ g shows that damage is mainly concentrated in the regions where the bell tower interacts with the walls of the church, involving the main façade and the transversal and longitudinal walls of the nave: such damage may be explained considering the different geometrical and dynamic features of the adjacent elements. A vertical damage is detected in the connection regions between the bell tower and the façade and between the bell tower and the perimeter wall: it is consistent with what was observed in situ, (Fig. 19f, photos 13–16). Moreover, a significant vertical damage is recognizable in the corner between the southern longitudinal wall and the transversal one: it was partially observed in situ, (Fig. 19e, photo 09). A visible damage along the connection between the vaults of the atrium and the supporting walls emerges and it reflects the real damage, (Fig. 19c, photo 05). A clear damage is visible along the arch connecting the presbytery and the hall: it does not represent exactly what was detected in situ, (Fig. 19d, photos 07–08). A localized damage is concentrated in correspondence with some openings along the longitudinal and transversal walls of the hall, the bell tower and the atrium: it was partially observed in situ, (Fig. 19b, photo 04; Fig. 19e, photos 11–12).

The non-linear dynamic analyses under higher values of PGA show an enlargement of damage in the façade and in the connection region between the bell tower and the perimeter wall. The perimeter walls exhibit a clear vertical damage that increases with increasing levels of PGA: such damage is compatible with in situ survey, even though it is less marked. The analysis under $PGA = 0.17$ g reveals a localized damage near the openings of the belfry, not visible in the real crack pattern. The damage maps clearly show a considerable damage in the masonry vault of the presbytery, which may indicate an incipient detachment between the vault system and the wall, not registered during the in situ survey. An extension of damage is also observed: (1) in the counter-façade, with damage that develops mainly close to the openings, as observed in situ, (Fig. 19a, photos 01–02); (2) in the chapels walls, with damage generally close to the arches, as observed in situ, (Fig. 19a, photo 03); (3) in the longitudinal and transversal walls, with vertical damage spreading from the top of the walls; (4) in the connection regions between the masonry vault of the *Cappella Gemella* and the longitudinal wall, with clear evidence of the detachment of the vault from the wall.
