Seismic performance of the infill masonry walls and ambient vibration tests after the Ghorka 2015, Nepal earthquake

Humberto Varum¹ · André Furtado¹ · Hugo Rodrigues² ·
João Dias-Oliveira¹ · Nelson Vila-Pouca¹ · António Arêde¹

Keywords Masonry infill walls · Damage survey · Ambient vibration tests · Nepal · RC structures

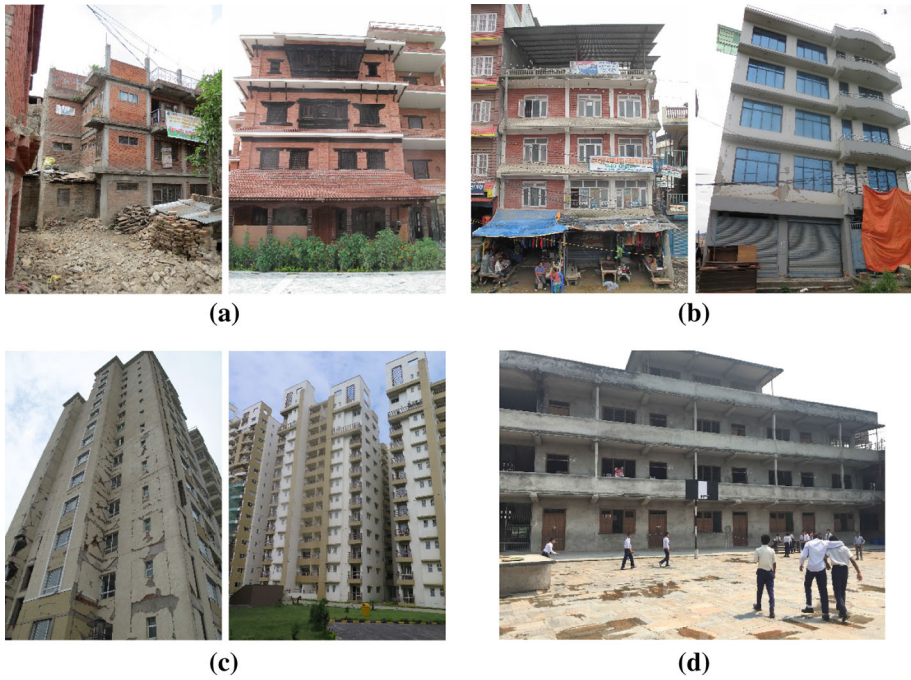
In the region of Kathmandu and Bakthapur the RC buildings are usually between 3–4 (low rise buildings), 4–6 storeys (medium rise buildings) and in isolated locations and considerably smaller number it was found some high rise buildings which clearly stand out from the surrounding buildings. In Fig. 4 it is observed four typical buildings according to the occupations (a) regular residential, (b) regular residential buildings with commercial stores in the ground level, (c) high rise residential buildings and (d) Schools or hospital buildings with large implantation dimensions.

Fig. 4 RC building typologies in Nepal: **a** residential buildings, **b** residential and commercial buildings, **c** residential buildings and **d** secondary school

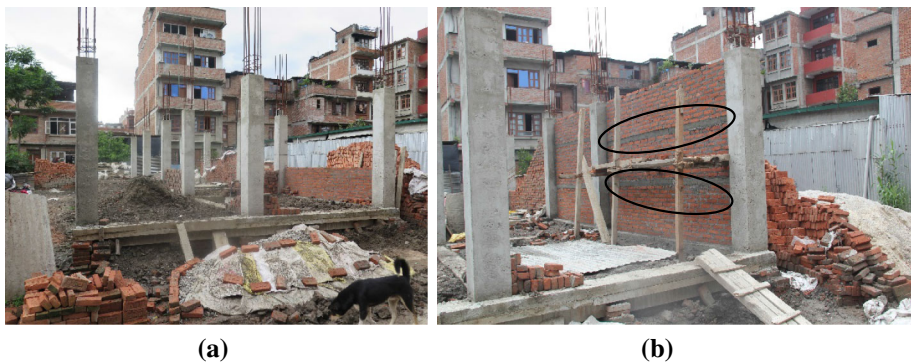
Fig. 5 Typical IM walls construction process in Nepal

row of bricks disposed on the transversal. In some cases, it was observed the existence of RC lintels with thickness around 5–7.5 cm, built at half-height of the panels or in the bottom/top of the openings as can illustrated in Figs. 5 and 6. The longitudinal reinforcement detailing of the lintels is usually composed by 206 mm, and a poor concrete quality.

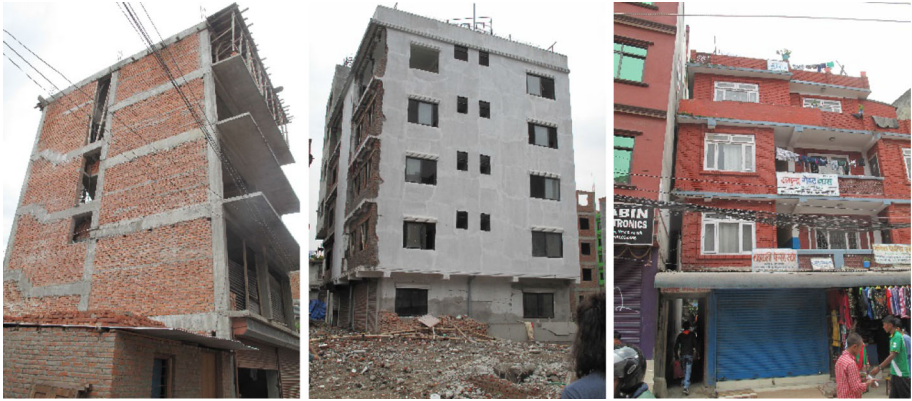
Fig. 8 IM walls typologies most common in Nepal

Regarding the IM walls, several typologies were found according to the existence of openings, the disposition and the size of the openings. Most part of the infill panels observed were composed by: (1) full panels without openings, (2) panels with a central window placed in the middle of the wall or next to the columns and (3) large door in the middle of the wall in the case of existence of balconies (Fig. 8).

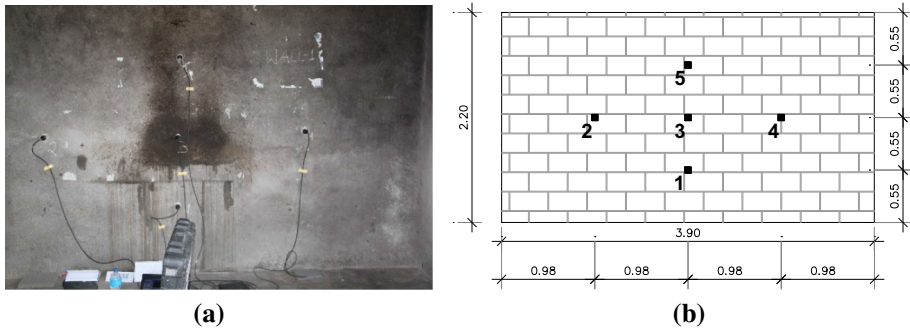
**Fig. 18** Wall 1 (NE3D) **a** geometric dimensions and **b** test setup

For the ambient vibration test it was used 5 accelerometers measuring the out-of-plane accelerations of the wall 1, and only one experiment test setup was adopted (Fig. 18a). The scheme is illustrated in Fig. 18b.

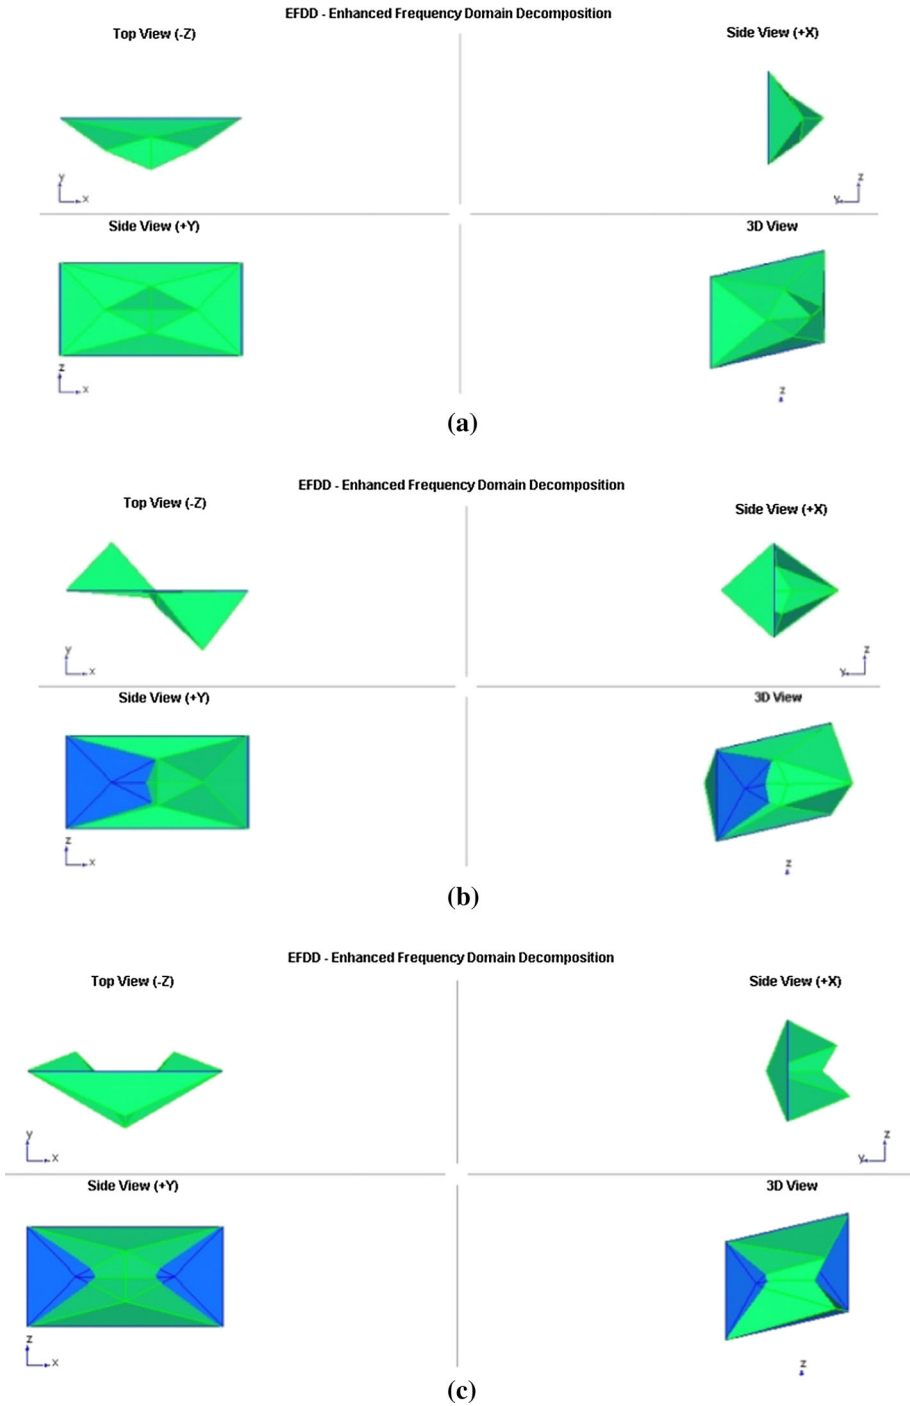
From the results of ambient vibration tests, it can be stated that the first natural frequency of the larger Wall 1 is unexpectedly 46 % smaller than the corresponding of smaller Wall 2. Regarding the influence of the openings in the variation of the natural frequencies, it was found that the presence of the window reduce 70 % the first frequency of the wall to about 10 Hz, as summarized in Fig. 27. Comparing the out-of-plane frequency of the wall 1 which dimensions are 3.90×2.20 m with those obtained by Furtado et al. (2016) for a rectangular infill wall 4.20×2.30 m composed by hollow horizontal bricks, typically used in the Southern region of Europe it can be observed that the Nepalese wall is 33 % stiffer. This stiffer characteristics associated with the use of some poor metallic mesh in their construction process justify the reduced number of out-of-plane collapses observed after the Ghorka earthquake.

Fig. 20 Wall 1 (NE3D): Natural frequencies and corresponding vibration modes. **a** $f_1 = 31.83$ Hz; **b** $f_2 = 45.02$ Hz and **c** $f_3 = 79.91$ Hz

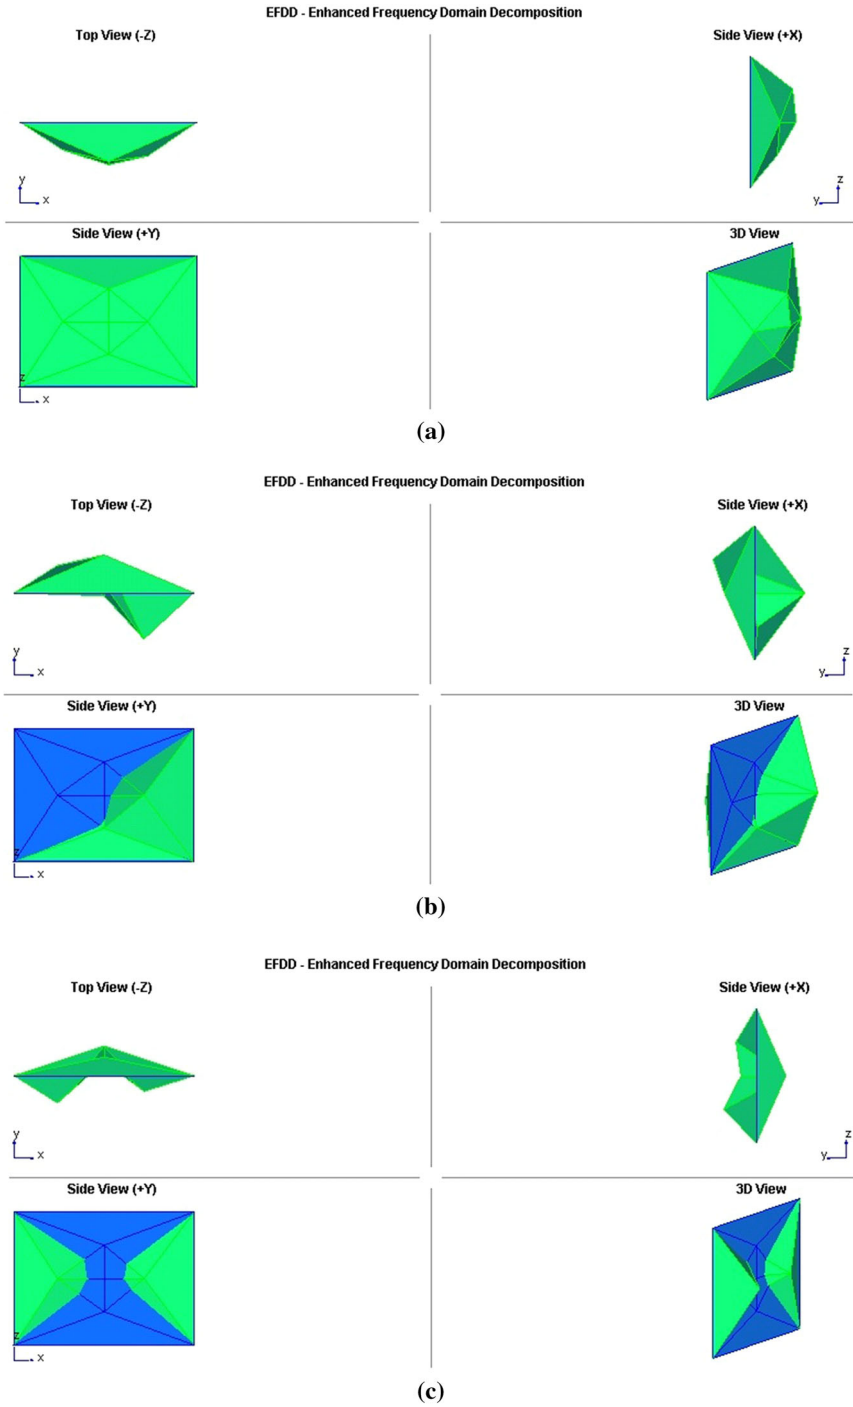
Fig. 23 Wall 2 (NE3D): natural frequencies and corresponding vibration modes. **a** $f_1 = 46.43$ Hz; **b** $f_2 = 77.11$ Hz and **c** $f_3 = 114.10$ Hz

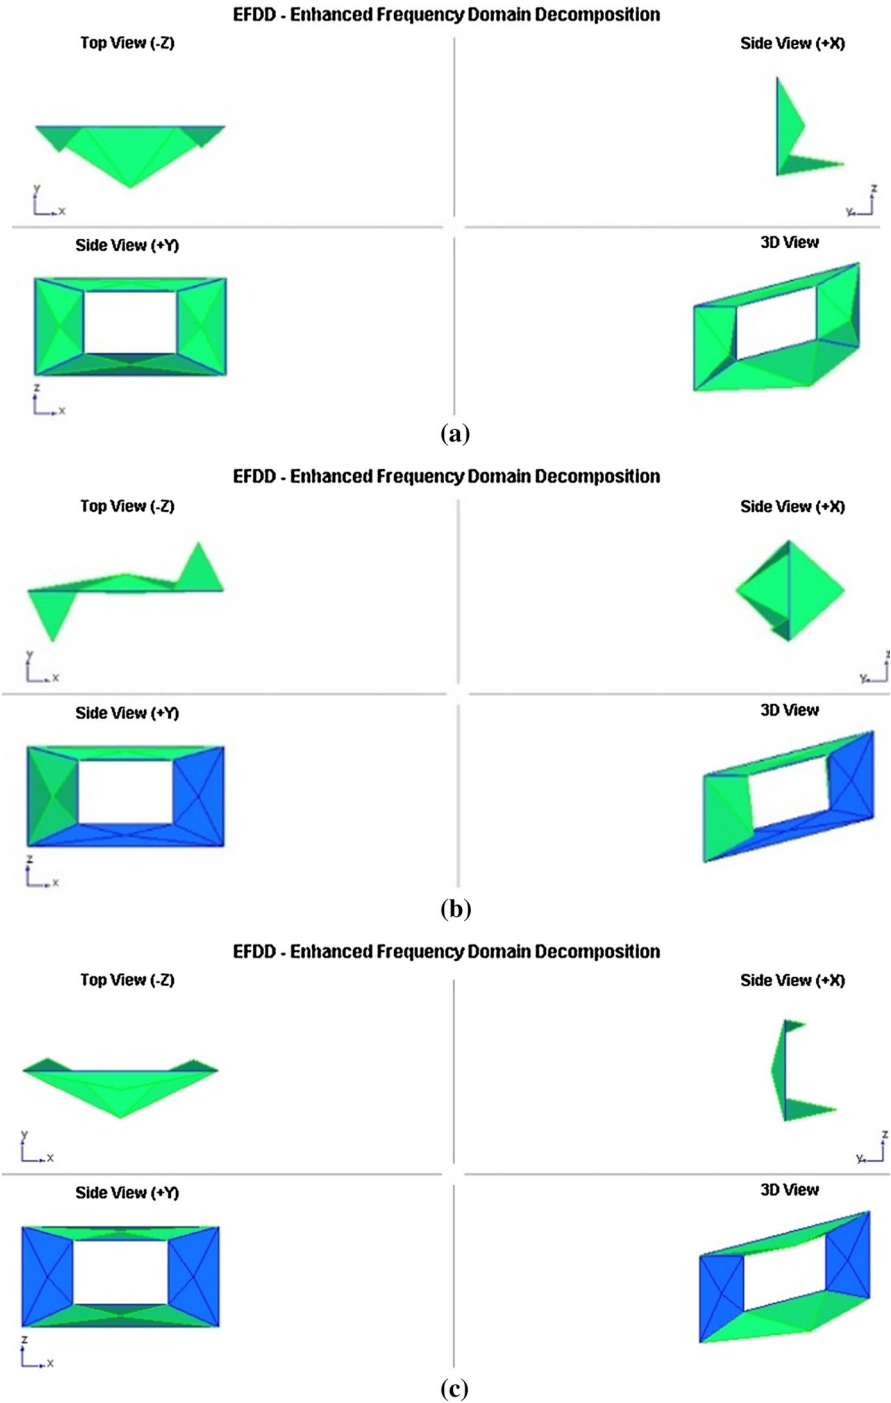
Fig. 26 Wall 3 (NE3D): natural frequencies and corresponding vibration modes. **a** $f_1 = 10.07$ Hz; **b** $f_2 = 61.39$ Hz and **c** $f_3 = 135.30$ Hz

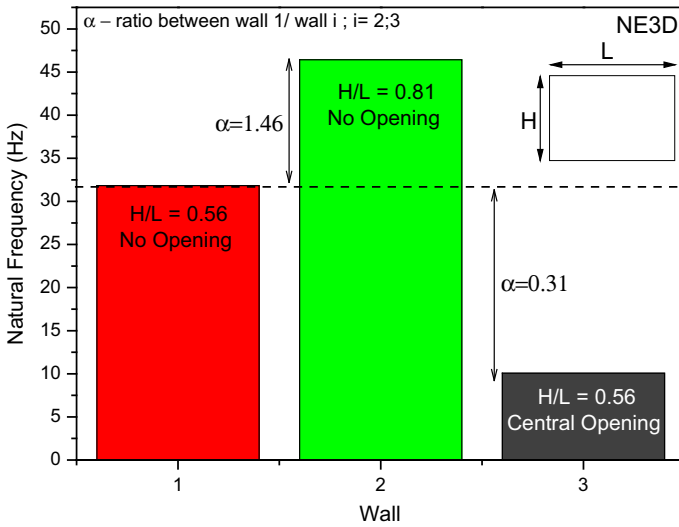
Fig. 27 IM walls natural frequencies obtained from NE3D

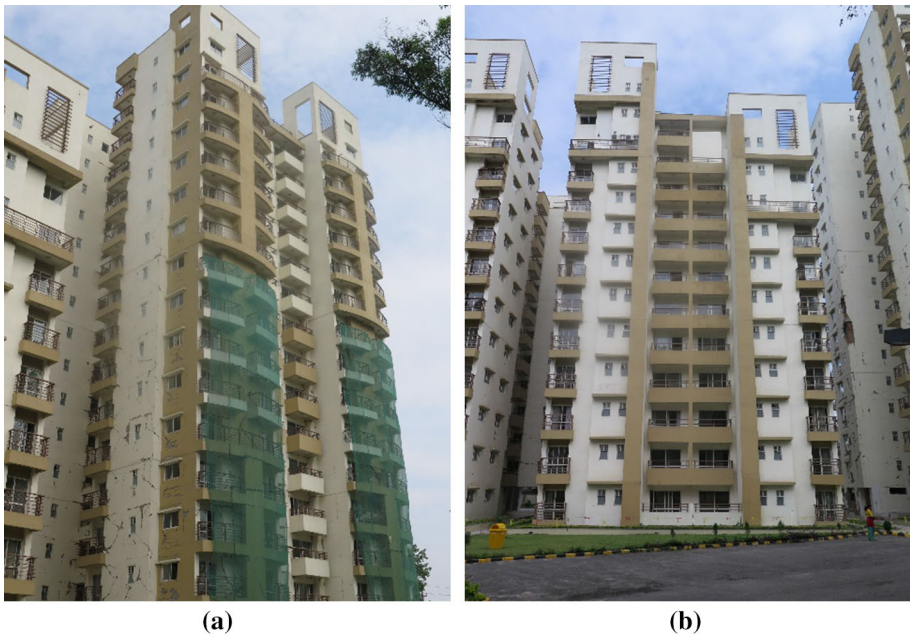
damaged (E12D), illustrated in Fig. 28. The CityScape apartments are composed by four high-rise apartment blocks, with different number of storeys (10–15). Tower 3 was selected for this study because it was the one with more damages along the entire building’s height. The building plant is illustrated in Fig. 29. The level of damaged observed in this building was classified as Grade 2, according to the EMS-58 (Grünthal 1998) classification, due to the several cracks in the IM walls from the ground-floor until the 6th floor. No significant structural cracks were found in the columns or beams of the building.

Fig. 28 General view of the building E12D. a Front view and b lateral view

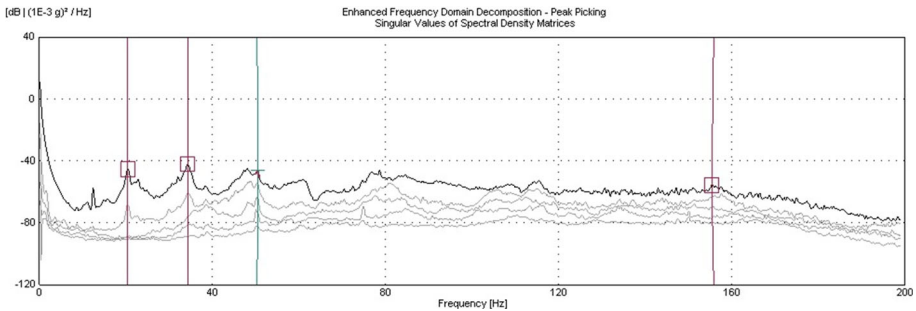
Fig. 39 Spectral of single values of spectral density matrices of Wall 4—E12D

Vibration mode	Frequency (Hz)	Damping ratio (%)
1	20.41	1.101
2	34.35	0.402
3	50.30	0.602

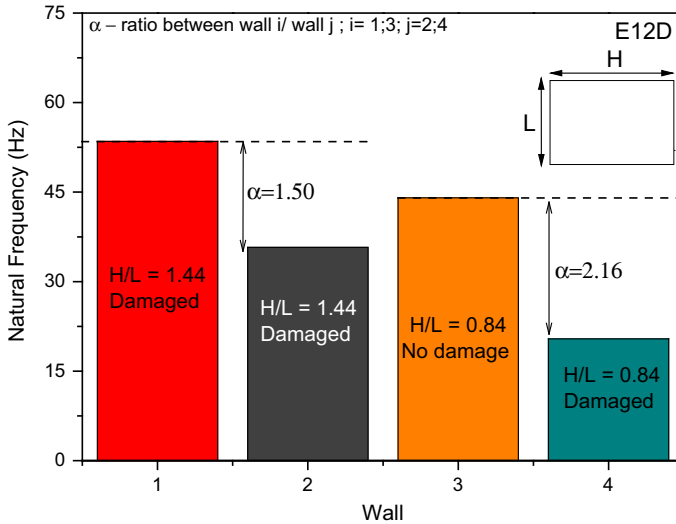
- The first natural frequency of the small IM panels is 20–40 % higher than the observed in the larger panels for the same level of damage;
- The first natural frequency is significantly affected by the damage state, with reductions about 25 % and 50 % respectively for the smaller and larger walls, as observed in Fig. 40;

- Similar conclusions performed in the Sect. 3.3.4 can be drawn here, since all the walls without damage feature higher first natural frequencies values than the ones obtained by Furtado et al. (2016). It appears that the introduction of damage on the panel reduces significantly the flexural stiffness thereof, however factors as the construction technique (described in Sect. 2.1) associated with intermittent use of poor metal mesh

Fig. 40 Walls natural frequencies obtained from E12D
