A knowledge-based approach for the structural assessment of cultural heritage, a case study: La Sapienza Palace in Pisa

Keywords Existing building · Cultural heritage · Masonry structure · In situ survey · Multidisciplinary approach · Static assessment · Vulnerability analysis

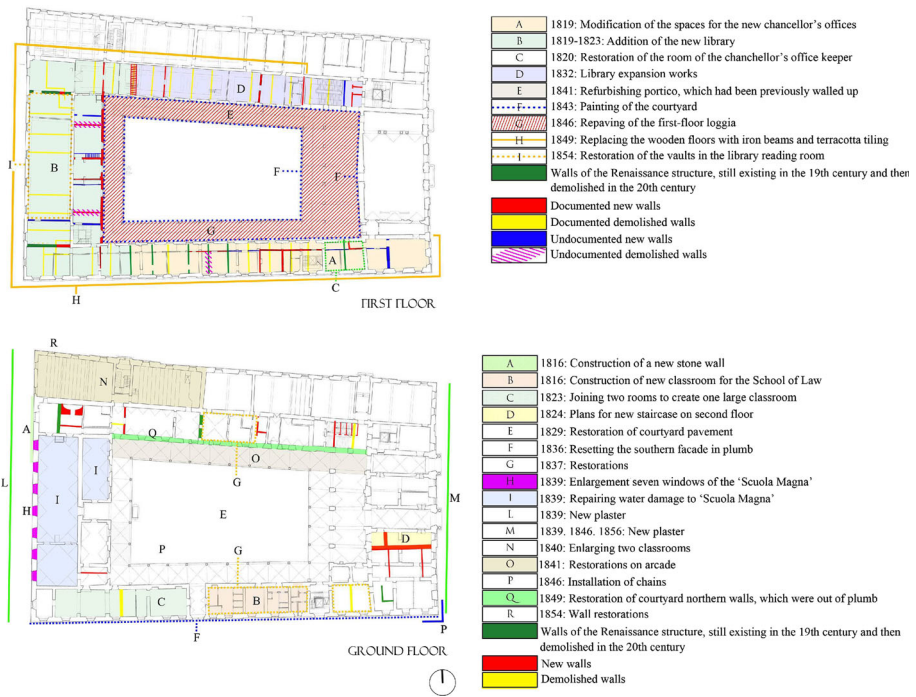
the western side of the first floor, demolishing various bearing walls, substituting the wooden canopies with masonry vaults, changing the arrangement, shape and size of the windows) caused considerable disruptions in widespread areas of the Palace (Fig. 6).

Fig. 6 Nineteenth-century works for ground and first floors

The technical surveys performed in the early nineteenth century attested the damage observed in the masonry due to water and the widespread cracking due to subsidence of the structure; further structural damages were evidenced because of the earthquake 1846. Due to the lack of funds, there was any consolidation operations—except for the introduction of five iron chains under the floor of the southern library rooms (Fig. 6).

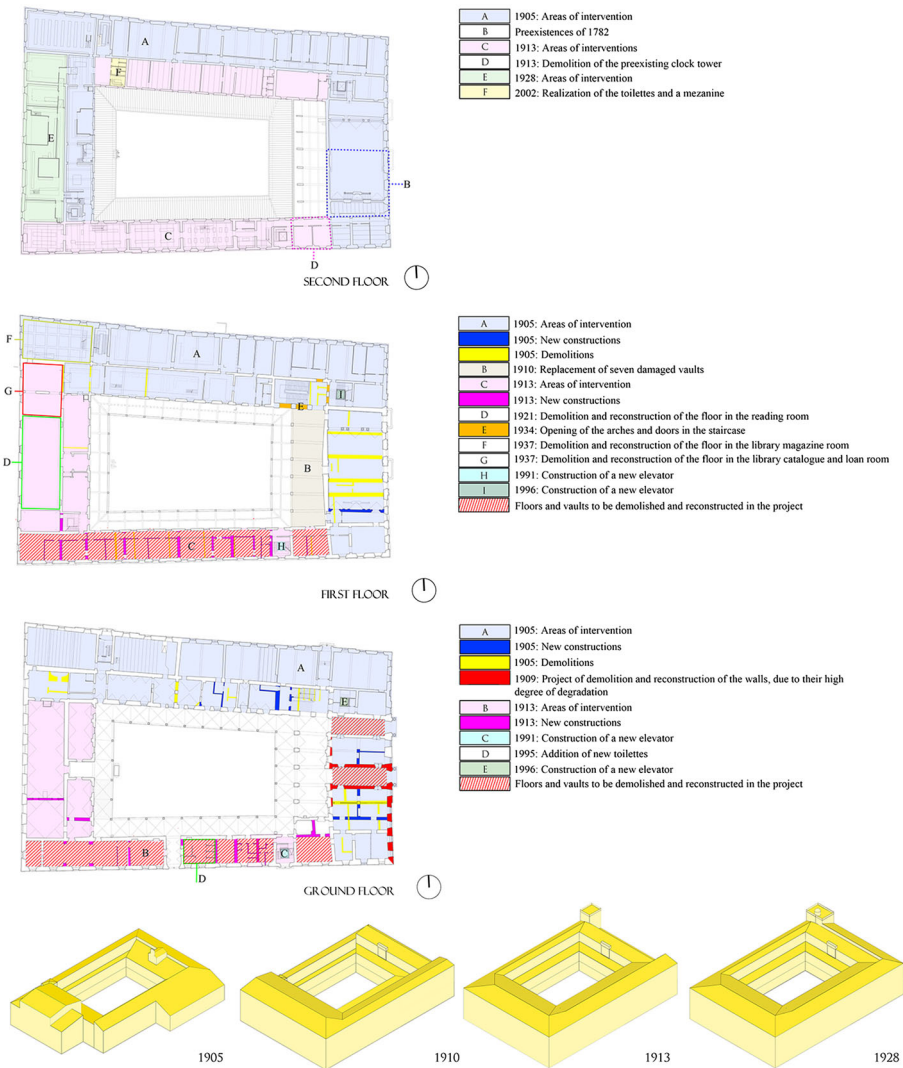
Towards the end of the nineteenth century, the Palace suffered a lack of space for teaching activities and for the libraries. This condition led to enlargement interventions, including the construction of a northern extension to the building, its raising up to three floors, the construction of the observatory, of a new double-volume vaulted Aula Magna on the first floor and of new staircases. The replacement of some of the damaged vaults of the interior arcade of the first floor with floor slabs of steel profiles and brick joists was also foreseen (Fig. 8).

The foundation settlement and the inadequate size of the foundations needed limiting the horizontal thrust exerted by the first and second floor vaults on the masonry bearing structures: non-thrust type floor slabs were employed, made up of steel beams, tubular bricks and steel Polonceau trusses for the roof of the new northern extension and the Aula Magna. In response to renewed need to expand the library facilities, during 1928–1929 the western building of the complex was raised to the height of the adjoining wings. From the 1930s, the Sapienza building underwent only maintenance and restoration operations, with the single exception of the vault of the new Aula Magna, rebuilt after the Second World War (Fig. 8).

Fig. 8 Twentieth-century works: ground, first and second floors, and 3D schemes

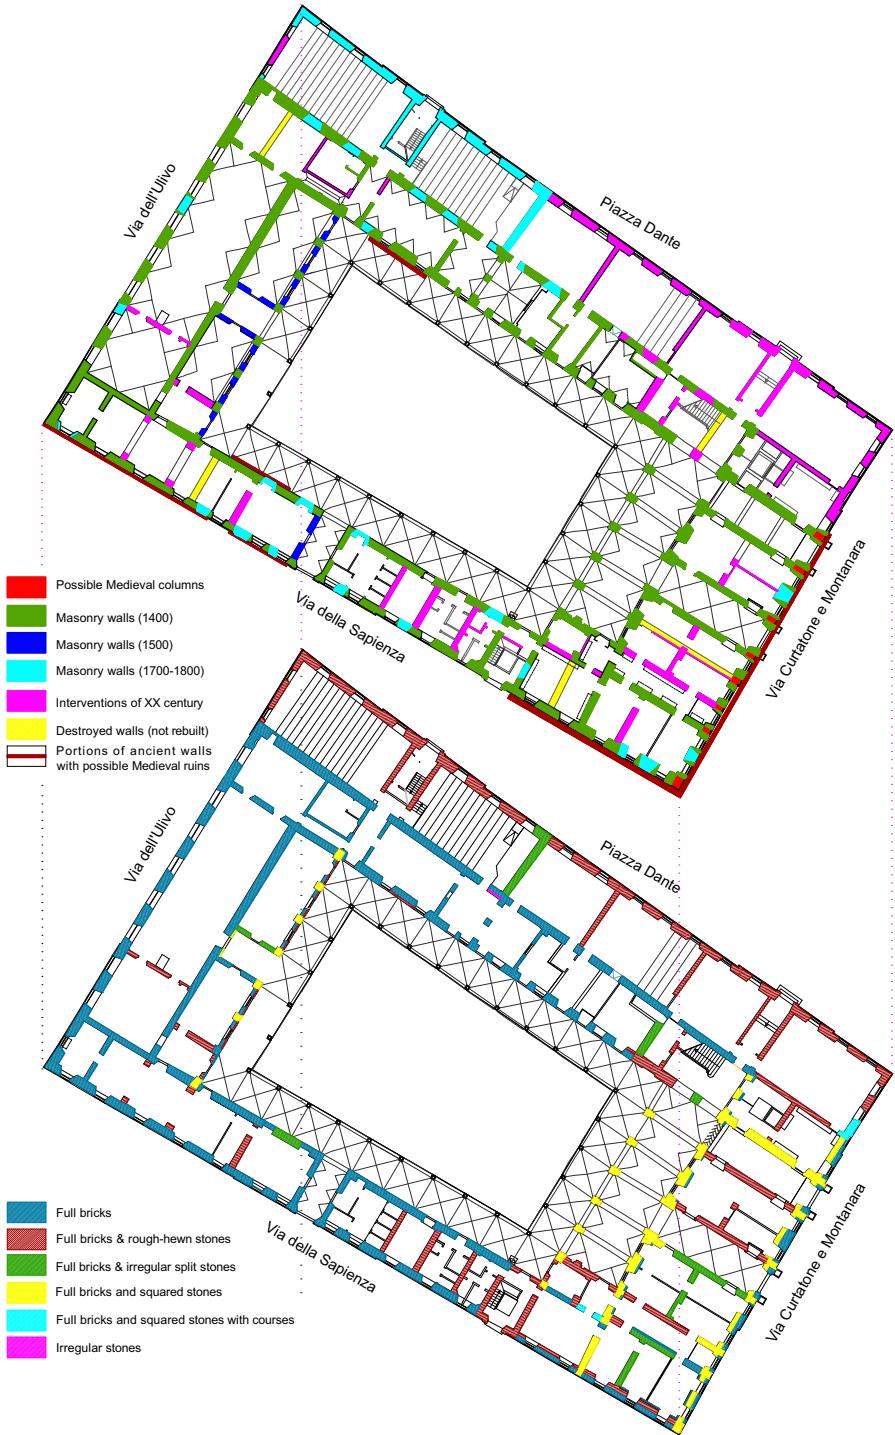
The masonry typologies of vertical walls were determined by removing the plaster on 50×50 cm portions with following endoscopic examination, checking the presence of cavities or adjacent facings of different thickness and type. Figure 9 shows the periods of realization of vertical walls of the ground floor (coming from the historical analysis) and the corresponding variability of masonry typologies: six different patterns and the absence of suitable connections between perpendicular walls were determined. Three tests with single and double flat jacks were performed, evidencing the uniformity of the compressive strength of the masonry and, at the same time, the high variability of the stress state in relation to the acting loads.

◀ **Fig. 9** Hypothesis of the evolutive development of the building and plan of ground floor with indications of the various types of masonry

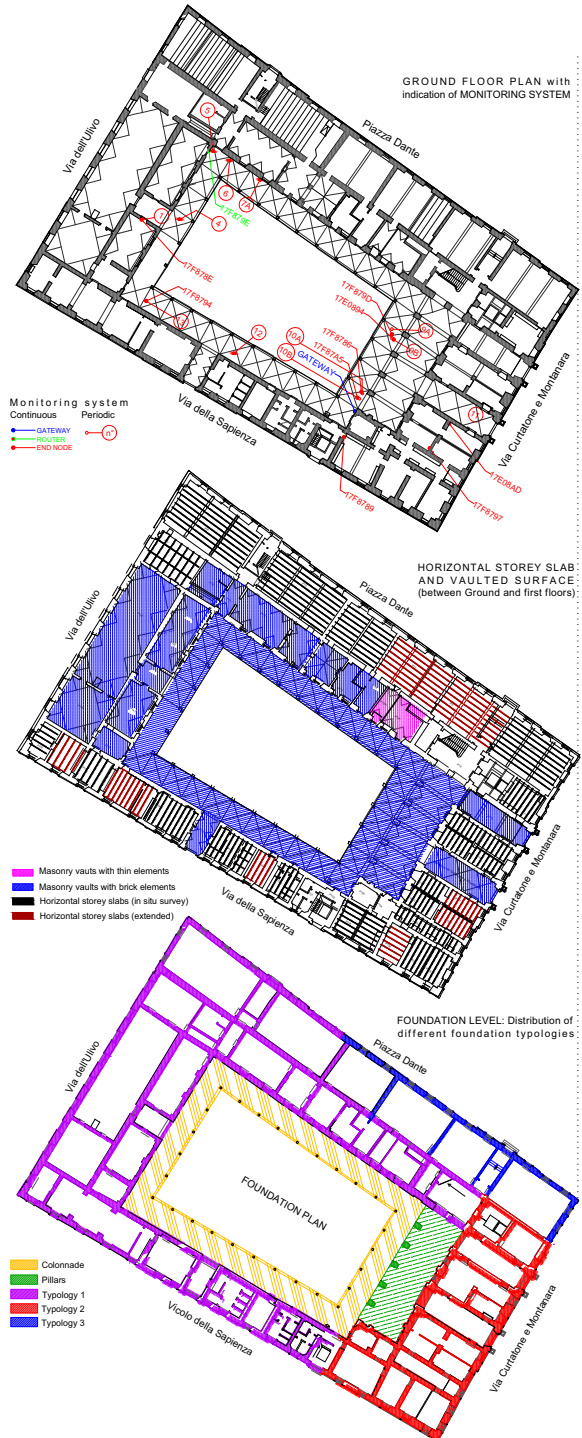
Two monitoring systems (one through periodical readings of fixed steel reference gauges and one through continuous readings at electronic transducers) were set up to determine the ongoing subsidence and the growth of the damage (Fig. 10). The analysis of

Fig. 10 Distribution of the floor slabs and types on the building's ground floor, Foundation plan, different typologies evidenced and ground floor plan with indication of monitoring points (continuous and periodic systems)

the monitoring results enabled the identification of the differential displacements, highlighting the evolution of structural cracking mainly in correspondence of the vaults of the ground floor colonnade and first floor arcade.

The cracking scenario in the vertical masonry walls relates to the differential subsidence of foundations: as visible from Fig. 10, in correspondence of US1 several typologies of foundation structures (i.e. Type 1, Type 2, columns and pillars) are recognized, characterized by different properties in terms of geometry and stiffness (Table 1). The heterogeneity of foundations strongly affects the relative displacements between the different US of the structural aggregate, with following spread of the cracks.

The diffused cracking scenario revealed in the crossed vaulted surfaces of the ground floor is the direct consequence of the differential subsidence due to the heterogeneity of foundations (Fig. 10; Table 1). The damages due to such discontinuities were highlighted by past seismic events (Fig. 7).

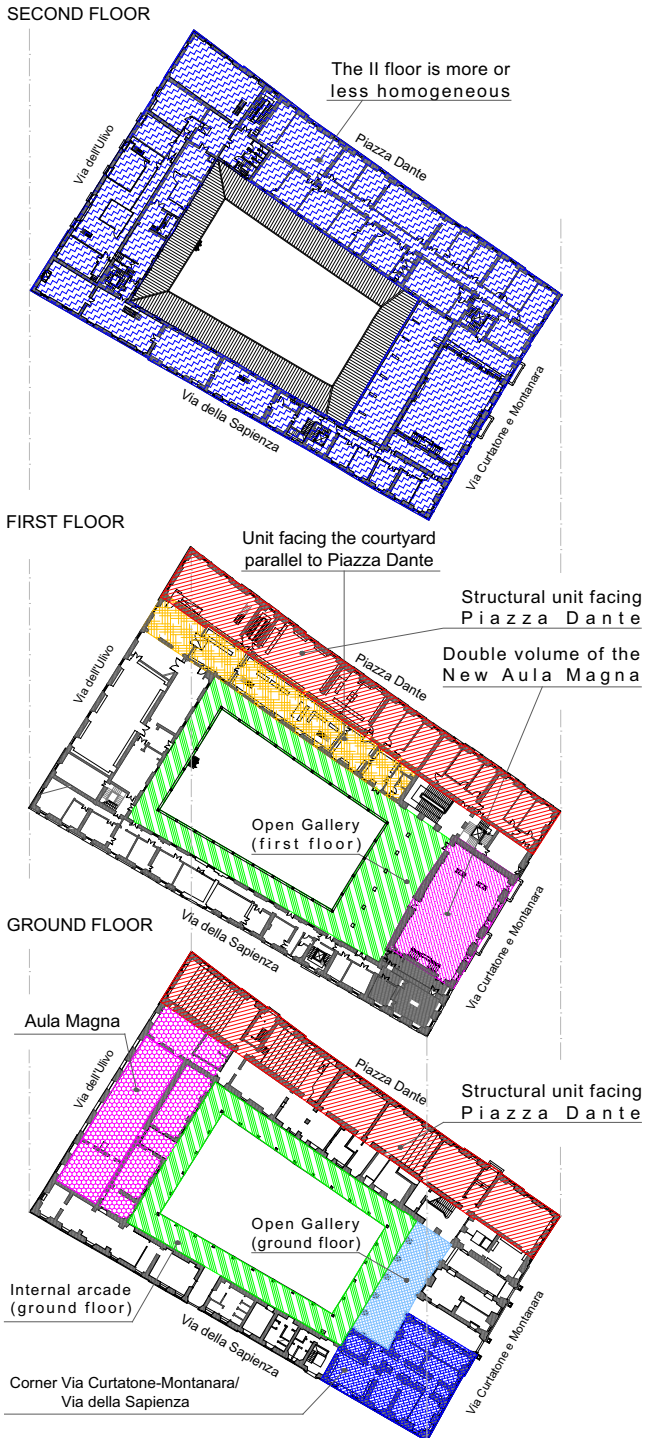
US1. *Corner between Via Curtatone e Montanara and Via della Sapienza.* As visible from Fig. 14, pillars characterized by the presence of full bricks and squared stones demonstrate the pre-existence of ancient tower-houses incorporated and connected to adjacent masonry structures during the centuries

Fig. 14 Structural units that can be determined as portions of the aggregate

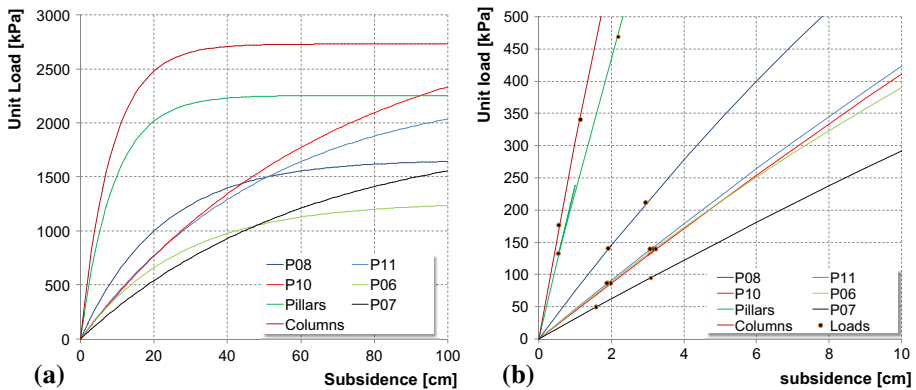
subsidence diagrams for the foundation-ground assemblage of the various analysed sections (Fig. 17a). The responses of the foundation elements evidence, especially for unit load values below 1.0 MPa, a wide variability. The substantial difference in the behaviour of the building's perimeter and of its interior (i.e. colonnade and pillars of the interior courtyard) leads to considerable damage in the areas where variation of stiffness characteristics and of acting loads are higher (Fig. 17b). The situation of foundation settlements, the different periods of realization and the following absence of connections between vertical elements also influence the behaviour of the colonnade at the first floor: relative displacements between the wooden roof of the colonnade and the masonry walls are clearly visible (Fig. 16). In particular, significant slips were determined between the wooden elements and the masonry walls: this was due to the insufficient support length of the wooden joist inside the walls (in some cases lower than 2 cm) and, together, to the thermal daily variations affecting the building as proved by the analysis of monitoring continuous data. The relative movements between the colonnade and the masonry walls are visible both at the ground floor (where vaulted surfaces are present) through the survey of the cracking scenario and at the second floor. Different foundations systems are, in fact, present, as revealed by the in situ investigations, and the differential displacements are evident considering the structural response of foundations (Fig. 17).

Fig. 17 **a** Unit load-subsidence curves for the different sections investigated, **b** estimates of the subsidence of different building zones as a function of the applied loads
