Remarks on damage and response of school buildings after the Central Italy earthquake sequence

Keywords School buildings · Earthquake · Usability and damage assessment · Seismic risk

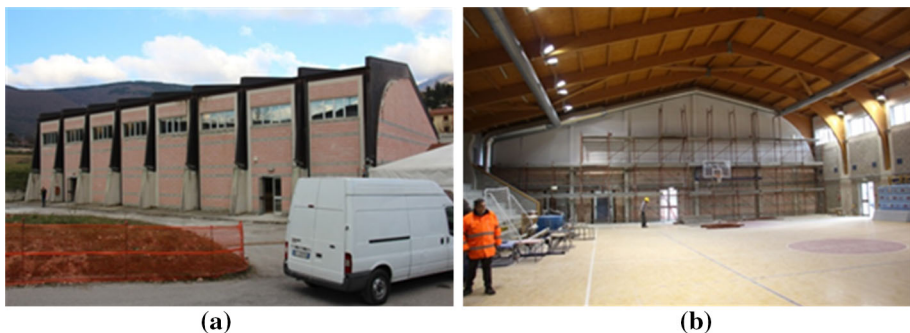
Although poor information are generally available on the Norcia’s school, a special focus on the gym structure can be done. In particular, it has rectangular in-plane shape, with area of about 900 m² and 10 m high. The resisting structure consists of one way frames made up with arched beams of lamellar wood supported by RC columns. Infill panels are made up with bricks of pumice concrete.

Although the maximum PGA recorded in Norcia on the October 30 event was very high ($a_g = 0.48$ g), no structural damage was observed on all structures. On the contrary, a significant damage was found on the infill walls due to both significant slenderness and

Fig. 6 The gym structure: external (a) and internal view (b)

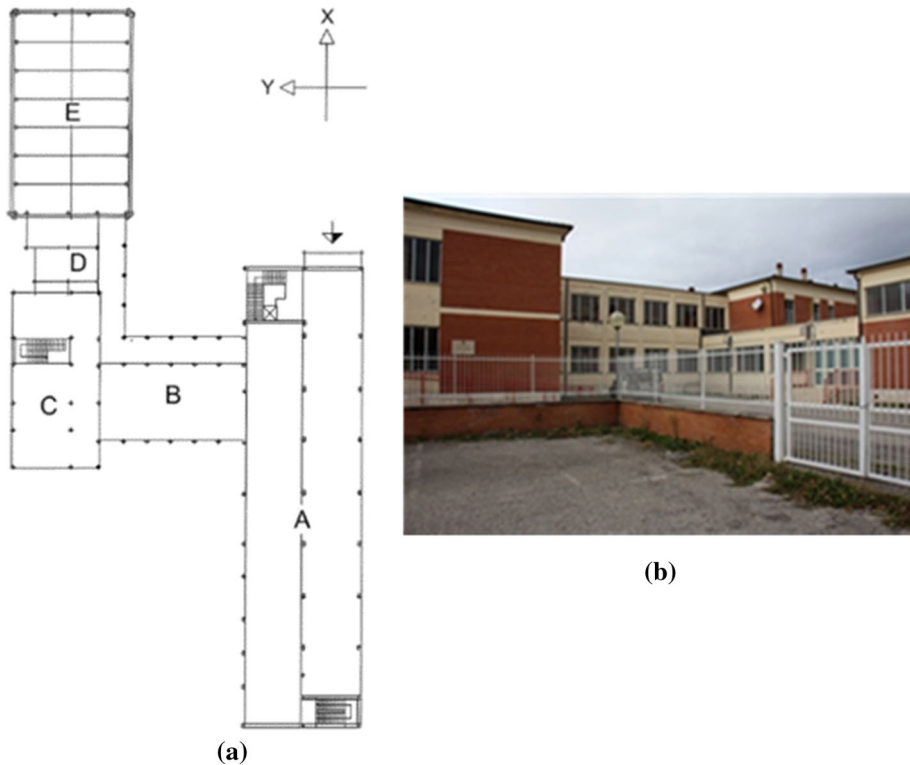
The structure has irregular in-plane shape with two 3.3-m-high storeys in elevation, and area of about 1100 m². Resisting system is made up of RC frames bearing the slabs without beams along the transverse direction. After the the post-earthquake survey, the school was unusable (i.e. E rating). Although no structural gap are present between the different blocks of the structures (Fig. 8), for the gym building (block E) a rating B (temporarily unusable but usable with short-term countermeasures) was assessed.

Fig. 8 Layout (a) and external view of the school (b)

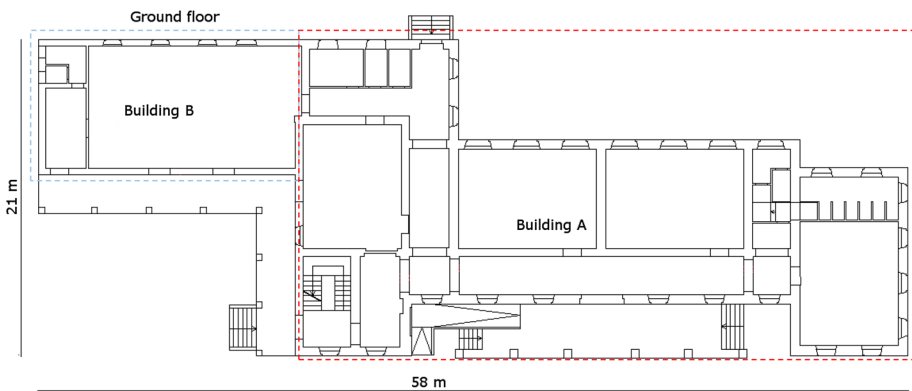
Fig. 10 Ground floor plan view of URM building school of Acquasanta Terme: school building, Building A (dashed red line box) and laboratory building (Building B)

minor damage after the first event; a slight aggravation was reported after the two October events. Falling of plaster and internal objects was observed during the inspections. The detailed visit of the structure after the two October events showed a general worsening of

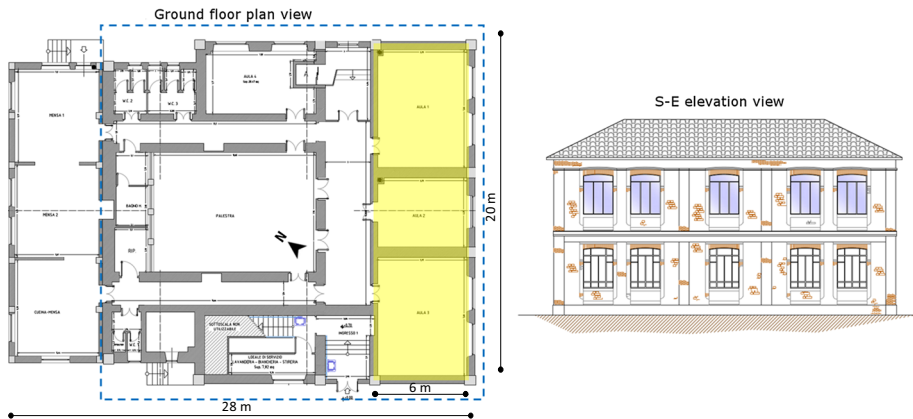
Like in the previous example, two different surveys were carried out, after the Mw6.0 August 24 event and the two events of October 2016 (Mw5.9 and Mw6.5), respectively. The nursery school of Force was hosted by an isolated URM building positioned on a hill ridge near the historic centre of the town. This two storey building was completed in 1910 and expanded in 1970 by means of a RC structure on the back side of the complex. The extension is about 600 m² per floor (Fig. 14). The original structure has load-bearing URM walls (see blue box with dashed line), composed of double-leaf rough-finished stone masonry with very poor lime mortar (Fig. 15a). The floors and the roof are very

Fig. 14 Ground floor plan view and South/East elevation view of URM/RC building school of Force: the URM part in the dashed blue line box and the most damaged portion highlighted in yellow
