Damage assessment and the effectiveness of prevention: the response of ordinary unreinforced masonry buildings in Norcia during the Central Italy 2016–2017 seismic sequence

R. Sisti¹ · M. Di Ludovico²

· A. Borri¹ · A. Prota²

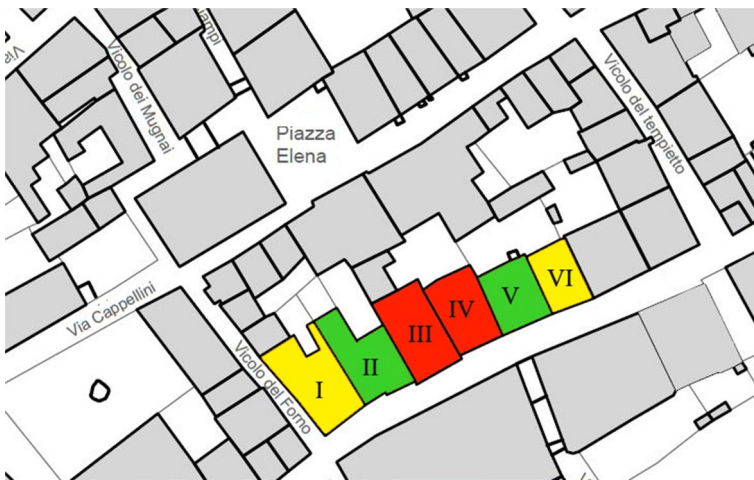
Fig. 14 Aggregate case study: MSU location and usability rating

MSUs I, II and IV have three storeys, while the remaining ones have only two. Furthermore, MSUs V and VI have a basement floor. Prior to the strengthening interventions, undressed natural stones (pebbles) with very poor lime mortar comprised all the original walls and there were different types of floor: timber floors, RC hollow brick slabs, and jack-arch floors. Following the 1979 earthquake, damage to the vertical load bearing walls was mainly detected on the first floor of MSUs I, V and VI due to the poor masonry quality and the lack of connections between the orthogonal walls (see Fig. 15). Figure 15 shows the type of damage detected on the MSUs: shear cracks; out of plane displacements; and vertical cracks at wall intersections.

After the M6.5 earthquake, the two central MSUs (III and IV) were unusable and a medium-severe damage level (D2-D3) was observed on both the vertical load bearing elements and floors. By contrast, no damage (MSUs II and V) or slight and limited damage (MSUs I and VI) was observed in the aggregate parts strengthened according to the original retrofitting project. This clearly confirms the effectiveness of sound strengthening interventions in terms of limiting or avoiding structural damage, even in historical aggregate masonry MSUs.

A repair and strengthening intervention design was submitted to the Umbria region in 1984. The strengthening interventions proposed are depicted in Fig. 16, along with their location. The analysis of the retrieved documentation shows that the following interventions were designed:

- The enlargement of the foundations by adding two RC elements placed besides the masonry ones, even if no foundation settlement had occurred.
- The strengthening of masonry walls through grout injections or grout injections plus RC plaster jacketing (violet or blue walls in Fig. 16), and the insertion of steel connectors to improve the connection between orthogonal walls.
- The reconstruction of damaged internal walls, with new walls composed of clay blocks (yellow walls in Fig. 16).
- The replacement of existing timber floors with new RC floors and the reinforcement of the existing steel floors and vaults with an RC slab applied at the extrados (red boxes filled or not filled at the floor location in Fig. 16).
- The construction of RC ring beams at the roof level of each MSU.
