Seismic performance of Reinforced Concrete Frame with Masonry Infill buildings in the 2010/2011 Canterbury, New Zealand earthquakes

Rijalul Fikri¹ · Dmytro Dizhur¹ · Kevin Walsh^{2,3} · Jason Ingham¹

Received: 28 August 2017 / Accepted: 15 September 2018 / Published online: 19 September 2018
© Springer Nature B.V. 2018

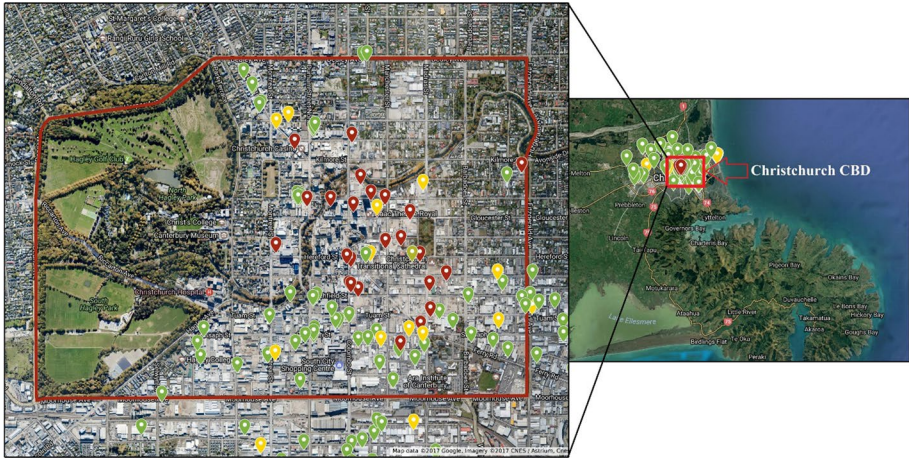
Fig. 1 Location of 191 damaged RCFMI buildings in Christchurch documented in the CEBA database. Green, occupiable; yellow, restricted entry; red, no entry

In general, RCFMI buildings exhibited good seismic performance during the Canterbury earthquakes, as the majority (129 out of 191 buildings; 68%) of the observed buildings were assigned green placards. It is noted that RCFMI buildings that were assigned green placards in the CEBA database exhibited insignificant to minor damage, with little attention given to undamaged buildings (Lin et al. 2016). It is also recognised that a large number of additional RCFMI buildings were observed in Christchurch during the sidewalk survey that were not included in the CEBA database. These non-surveyed buildings potentially result in significant coverage error in the building database, and this error can lead to a bias in the building damage statistics. According to Rossetto et al. (2013), the sampling bias can be treated by assuming that non-surveyed buildings were undamaged, and that the building stock can be completed using census data available in the region. However, the census building data in the Canterbury region were again not available, and therefore the RCFMI buildings reported herein were identified exclusively based on the damaged RCFMI buildings available in the CEBA database. Because the non-surveyed buildings presumably exhibited no damage, the proportion of buildings meriting green placards may well be significantly higher than 68%. Moreover, a comparatively small number of RCFMI buildings were assigned yellow placards (45 out of 191 buildings; 24%) and red placards (17 out of 191 buildings; 8%), and these proportions would be further reduced when accounting for the potential sampling bias.

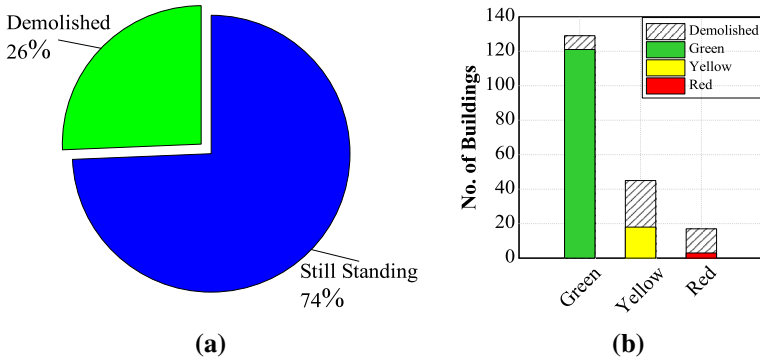
From an analysis of the current state of the 191 RCFMI buildings as documented on 31 October 2016 it was identified that 49 out of 191 RCFMI buildings (26%) were demolished, while the majority (74%) of these buildings remained standing (see Fig. 2a). A high proportion of the RCFMI buildings that were demolished following the 2011 Lyttelton earthquake were initially assigned a red placard (14 demolished buildings out of 17 with red placard; 82%) or a yellow placard, (27 demolished buildings out of 45 with yellow

Fig. 2 Demolition statistics for RCFMI buildings as documented on 31 October 2016. **a** Current state of buildings, **b** proportion of demolished building for each building placard type

placard; 60%), as presented in Fig. 2b, whereas only a small number of demolished RCFMI buildings were initially assigned to green placards, (8 demolished out of 129 buildings with green placard; 6%), despite the fact that these buildings exhibited insignificant to minor damage. The cost of repairing and strengthening these buildings to the minimum national standard of required earthquake capacity is likely to have been the dominant factor dictating building demolition, with stakeholders perhaps deeming that replacement with a new building was more cost effective (King et al. 2014).

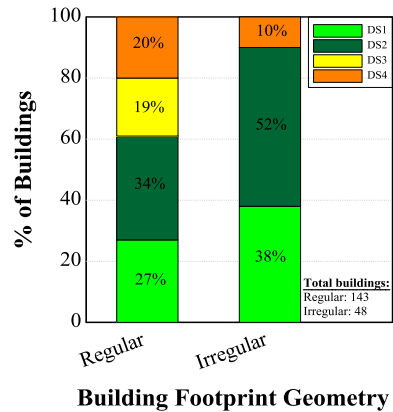
RCFMI buildings with a regular footprint exhibited more severe damage in the 2011 Lyttelton earthquake compared to RCFMI buildings having an irregular footprint (see Fig. 9). It was observed that 39% of RCFMI buildings with a regular footprint sustained moderate to heavy damage (D3 to D4), whereas only 10% of RCFMI buildings with an irregular footprint (10%) sustained moderate to heavy damage. This finding is contrary to the widely understood effect where building geometric irregularity negatively influences building earthquake performance, and suggests that building footprint geometry did not significantly contribute to the observed damage characteristics of RCFMI in the 2011 Lyttelton earthquake.

Fig. 9 The influence of building footprint geometry on damage to RCFMI buildings

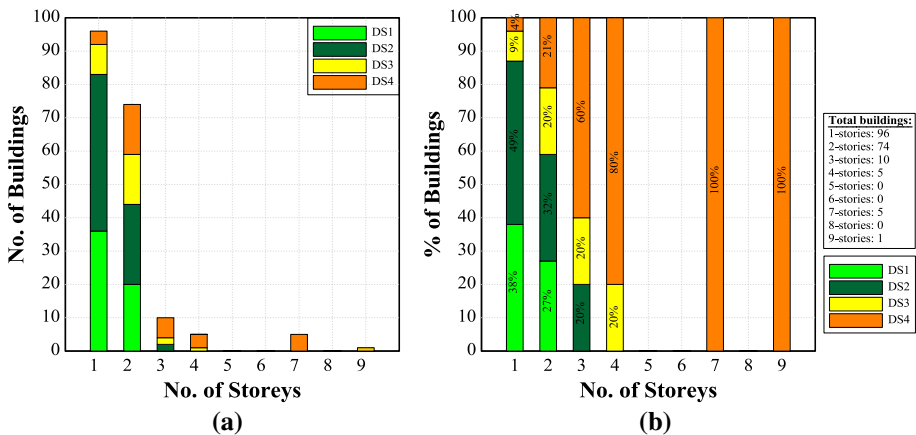
Following the 2011 Lyttelton earthquake it was observed that taller RCFMI buildings sustained a higher degree of damage in comparison with low-rise RCFMI buildings (see Fig. 11). The majority (more than 80%) of RCFMI buildings having 3+ stories sustained moderate to heavy damage (D3–D4), whilst most of the RCFMI buildings having 1–2 stories experienced less severe damage.

Fig. 11 The influence of building height on damage to RCFMI buildings. **a** Total number of buildings, **b** percentage of buildings

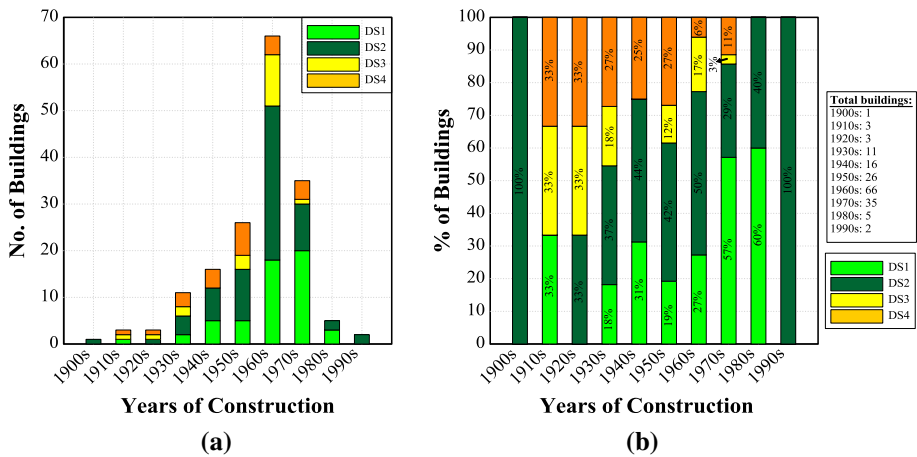
Figure 12 presents the recorded level of damage sustained by RCFMI buildings following the 2011 Lyttelton earthquake, correlated against the period of construction. It was observed that RCFMI buildings constructed between the 1910s and the 1930s (more than 45% of the total number of surveyed buildings) sustained moderate to heavy damage

Fig. 12 The influence of period of construction on building damage. **a** Total number of buildings, **b** percentage of buildings

(DS3–DS4). It is noted that the first New Zealand seismic code were introduced in 1935 (NZS 95 1935). Therefore, the observed earthquake vulnerability of RCFMI buildings constructed from the 1910s to the 1930s is not surprising.

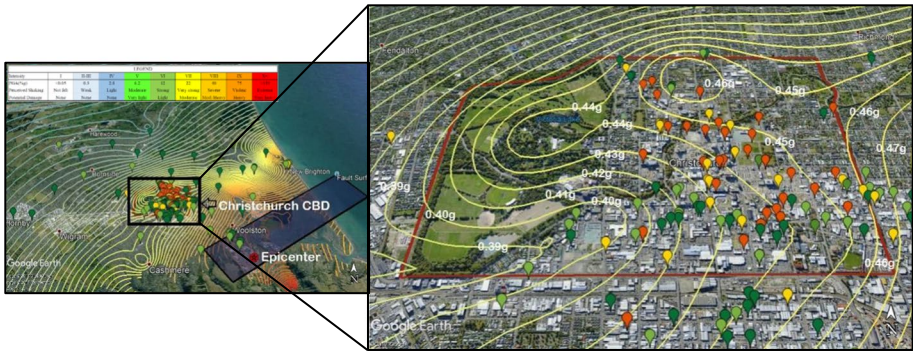
As seen in Fig. 13, during the 2011 Lyttelton earthquake the RCFMI buildings in the Christchurch region experienced PGA levels ranging from 0.20 to 1.00 g. These high PGA levels were a result of the epicentre occurring at a shallow depth and being located close to the RCFMI building population. The majority of RCFMI buildings (177 out of 191; 93%) experienced PGA levels ranging from 0.30 to 0.59 g.

Fig. 13 The distribution of RCFMI buildings with different damage states that were subjected to varying PGA levels in the 2011 Lyttelton earthquake. Light Green, DS1; Dark Green, DS2; Yellow, DS3; Orange, DS4

It was also observed that some RCFMI buildings that were clustered together in the Christchurch CBD were assigned heavy damage (DS4) and were subjected to PGA levels ranging from 0.43 to 0.49 g. The high level of damage that occurred to these RCFMI buildings in the Christchurch CBD was attributed to their date of construction, recognising that the city developed outwards from the city centre and therefore the buildings located in the CBD were generally the oldest and consequently the most seismically vulnerable (see Fig. 14). Unfortunately, in most cases it was not possible to obtain accurate records for the specific ages of these buildings. According to photographic records obtained from Christchurch City Libraries, these buildings were well established in the 1950s (see Fig. 14b) and the actual date of construction of these buildings is therefore surmised to be prior to the 1950s. Therefore, the observed seismic vulnerability of these pre-1950s buildings was unsurprising.
