24 January 2020 Sivrice-Elazığ, Turkey earthquake: geotechnical evaluation and performance of structures

Abstract

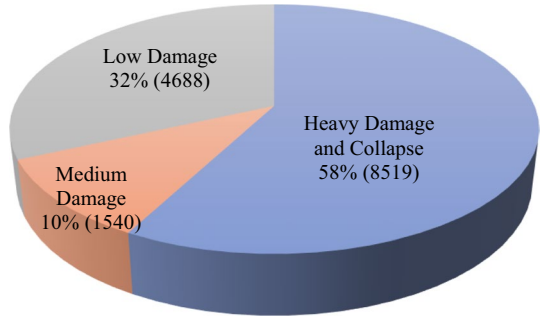
Even if the 2020 Sivrice-Elazığ earthquake was a moderate earthquake, 41 people died, and 1607 people were injured. This earthquake caused collapses and failures of dwellings. Immediately after the seismic shock, a field observation and damage classification process were started by expert teams. Figure 11 shows statistical data based on damage and collapse.

Fig. 11 Damage and collapse percent (URL2)

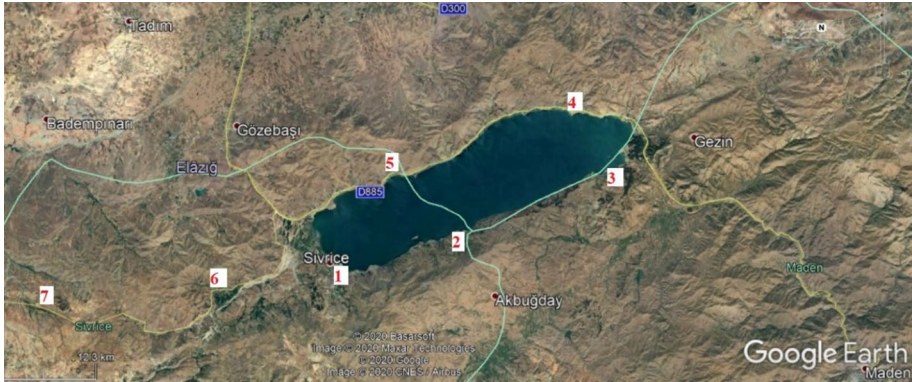
Geotechnical observations were conducted in Sivrice district, the epicenter of the earthquake, and in the villages connected to it as well as on the shores of the Hazar Lake in the region. As a result of the observations at seven investigation areas shown in Fig. 12, four geotechnical findings (lateral spreading, soil liquefaction and sandy soil, rockfalls, and soil deformations) were obtained in general (Fig. 13).

Fig. 12 Region and observation points where geotechnical investigations were performed (adopted from Google Earth)

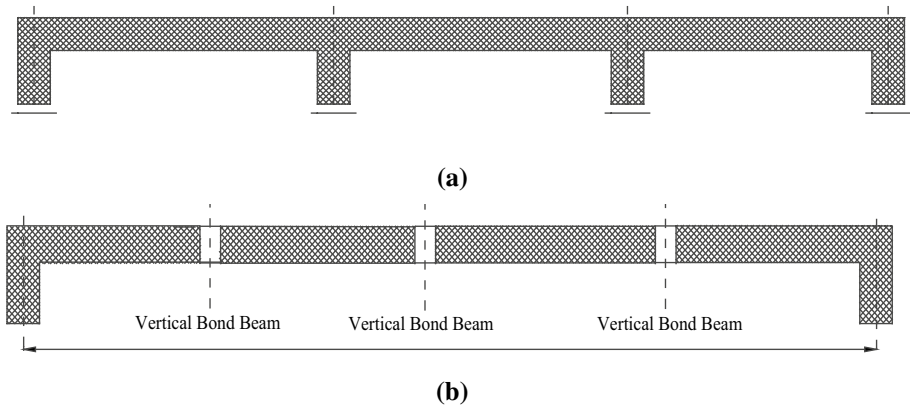
Fig. 31 Limitation of unsupported wall by **a** perpendicular walls and **b** vertical bond beams

This type of failures can be arisen from several factors such as large unsupported walls, weak wall-to-floor connections or poor wall-to-wall connections, and absence of bond beams which should provide structural integrity to prevent out-of-plane failure damage to walls. These deficiencies cause partial or total wall failure during an earthquake. Furthermore, to prevent these damages in masonry buildings, the unsupported length of a wall should be limited by using perpendicular walls and vertical bond beams. Figure 31a, b shows this type application. Reinforced concrete vertical bond beams should be built along the full story height at the corners and near the openings.

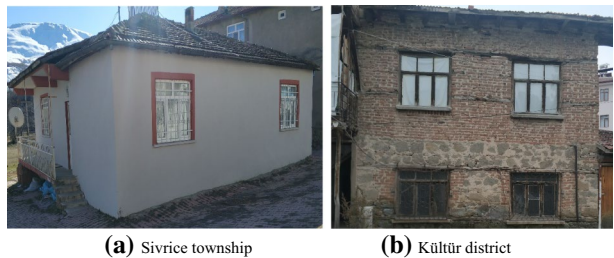
Fig. 34 Well-performed masonry buildings

Apart from damaged and failed buildings, well-performed masonry dwellings were also available after the main shock at the epicenter of the earthquake in Sivrice township. These dwellings were demonstrated at Fig. 34 below.
