# Geotechnical aspects of reconnaissance findings after 2020 January 24th, M6.8 Sivrice–Elazig–Turkey earthquake

## Abstract

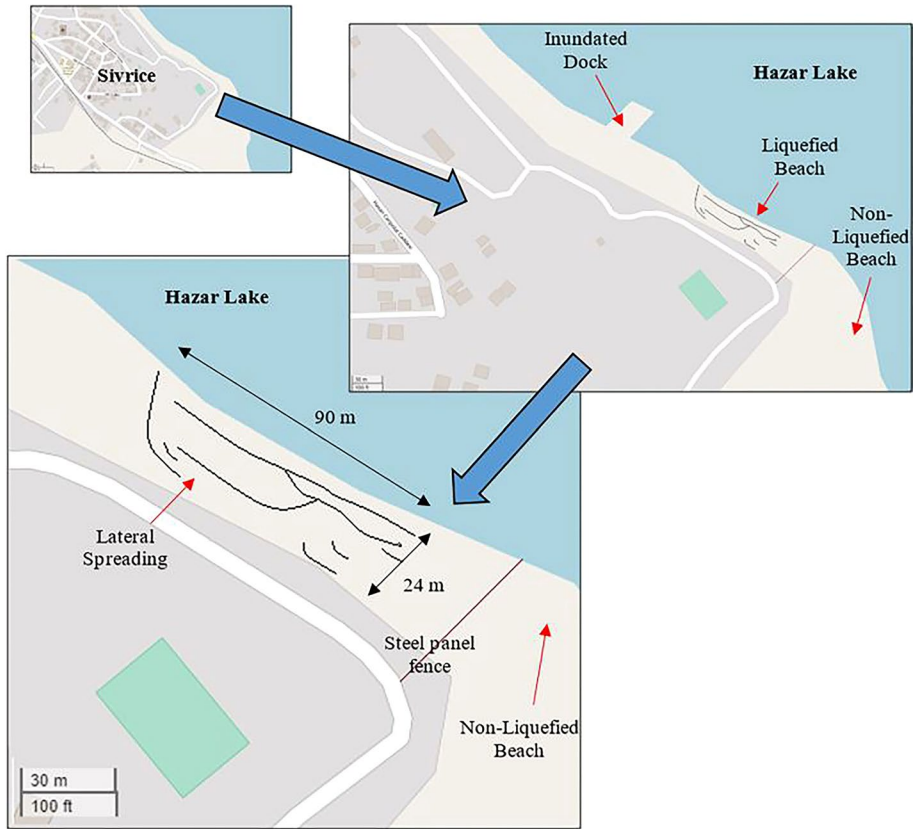
Similarly, liquefaction-induced lateral spreading deformations, presented in Fig. 6, were mapped along a 90 m by 24 m shoreline neighboring to Sivrice Dock, with induced crack widths varying from 3 to 5 cm. The total maximum lateral deformation at the most critical section was mapped as 10–14 cm. Immediately in the south-east of this local beach, there is another beach, where no signs of permanent ground deformations or liquefaction manifestations were evident, as shown in Fig. 7. This beach was observed to have a milder slope when compared to the lateral spreading site.

**Fig. 7** A sketch of lateral spread deformations ( $38^{\circ}28'10.0''\text{N}$   $39^{\circ}17'03.6''\text{E}$ /31.01.2020/12:11), Google Maps, 2020

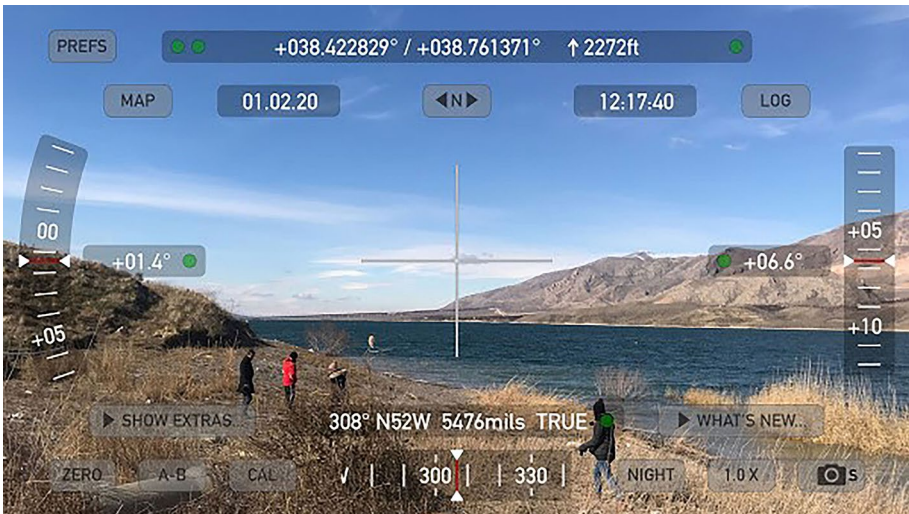
Sivrice–Elazig event also shook Malatya Downtown and its surrounding towns. Toygar Neighborhood of Battalgazi District was visited during the reconnaissance study. Although this site is composed of alluvial deposits with potential for ground failure, no signs of it were observed. Surficial soils, observed to be of high plasticity clays, and to be frozen are listed as the two factors, which might have impeded the development of permanent ground deformations or cyclic mobility manifestations. Seismically-induced liquefaction manifestations were observed at Kale District shore, in the form of sand boils. Figures 11 and 12 illustrate a view of the site and sand boils documented. Soil samples were collected for sieve analysis.

**Fig. 11** View of Kale shore ( $38^{\circ}25'22.2''\text{N}$   $38^{\circ}45'40.9''\text{E}$ /01.02.2020/12:17)

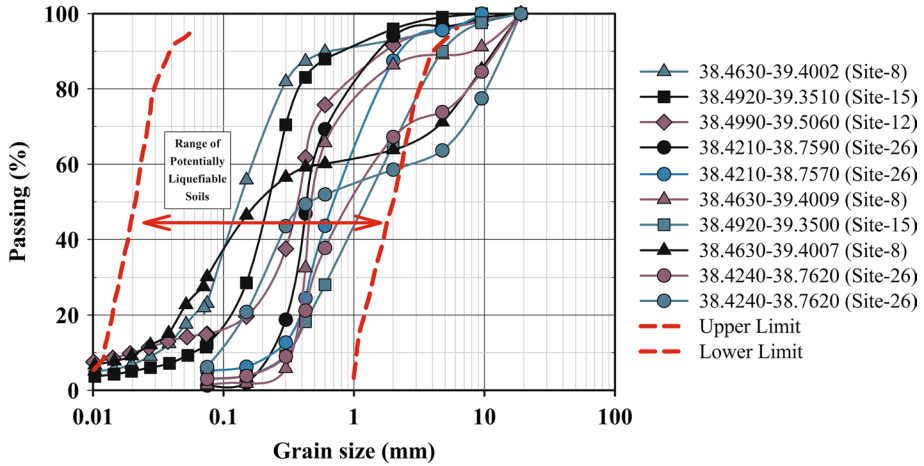
As stated earlier, disturbed samples were retrieved from soil ejecta at various sites. These samples were tested in conformance with ASTM D7928-17 and ASTM D6913/D6319M-17 standards to assess grain size distribution characteristics, and to classify them. The locations of sites, and grain size distribution characteristics are summarized in Table 3. In Fig. 13, grain size distribution curves are also comparatively presented with the range of potentially liquefiable soils (Tsuchida 1970). Based on Unified Soil Classification System (USCS) (ASTM D2487-17e1), most of the sand ejecta samples were classified as SP (poorly graded sand) and SM (silty sand) and fall in the range of potentially liquefiable soils. Consistent with available literature, ejecta materials were classified as non-plastic with fines less than 30%.

Fig. 13 Particles size distribution curves of the sand ejecta retrieved from liquefied sites

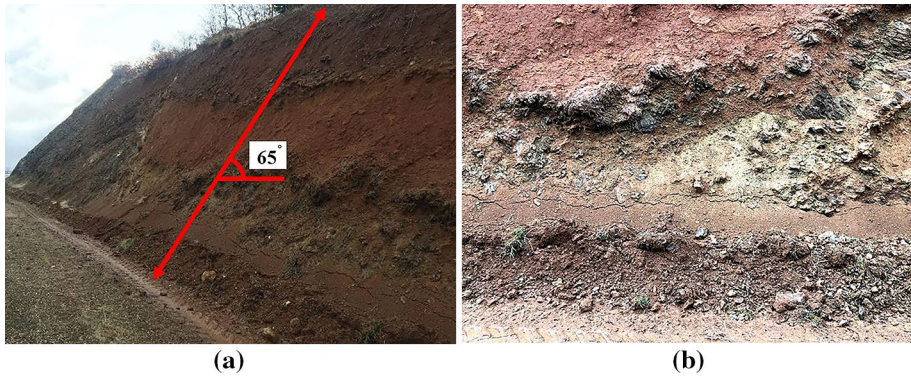
**Figure 17** a Side view of Site 14 the slope 65° (38°30'11.7"N 39°23'33.4"E/31.01.2020/16:34), and b interlayering at rock formation (38°30'11.8"N 39°23'33.3"E/31.01.2020/16:34)

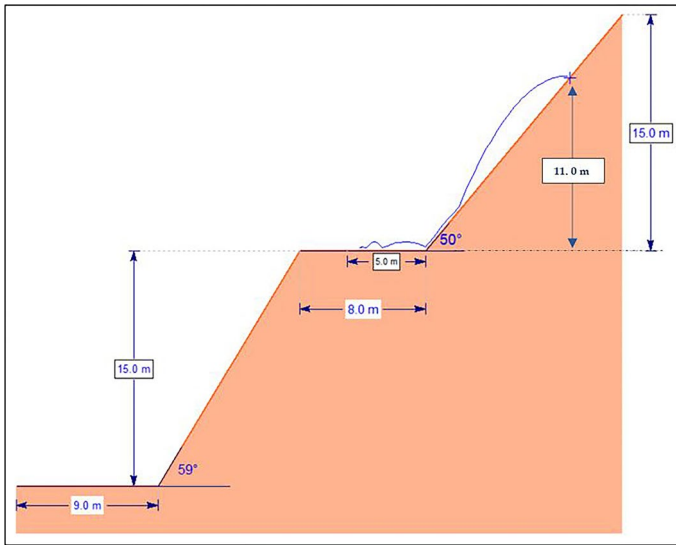
sample of these back analyses. These simulations suggested a peak ground velocity of 4–6 m/s at the site to produce comparable rock fall paths. Comparably, the peak ground velocity (PGV) at this site was estimated to fall in the range of 5–19 m/s by ASK14.

**Fig. 21** A sample back analysis of rockfall cases with RocFall 2019 software

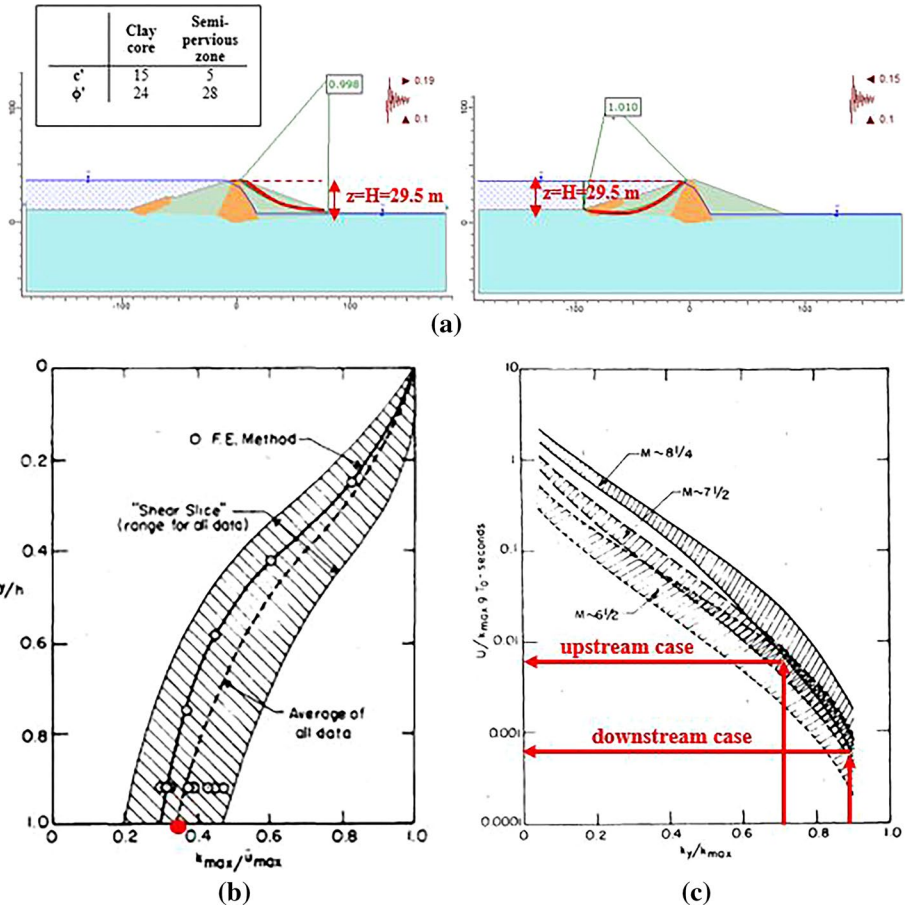
were determined to pass through the toes of the dam. The shear strength parameters for the clay core (high plasticity clay, CH) and semi-pervious zone (silty-clayey sand, SM-SC) were preliminarily used as  $c' = 15$  kPa &  $\phi' = 24^\circ$  and  $c' = 5$  kPa &  $\phi' = 28^\circ$ , respectively, consistent with available field and laboratory test results. The natural period of the dam and crest accelerations were estimated as 0.27 s and 0.62 g on the basis of relationships proposed by Dakoulas and Gazetas (1985) and Kavruk (2003). As shown in Fig. 23, the permanent deformations by Makdisi and Seed (1977) procedure were estimated approximately 1 and 5 mm for the slip surfaces passing through the upstream and downstream toes, respectively, which were concluded to be in good agreement with the width of cracks observed in the crest. It should be noted that these assessments are preliminary in nature and more refined analyses are to be performed for improved evaluations.

Fig. 23 **a** Limit equilibrium-based slope stability models for Dedeyolu Dam, **b** maximum acceleration ratio of Dedeyolu Dam, **c** normalized permanent displacement estimated for Dedeyolu Dam

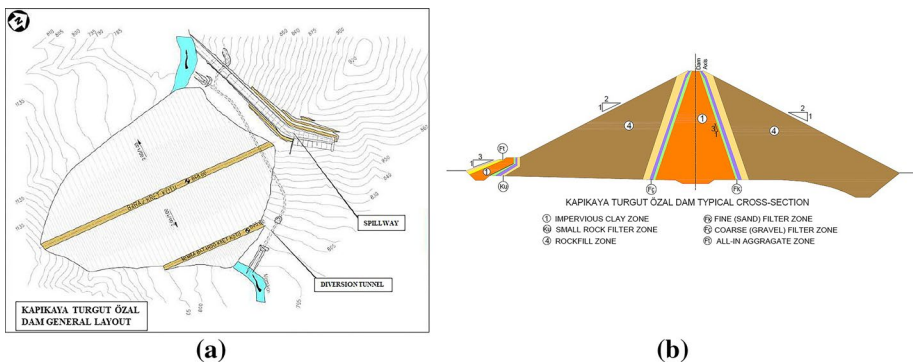
Reconnaissance team has investigated the dam and documented no signs of seismically induced permanent deformations along the dam crest. During site visit, the water level was measured at +854.70 m elevation. Both the upstream and downstream slopes along with the dam axis itself were documented to be unaffected from the shaking. Also, no damage

Fig. 24 **a** General layout of Kapikaya Turgut Ozal Dam (Courtesy of DSI), **b** typical cross section of Kapikaya Turgut Ozal Dam (after DSI)

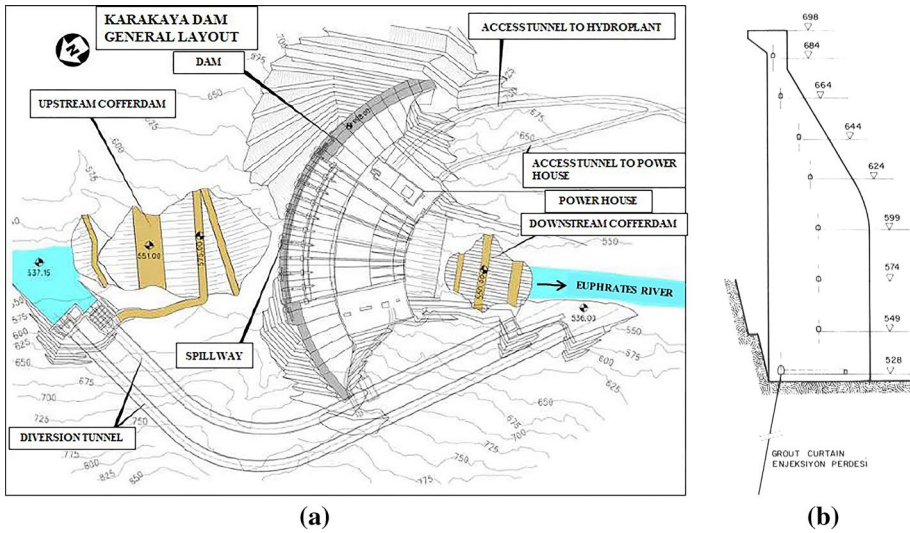
DSI reconnaissance team documented no signs of seismically induced permanent deformations along the dam crest and inside the galleries. Spillway gates were opened and closed with no problem, which have confirmed their elastic response during and after the event. A slight increase in water discharge from drainage holes at +528 m elevation gallery. The discharge was reported as 127.4 lt/min. measured after the event. Additionally, MTA (General Directorate of Mineral Research and Exploration) reconnaissance team observations from Karakaya Dam reservoir revealed some traces of surface rupture and lines of water or gas extrusions crossing the dam reservoir. Figure 27 presents a view of the water or gas bubbles. Also, Karakaya Dam hydropower plant staff has reported that dam reservoir was observed to be muddy, following the few days of the main event.

**Fig. 26** **a** The general layout of Karakaya Dam (Courtesy of DSI), **b** Typical cross-section of Karakaya Dam (Courtesy of DSI)

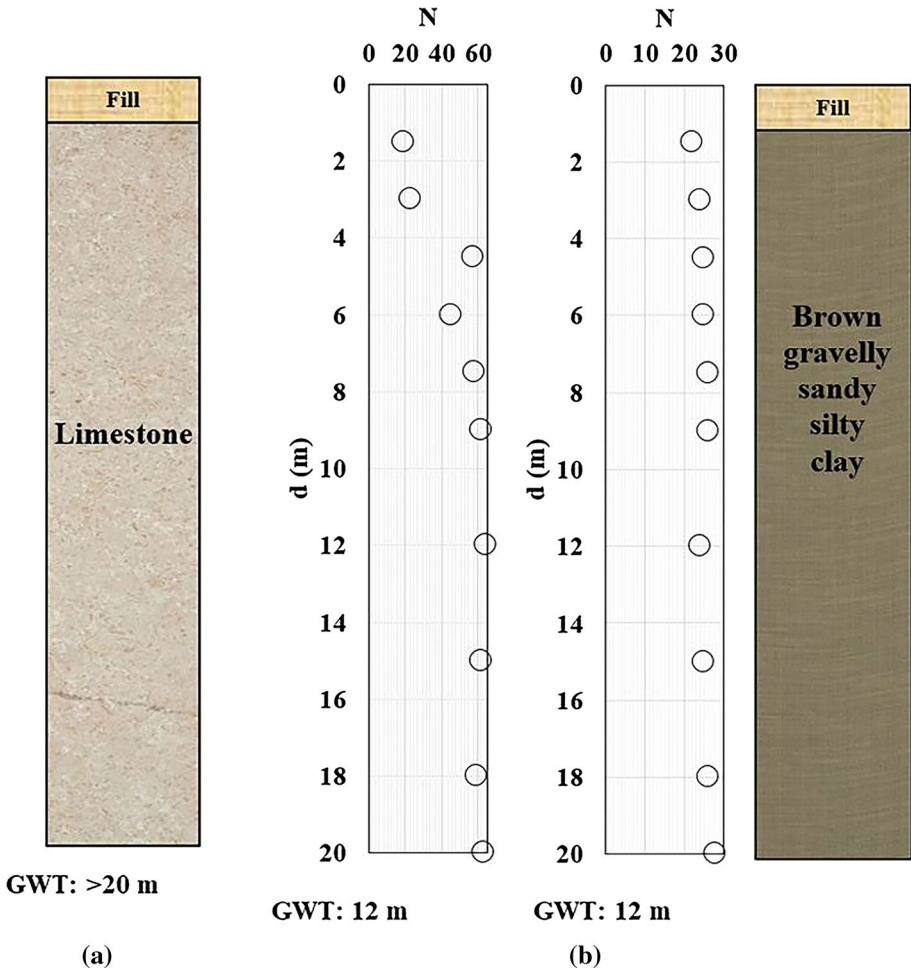
**Fig. 30** Typical borelogs for Elazig-Abdullah Pasa District: **a** northern part, **b** other parts (M. Gor, personal communication 2020)

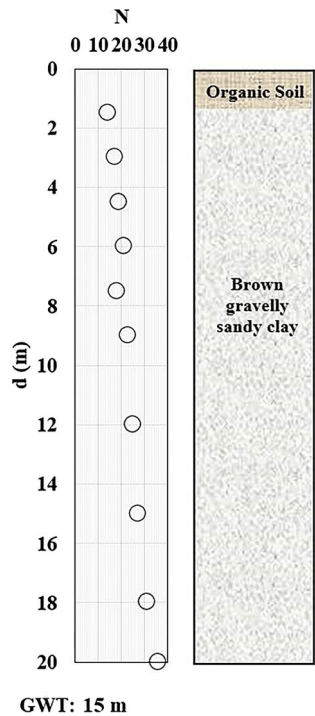
**Fig. 32** Typical borelog for Elazig-Sursuru District (M. Gor, personal communication 2020)

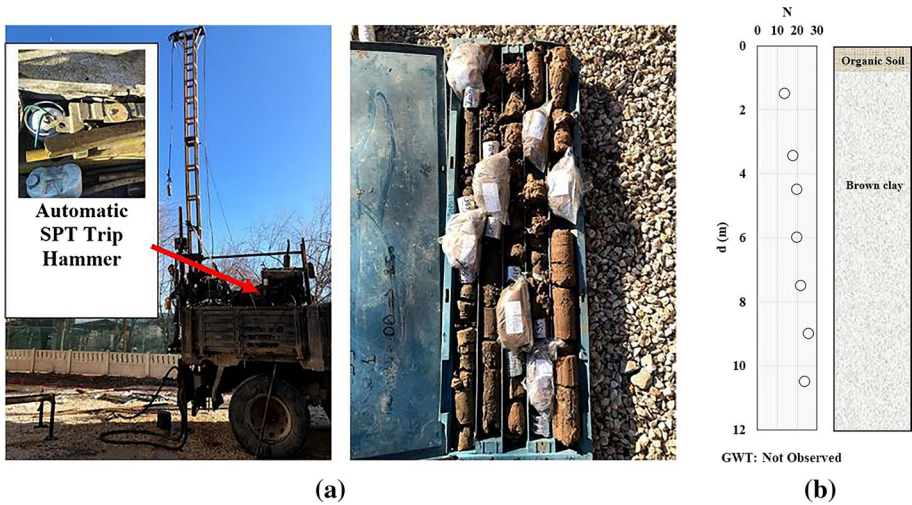
**Fig. 33** **a** Drilling efforts (38°40'03.9"N 39°11'14.8"E/01.02.2020/15:18 & 38°40'03.1"N 39°11'16.1"E/01.02.2020/15:18), **b** the borelog of the witnessed site investigation at Sursuru District (38°40'03.9"N 39°11'14.8"E)

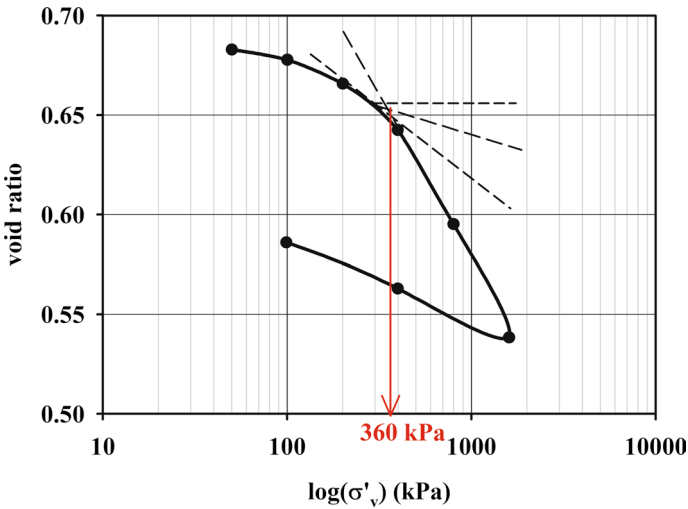
Oedometer tests were performed on this undisturbed sample retrieved at 9.5 m depth following ASTM D2435/D2435M-11 standards. The results are given in Fig. 34, confirming slightly overconsolidated ( $OCR=2-3$ ) and compressible nature of Sursuru District

**Fig. 34** Oedometer test results

clayey soils. Pre-consolidation pressure ( $\sigma'_p$ ), recompression index ( $C_r$ ) and compression index ( $C_c$ ) were calculated as 360 kPa 0.038 and 0.156, respectively.

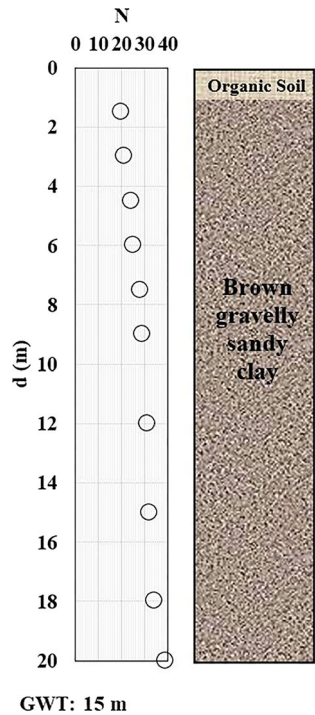
Fig. 36 Typical borelog for Elazig-Mustafa Pasa District (M. Gor, personal communication 2020)

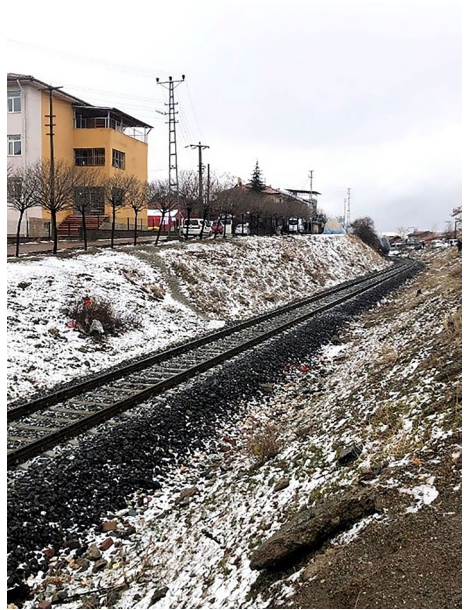
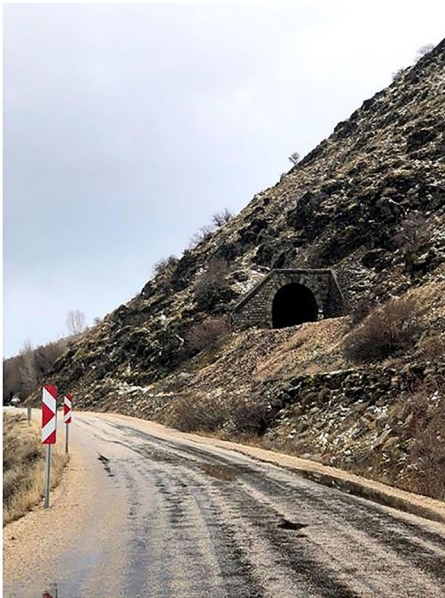
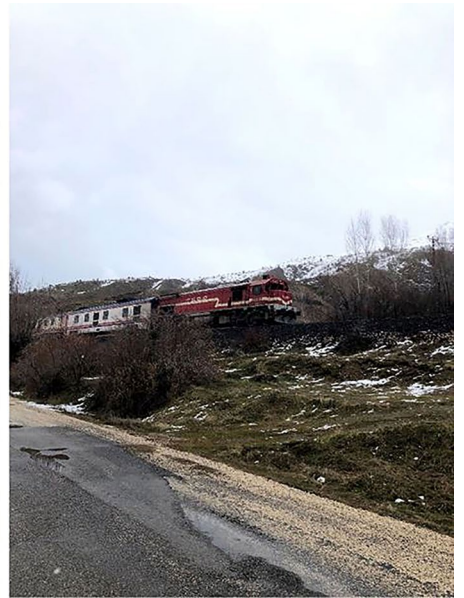
**Fig. 37** A view of railway tracks without any damage at Sivrice ( $38^{\circ}26'49.5''\text{N}$   $39^{\circ}18'33.4''\text{E}$ /31.01.2020/13:29)

**Fig. 38** A view of the tunnel and Guneş Kurtalan Express Train passing by ( $38^{\circ}26'43.7''\text{N}$   $39^{\circ}20'40.8''\text{E}$ /31.01.2020/13:54 &  $38^{\circ}26'56.9''\text{N}$   $39^{\circ}21'16.7''\text{E}$ /31.01.2020/13:59)

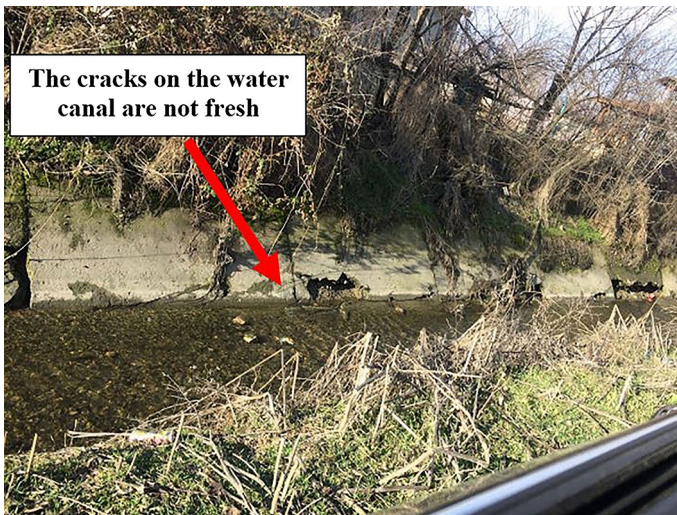
**Fig. 40** Water canal in Dolamantepe Neighborhood of Battalgazi Village ( $38^{\circ}26'00.4''\text{N}$   $38^{\circ}21'44.1''\text{E}$ /01.02.2020/9:25)
