# Performance of structures in İzmir after the Samos island earthquake

## Abstract

**Keywords** Earthquake damage · Samos earthquake · Site effects · RC building deficiencies · Turkish seismic codes

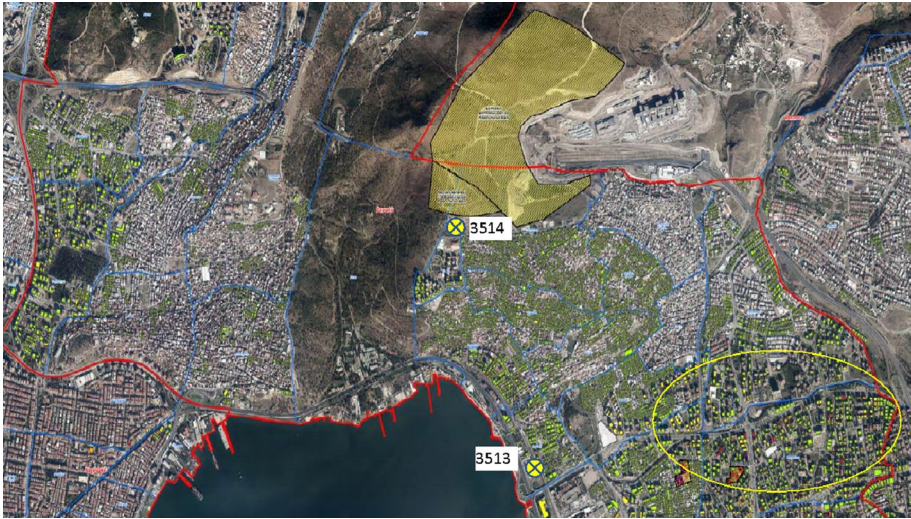
Fig. 3 Satellite view of Izmir Bay, and the region of heaviest damage

A satellite photo of the Northern shore of the inner bay is shown in Fig. 3, which includes stations 3513 and 3514. The regions of heavily damaged buildings are enveloped with a yellow ellipse, where the red spots are indicating the collapsed building

blocks. Yellow and green spots in the photo mark heavily and moderately damaged buildings, respectively. Station 3513, marked in yellow, is very close to the region of heavy damage.

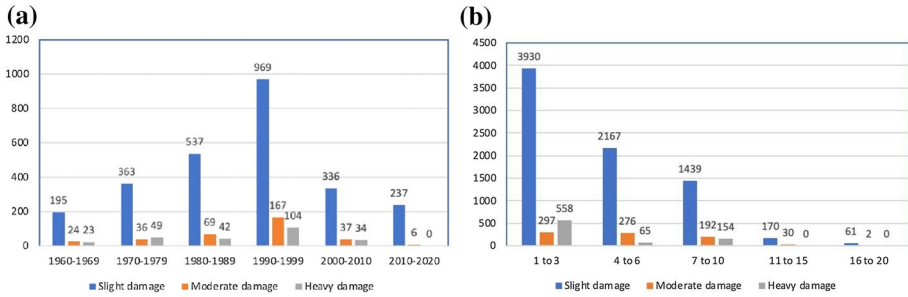
**Fig. 6** Building damage distribution; **a** per building age, **b** per number of stories

in Fig. 6a, a remarkable portion of damaged buildings seem to be constructed during 1990–2000. The structural damages in the buildings constructed after 2010 are significantly less.

The height-wise distribution of damage indicates that mainly buildings up to 10 stories suffered significant damage, no buildings with more than 10 stories were assigned heavy damage. Nevertheless, quite a large number of such buildings were slightly damaged, most of which are deemed to stem from damage to non-structural infill walls. It is interesting to note that 558 buildings with three stories or less have also been assessed as heavily damaged by the inspectors. However, these buildings are relatively old, poorly constructed, poorly maintained, and located in suburban areas which were previously selected to conduct urban transformation projects, hence they were vacated. Structural systems of most of these buildings are composed of irregular masonry walls and there are only few reinforced concrete buildings among them.

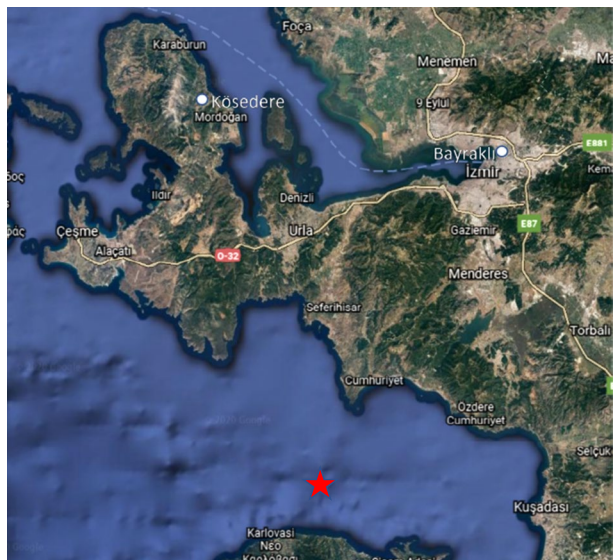
Fig. 15 Location of Kösedere Village

Most of the masonry building damages were concentrated in Kösedere, approximately 75 km away from the epicenter (Fig. 15). Forty masonry buildings suffered structural damage. These are 60–80 years old traditional, rubble stone masonry structures. Typically, lime mortar was used for the walls, most with plaster on both sides. Almost all the structures have two stories with wooden floors and roof trusses. The floor and the roof framing of the structures were observed to be weak, and the perimeter walls of the buildings provided the main resistance. It should be noted that the neighboring villages with very similar construction type and quality did not suffer comparable damage. There existed either none or very few damaged masonry structures in the rest of the peninsula. A typical example of

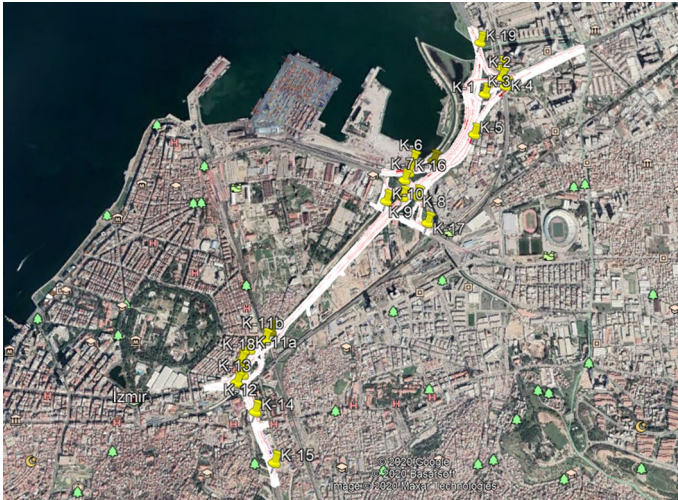
**Fig. 18** The highway line selected and bridges assessed

In addition to buildings, bridges in İzmir were also assessed by METU/EERC teams to investigate their response to the earthquake. The bridges located along Mürselpaşa—Zafer Payzın highway line, shown in Fig. 18, were investigated in detail. All the visited bridges are also marked in Fig. 18. As alluded before, the investigated bridges are approximately 75 km away from the earthquake epicenter. They were observed to perform satisfactorily. These analyzed bridges are in the close vicinity of the Bayraklı region and close to the seismic recording station 3513. Most likely, they have been subjected to spectral accelerations around 0.3 g at their corresponding vibration periods. No permanent movement has been observed in the superstructure beams and supports. The bending and shear capacities of the bridge columns and foundations were exceeded and no visible cracks were observed due to the earthquake. There were no settlements on the foundations mostly located on soft soil. No movement was observed at the bridge expansion joints. No loss of function such as

rupture or fracture was observed in non-structural bridge elements (precast panels, pedestrian railings, lighting poles, etc.). The earthquake performances of longitudinal joints between twin bridges were also satisfactory, and some small concrete pieces not more than 2–3 cm fell on the ground only at some local zones. After the examination of the superstructure and infrastructure of the bridges, no earthquake-related damage was detected. Bridges were available for use right after the earthquake. As a result, it was determined that bridges that performed successfully during the earthquake were serviceable without a need of emergency intervention (Fig. 19).

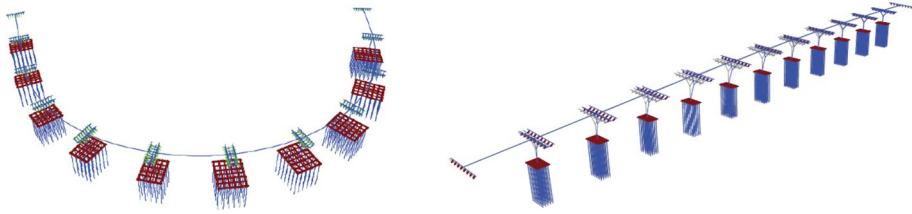
**Fig. 20** Modeled sample bridges in Bayraklı: a curved bridge and, a straight bridge

A structural modal analysis has been performed on two segments of bridges, one curved and the other straight. The vibration periods of curved bridge along the transverse and longitudinal axes are found as 0.65 and 0.85 s, respectively, those for the straight bridge are 1.25 and 1.55 (Fig. 20). These analyzed bridges are in the close vicinity of the Bayraklı region and close to the seismic recording station 3513. Most likely, they have been subjected to spectral accelerations around 0.3 g at their corresponding vibration periods.

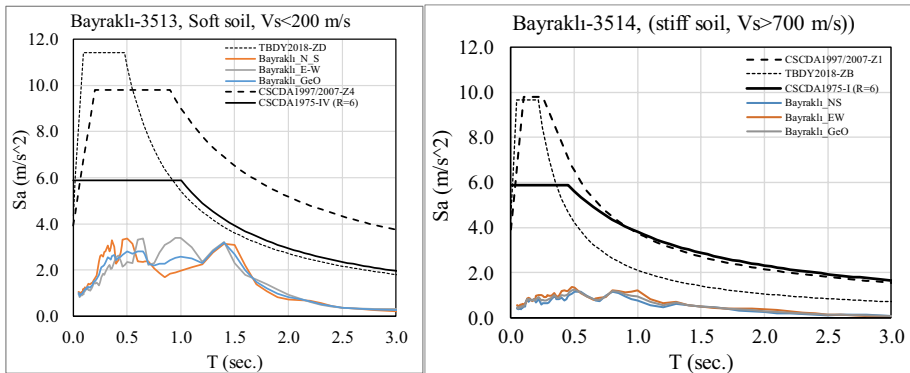
**Fig. 25** Comparisons of code design spectra and the spectra of recorded ground motions in stations 3514 and 3513

The elastic response spectra of all four codes are compared for soft and stiff soil sites of Bayraklı station in Fig. 25. The 1975 code spectra are converted to elastic spectra by assuming a moderate ductility level. Although there is no explicitly specified R factor in the 1975 code, the requirements given for detailing, reinforcement and sizes imply an inherent R factor in the buildings designed per the code. Thus, a value of  $R = 6$  that corresponds to moderate ductility defined in the recent codes is assumed to be reasonable. The relative ductility factor K is taken as 1.0. Figure 24 reveals clearly that corner periods of TBEC 2019 are smaller than the other codes implying that it is less conservative in the period range of 0.6–1.5 s as compared to the 1997 and 2007 codes.

Figure 25 also displays the spectra of recorded ground motions at Bayraklı. As mentioned before, all code spectra are above the recorded values, even in the 0.6–1.5 s period range where significant amplification is observed. The shorter period regions ( $T < 0.5$  s) fall significantly below the design spectra. This is understandable, because the seismic waves from the October 30 earthquake arrive from 70 km distance, and high frequency components in seismic waves were filtered out along this long travel path. Long period waves however retain their energy and dominate the response spectra, both at the stiff and soft soil recording sites. In fairness, it is not consistent to compare the response spectra from a single recorded event and the design spectra obtained by PSHA in the seismic hazard map. Seismic hazard maps account for all causative faults shown in the area in estimating spectral design accelerations at these stations. The faults closer to the strong motion stations will perhaps produce seismic waves that are richer in high frequencies, which will eventually increase the spectral response accelerations at shorter periods. Nevertheless, the two sets of spectra displayed in Fig. 25 clearly reveal that the medium period structures with the fundamental period range of 0.5–1.5 s (approximately 7–12 story RC buildings) are affected more heavily compared to similar buildings on stiff soil sites. This observation has been ratified by the associated building damages, although the observed spectral accelerations were less than half of the spectral design accelerations. If seismic strengths of buildings in the region are uniform over stiff and soil sites, which seems likely, amplified ground accelerations on soft soil sites played a major role in the localization of building damages shown in Fig. 25. The details of the collapsed or heavily damaged buildings are not available to determine adequately the ductility demands. However, considering that the buildings that have collapsed are mainly 7–10 stories having periods of nearly 1.0–1.5 s, approximate concrete strength of 10 MPa, the columns have an average cross-section area of 0.18 m<sup>2</sup> and an average tributary loading area of about 11 m<sup>2</sup> with 1 ton/m<sup>2</sup> gravity load on floors, and they have experienced spectral acceleration in order of 0.3 g, the maximum drift demands can approximately be computed as 0.8–1.4%. This demand corresponds to ductility of 3–6, that is believed to be much higher than the capacity considering the high axial load ratio and inadequate lateral confinement of these buildings.

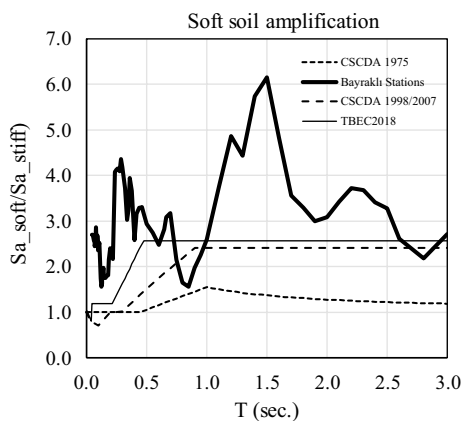
**Fig. 26** Soft-to-stiff soil amplifications based on Bayraklı Stations

The spectral ordinates obtained for station 3513 (soft soil) are divided with the ones determined for 3514 (rock) to obtain the soil amplification coefficients, which are compared in Fig. 26. This figure clearly shows that the code amplifications are below the measured amplification levels in Bayraklı. Therefore, site-specific response spectra for such areas have to be considered and necessary modifications in the current code should be undertaken. Aside from this exception, TBEC (2018) appears to address the requirements for earthquake resistant building design adequately.
