Field reconnaissance on seismic performance and functionality of Turkish industrial facilities affected by the 2023 Kahramanmaraş earthquake sequence

Gulsah Sagbas¹ · Ramin Sheikhi Garjan¹ · Kerem Sarikaya¹ · Derya Deniz¹

Abstract

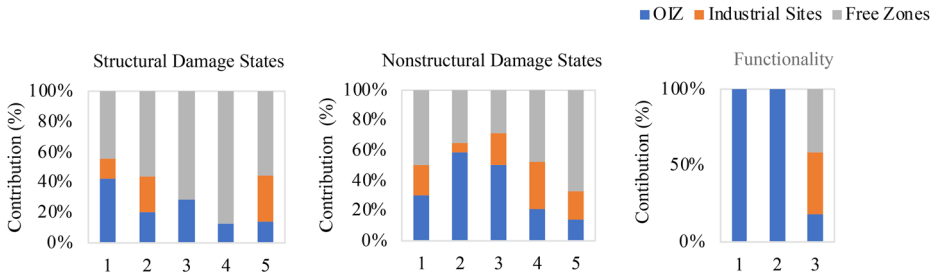
Fig. 4 Distributions of performance and functionality assessment results based on the industrial zone types (note: OIZ, IS and FS stand for organized industrial zone, industrial site, and free site)

Fig. 4 categorizes the inspected facilities into three types of industrial zones, as mentioned before in Sect. 2.1 (see Table 1). The facilities in organized industrial zones (OIZ) tend to have less serious damage than those in free sites (FS) and small industrial sites (IS). Because the requirements and constraints for an OIZ are more stringent than those for IS and FS zones, buildings are more likely to be properly designed for earthquakes, and as a result, fewer significant damages were observed for both structural and nonstructural assessments, even for OIZs in Hatay and Kahramanmaraş. Similarly, although factories in OIZs have mostly FS1 and FS2 functionality levels, the other two zones all have FS3, indicating no functionality.

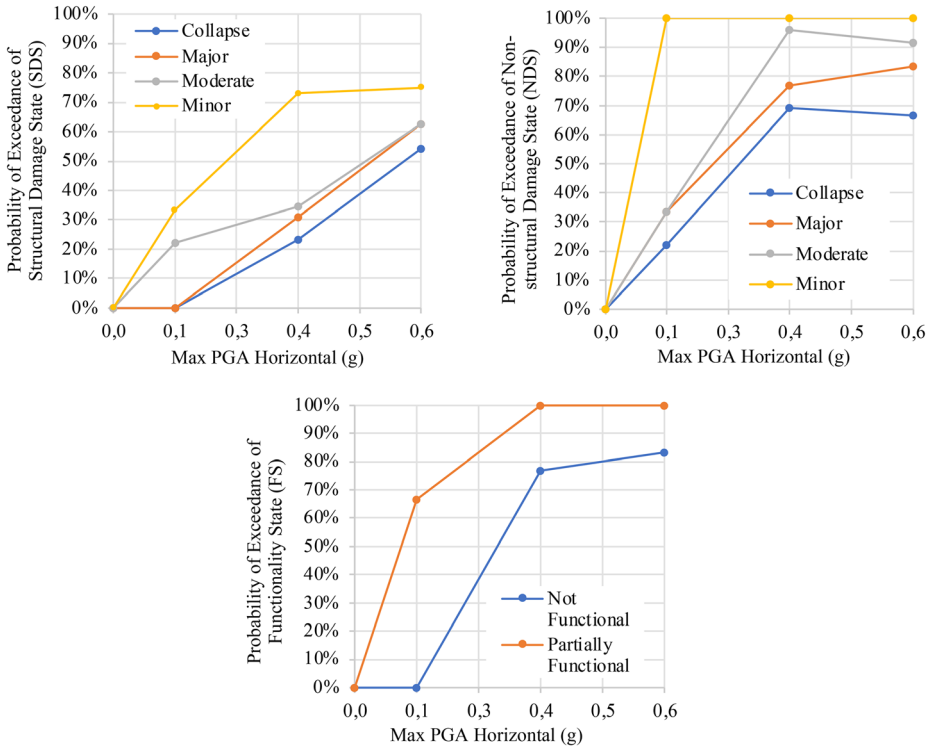
Fig. 5 Empirical performance and functionality models for precast RC buildings (note that spatial distances of the facility sites to the recording stations were not considered yet in these preliminary models)

assessment data (Table 3) and seismic demands (Table 5). Because all facilities have different structural systems that result in high variability in assessment results, the 59 inspected precast reinforced concrete buildings (precast RC types, including precast column buildings with steel roofs) were focused on here to assess the relationships for the exceedance of probabilities (i.e., fragilities) with respect to PGA values. It should be noted that the horizontal PGA values (maximum of north-south or east-west) of the first earthquake at the nearby stations (see Table 5) were used directly in the assessment of the fragility relations for the facilities, without considering high spatial variability of the ground motion recordings between the stations and the facility sites. The empirical performance and functionality fragility models for the investigated precast RC structures are depicted in Fig. 5. As predicted, all models exhibit a nearly increasing trend as the PGA gets larger.

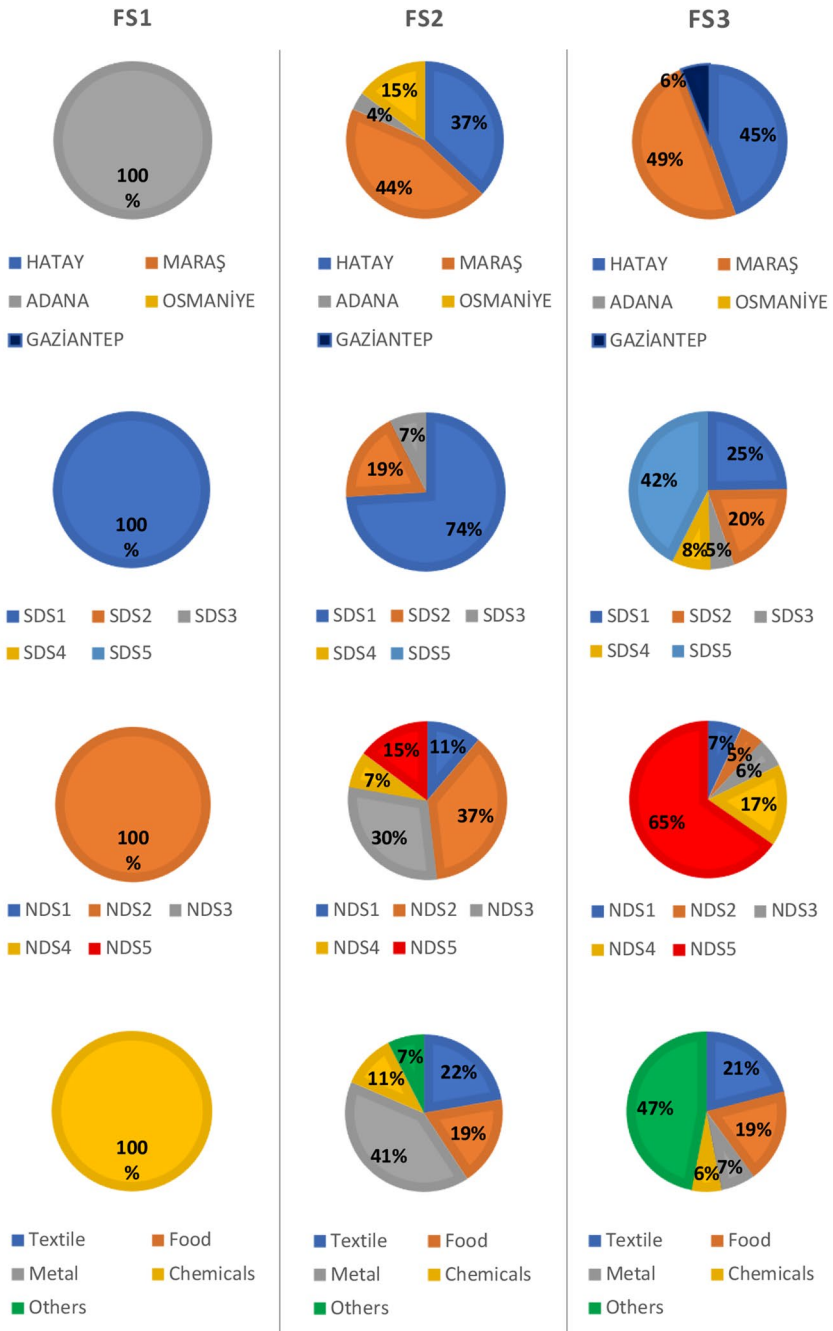
Fig. 16 Distributions of the functionality state levels FS1, FS2 and FS3 for the inspected industrial facilities based on their locations (note that Maras corresponds to Kahramanmaraş), structural and nonstructural damage levels (SDS and NDS, respectively), and industrial sectors

Fig. 16 demonstrates that, while most facilities in Kahramanmaraş and Hatay were either partially or completely functional, the sole places with nearly full functionality (FS1) were found to be in Adana, where low PGA values were reported in Table 5.

When the state distributions in Table 6 are compared, the ones for nonstructural damage states and functionality states show a similar increasing trend from none to severe case, indicating a closer relation. Even if some industrial firms had negligible structural damage (SDS1), the relocation of some production equipment as a result of earthquake shaking (NDS2) may necessitate some repair time before they can restart operations. This can also be seen from Fig. 16, where SDS1 and NDS2 contribute the most to partial functionality (FS2) state, with 74% and 37% respectively. This is especially true for textile manufacturers, as seen in Fig. 16, where the textile industry is one of the most affected industry sectors among the visited locations assessed with partial (FS2) or no (FS3) functionality. This is
