## 2022 Düzce, Türkiye earthquake: advances in the past 2 decades, lessons learned, and future projections

### Abstract

In the year 1999, two devastating earthquakes ( $M_w$  7.4 Kocaeli earthquake in August and  $M_w$  7.2 Düzce earthquake in November) occurred in Northwest Türkiye. These two earthquakes led to a very large number of casualties and building collapses. When the 1999 earthquakes occurred, most of the structures in the earthquake-impacted region were not designed according to modern seismic design codes. During the 25 years following those earthquakes, there have been significant advances in building construction in the light of earthquake engineering, including adequate seismic codes, new regulations, and effective code enforcement in the earthquake impacted region. These advances have been reflected in the construction of new structures in the region and the retrofitting of existing ones. As a result, 70–80% of the current building stock in Düzce was designed, constructed, or retrofitted after the 1999 earthquakes. Almost 23 years later, in 2022, an  $M_w$  6.1 earthquake occurred in Düzce, with ground shaking close to the seismic design code life safety performa

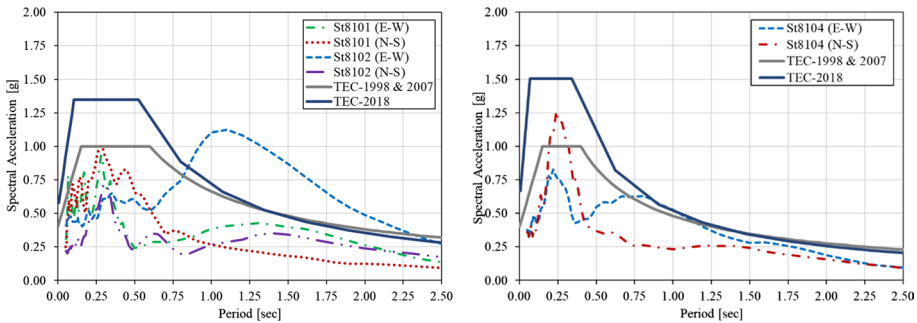
**Fig. 3** Comparison of acceleration response spectra of the recorded ground motions at three stations of the 2022 Düzce earthquake with the design spectrum per TEC (1998), TEC (2007) and TEC (2018)

Horizontal components of the ground motions recorded near the city center of Düzce (at stations 8101, 8102 and 8104 in Fig. 2) are used to calculate the response spectra and compare with the design spectrum given in the current Turkish Earthquake Code, TEC (2018) and previous versions of it (TEC 1998 and TEC 2007), as shown in Fig. 3. The design response spectrum corresponds to the design basis earthquake (DBE) level with a corresponding return period of 475 years in Turkish earthquake codes. Stations 8101 and 8102 are located on soft soils (e.g.,  $V_{s,30}=280$  m/s at station 8102), which corresponds to site class ZD in TEC (2018). Station 8104 is located on soil with shear wave velocity,  $V_{s,30}=398$  m/s, for the corresponding site class ZC in TEC (2018). Due to differences in soil properties, the design spectrum presented in Fig. 3 differs between the site of station 8104 and that of stations 8101 and 8102. Since these three stations are located 10.62–13.74 km away from the epicenter (Table 2) and near Düzce city center (Fig. 2), they provide good estimates for the seismic demand experienced by the structures in Düzce. Figure 3 indicates that the spectral accelerations were less than the corresponding seismic design accelerations specified in the current design code, TEC (2018), except for the ground motion measured in the E–W direction at station 8102. For this ground motion, spectral accelerations for periods between approximately 0.9 and 2.4 s are larger than those implied in the design code, which is particularly due to soft-soil conditions at this location, as discussed earlier. This motion can particularly be demanding for structures with periods greater than 0.8 s due to the high spectral accelerations in this range. As these structures experience damage, their periods elongate, leading to similar or greater demands due to the shape of the response spectrum. However, this effect did not cause any damage in the region as there are a limited number of long-period structures present.

the spectral accelerations in the period range of interest are close to design accelerations for stations 8101 and 8102, while the East–West component of accelerations at station 8104 is higher than the design accelerations given in the TEC (1998) and 2007. Consistent with similar codes in the US and around the world, the intent of the Turkish earthquake code is to limit damage to repairable levels in design-level earthquakes. As described in the forthcoming sections of the paper, the observed structural damage was quite low, not only satisfying this objective but performing beyond that.

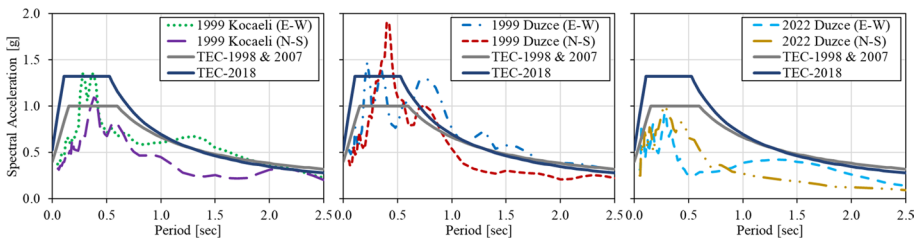
**Fig. 4** Comparison of acceleration response spectra of the recorded ground motions at station 8101 with the design spectrum per TEC (1998), TEC (2007), and TEC (2018)

The calculated response spectra and features of the motions are illustrated in Fig. 4. Both the 1999 Düzce and 1999 Kocaeli earthquakes were longer in duration. Comparing the peak values and the response spectra of the Düzce motions from the 1999 Kocaeli and 2022 Düzce earthquakes, it is observed that while the 1999 Kocaeli earthquake motion is a bit more intense, both are close to design levels (Fig. 4). Despite the two events being close to design levels, major damage in Düzce during the 1999 Kocaeli earthquake was due to the low construction quality and the incompatible design of structures with the earthquake engineering principles (Sezen et al. 2000). The N–S components of the 1999 Düzce earthquake produced exceptionally high spectral accelerations (1.91 g), exceeding the TEC (1998) and TEC (2018) design spectral acceleration value by 91% and 44% at a period of 0.42 s. TEC (1998) had only been approved for building design prior to that earthquake. Design spectral accelerations were even lower in TEC (1975), which was used for the design of most buildings that
