SAFETY, DIAGNOSIS, AND REPAIR

EXPERIENCE GAINED IN APPLIED SYSTEMS

ANALYSIS OF DAMAGED LOAD-BEARING

STRUCTURES OF PROCESS EQUIPMENT

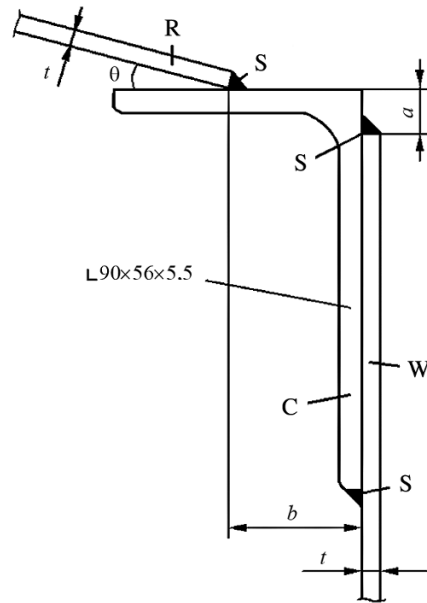
Fig. 1. Geometric diagram of coupling unit of conical roof with wall.

As an example, let us consider simulating the over-design load produced by snow loads in the coupling unit of a self-supporting conical roof with wall of a 100-m^3 vertical low-pressure steel cylindrical tank used for storage of petroleum residue [1]. The inner diameter of the body of the tank is 4730 mm and the height 5960 mm. The structural diagram of the unit (Fig. 1) incorporates the shell of the roof R, wall W, and corner angle C connected by three weld joints S. The geometric parameters are as follows: $a = 10$ mm, $b = 30$ mm, thickness of walls of body and cover $t = 4$ mm, $\theta = 15^\circ$, and leg of seam 4 mm. The maximum height of infusion of the petroleum residue is 5560 m and its density 990 kg/m^3 . The structure material consists of VSt3sp2 steel (All-Russia State Standard GOST 27772–20156) with yield limit 245 MPa and ultimate strength 370 MPa. A bilinear model of deformation of the material with isotropic hardening in a proposed associative flow law is used.
