Post-Earthquake Fire Performance of Buildings: Summary of a Large-Scale Experiment and Conceptual Framework for Integrated Performance-Based Seismic and Fire Design

*Brian J. Meacham**, Department of Fire Protection Engineering, Worcester Polytechnic Institute, 100 Institute Road, Worcester, MA 01609, USA

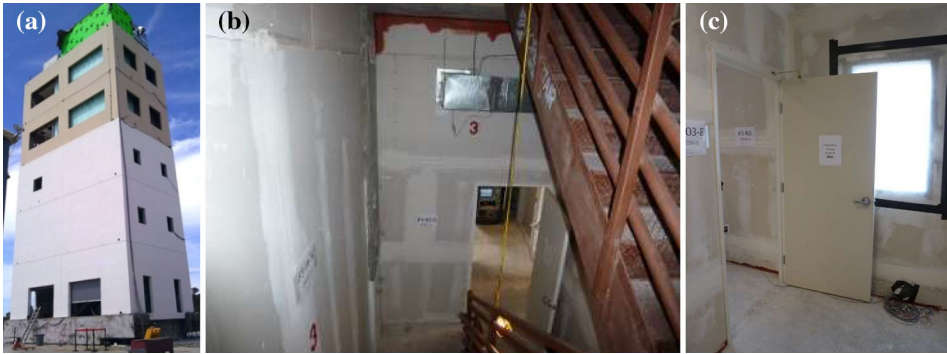
Figure 3. Photographs of (a) the façade systems on the BNCS test specimen, (b) stair enclosure looking onto Floor 3, and (c) partition wall and door on Floor 3 [19, 23].

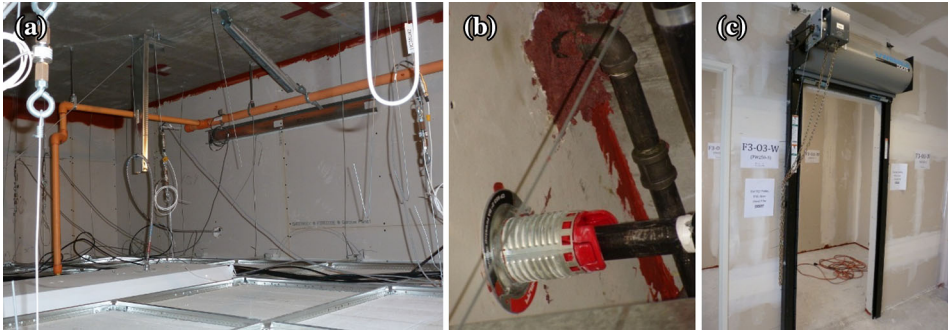
Figure 4. Photographs of (a) above ceiling space showing sprinkler piping and brace, fire seal and ceiling system on Floor 2, (b) representative firestop systems on Floor 3, and (c) fire door and partition walls between compartments on Floor 3 [23].

The sprinkler system and the various firestop systems generally performed well. There was clear displacement of the sprinkler riser in some locations, but no leaks or loss of pressure [20, 23, 25, 28]. While the sprinkler system performed well, it is worth noting that the hangars, bracing and other components were installed in accordance with current regulatory requirements, which may reflect a higher degree of performance than older, existing systems. Recent testing of sprinkler and ceiling systems at the University of Buffalo points to sprinkler performance considerations for earthquake prone buildings [33, 34]. Most firestop systems were undamaged; however, those systems designed for static joints, which were subjected to the dynamic movement of the specimen, were damaged as gaps opened at connection points (e.g., wall to wall, wall to ceiling) [20, 23, 25, 28]. This can be seen in Figure 6f. This situation does not appear to be addressed in current building regulations and design practice.
