A Review of Seismic Damage of Mountain Tunnels and Probable Failure Mechanisms

Nishant Roy · Rajib Sarkar

Keywords Mountain tunnel · Seismic damage · Failure mechanism · Case histories

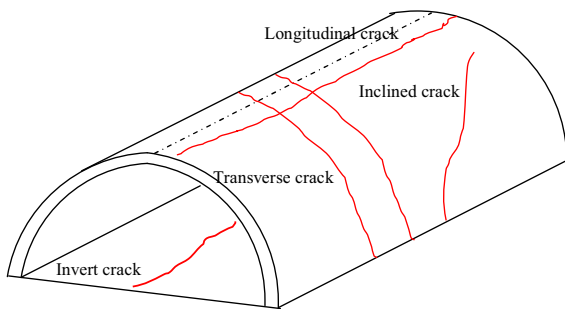
The most frequent form of earthquake induced damages in tunnels is the cracking of the tunnel lining. Based on field observations of tunnel damages, the cracking have been classified as longitudinal, horizontal, oblique breakage, ring breakage and invert cracks. Figure 10 shows some of the crack patterns generally observed following recent past seismic events. Many tunnels severely damaged in 1923 Great Kanto earthquake developed longitudinal, horizontal and oblique cracks in the lining. Various forms of cracking have also been reported by Li (2012) for the tunnels of the Du Wen highway following the Wenchuan earthquake of 2008. In some cases, cracks developed at both sides of arch wall. Moreover, at some sections, extensive collapse of the concrete lining coupled with the exposure and buckling of steel reinforcements compromised the safe operation of the tunnels.

Fig. 10 Different patterns of cracks in tunnel lining

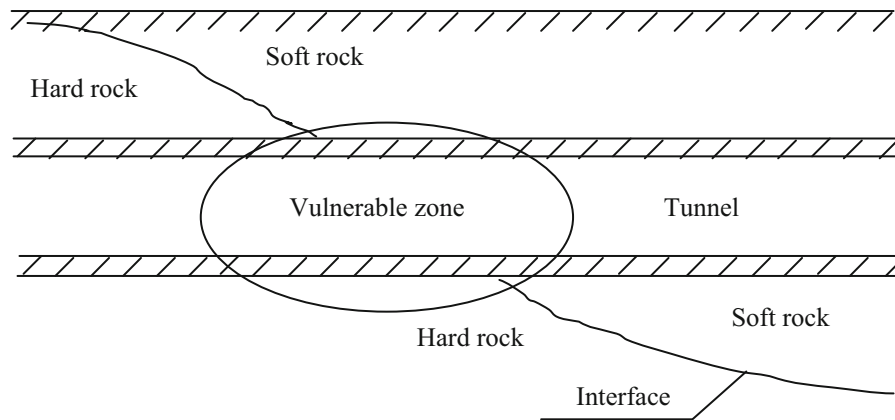
Seismic vulnerability also increases when the tunnel passes through a transition zone between hard and soft rocks. For example, in case of Longxi tunnel, greater seismic damage occurred for the portal region situated in mudstone in comparison to the zone passing through granite rock. Figure 11 illustrates the vulnerability of tunnel passing through a transition zone. In such geological condition, mismatch in both stiffness and seismic impedance leads to differential kinematic movement. This kinematic movement coupled with amplified ground motion due to the softer strata results in an additional horizontal force on the tunnel liner leading to the development of cracks at the junction between the arch shoulder and the sidewall as

Fig. 11 High vulnerability at interface between two types of rock mass

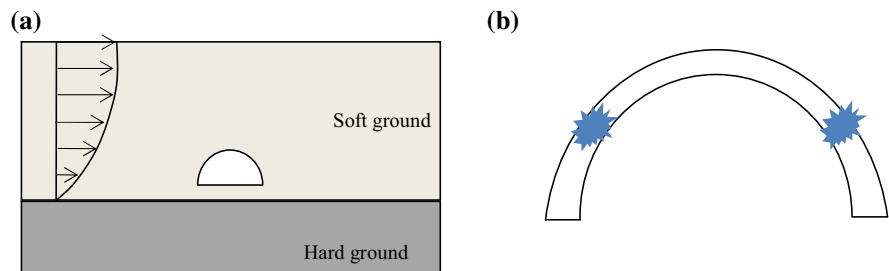
Fig. 12 Vulnerability near junction of hard and soft ground. **a** Amplified ground movement in softer strata, **b** development of crack at junction of shoulder and sidewall

shown in Fig. 12. Such a mechanism is believed to have caused major damages to mountain tunnels as reported by Miyabayashi et al. (2008).

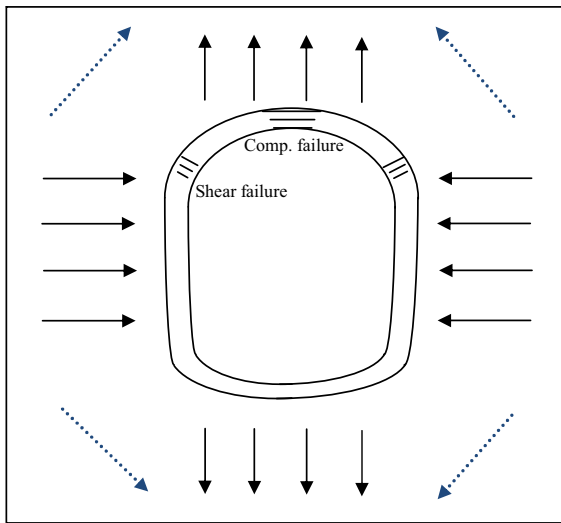
A wide range of tunnel lining failures has been identified based on the case studies of damaged mountain tunnels. A few mechanisms proposed to explain some of them are presented in this section. Figure 13 presents the case of seismic shear wave propagating along the diagonal directions which causes shear stresses on the tunnel cross section as

Fig. 13 Mechanism of compressive and shear failure of tunnel lining

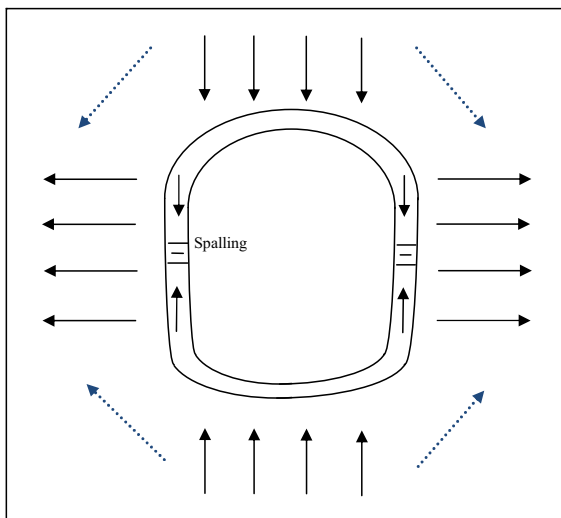
Figure 14 shows a case in which the diagonal stresses give rise to tensile and compressive forces in the horizontal and vertical direction respectively. Such an action causes the vertical compression of the tunnel cross section coupled with an extension of the sidewalls. Spalling of concrete at the sidewalls may be observed in such a scenario resulting in exposure of lining reinforcements.

Fig. 14 Mechanism of spalling of tunnel lining

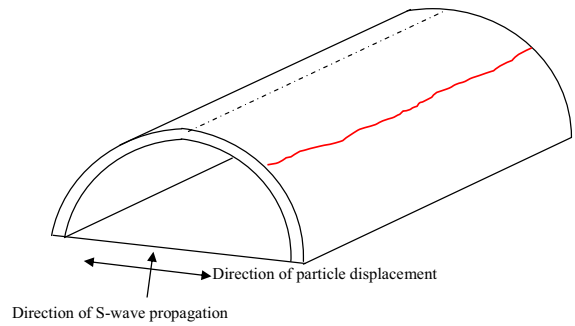
propagation of S-waves parallel to the tunnel cross-section. It causes particle movement in a horizontal direction as shown in Fig. 15 resulting in stress concentration at the junction of the sidewall and the arch.

Fig. 15 Longitudinal cracks of tunnel lining

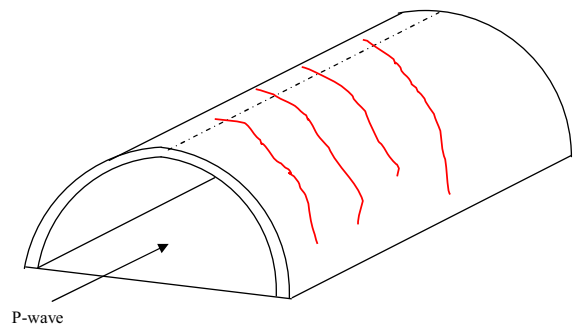
Transverse cracks are a result of propagation of P-waves along the direction of tunnel axis. Under this condition, alternate tension and compression along with the pounding of construction joints leads to the

Fig. 16 Transverse crack due to propagation of P-wave along longitudinal direction

development of cracks along the circumference of the tunnel as shown in Fig. 16.

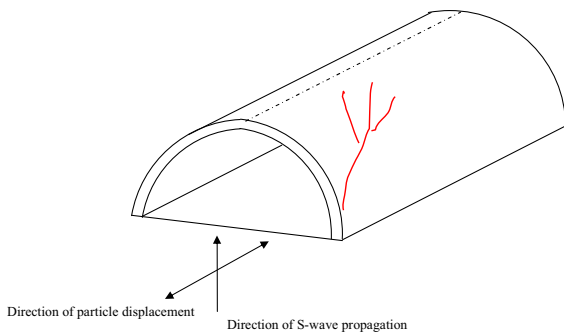
Propagation of S-waves in the vertical direction in a plane parallel to the longitudinal axis of the tunnel results in development of tensile forces resulting in inclined cracks as shown in Fig. 17.

Fig. 17 Inclined cracks due to propagation of S-wave

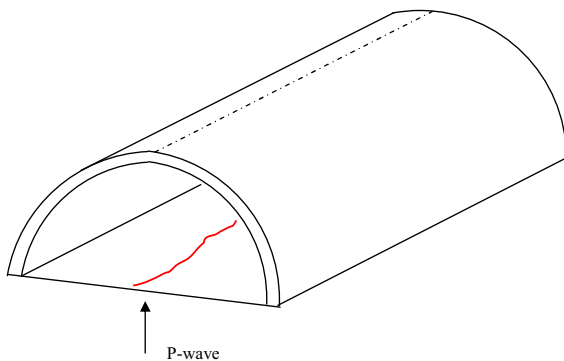
The pavement cracks are a result of vertical propagation of high frequency P waves parallel to the cross section. Under such wave propagation pattern arching or bending of the bottom pavement occurs as shown in Fig. 18.

Fig. 18 Cracking of bottom pavement under action of P-wave sustained in such cases are very severe and may result in complete collapse of the tunnel. Figure 19 illustrates the shear failure of lining induced due to fault movement.

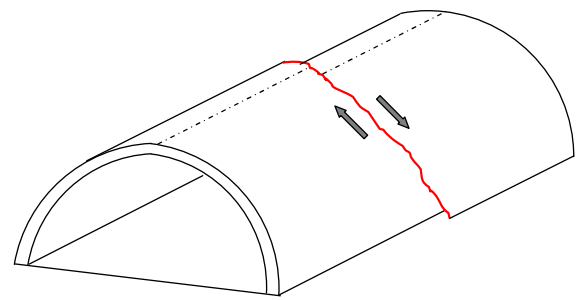
The shearing failure of tunnel lining results from a relative movement of adjacent parts of the tunnel intersecting the fault plane. Generally the damages

Fig. 19 Shear failure of tunnel lining due to fault movement
