# Seismic intensity map and typical structural damage of 2010 Ms 7.1 Yushu earthquake in China

Maosheng Gong · Shibin Lin · Jingjiang Sun · Shanyou Li · Junwu Dai · Lili Xie

**Keywords** Yushu earthquake · Earthquake disaster survey · Seismic intensity map · Typical structural damage · Structural seismic capacity

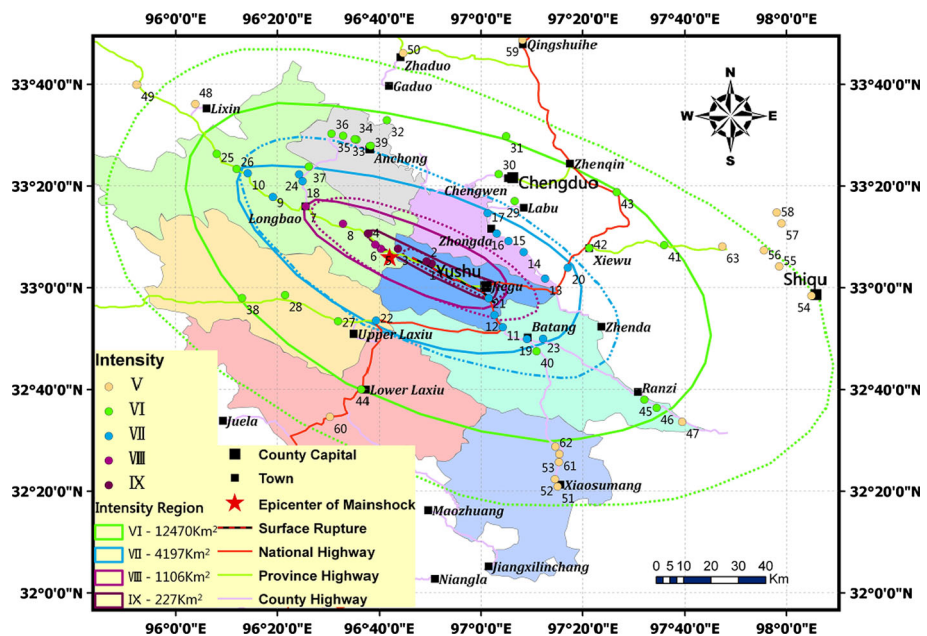
**Fig. 2** The surveyed (solid lines) and temporary (dashed lines) seismic intensity maps of the Yushu earthquake

and the TSIM indicates that: (1) the VI region in the SSIM is significantly smaller than the corresponding region in the TSIM, especially along its long axis; (2) the VII region in the SSIM is narrower in both the southeast and northeast directions than the corresponding region in the TSIM; (3) the VIII region in the SSIM is shorter in the southeastern direction; and (4) the IX region in the SSIM is longer along its long axis in the northwest direction. The SSIM should be more accurate than the TSIM because more time was allotted for the survey and for detailed analysis of structural damage.

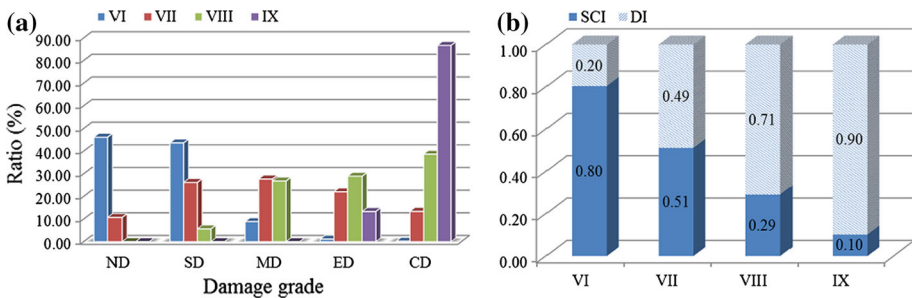
Figure 3 shows that (1) the VI region had the least damage in terms of the highest percentage of buildings with slight or none damage grades (89.78 %) and the highest seismic capacity ( $SCI = 0.80$ ); (2) the VII region had a uniform distribution of damage and similar values of DI and SCI; and (3) the VIII and IX regions had few buildings at slight and none damage grades, the lowest SCIs (0.29 and 0.10), and the most buildings with extensive and complete damage grades and with the highest DIs (0.71 and 0.90).

**Fig. 3** a The damage ratios of non-engineered adobe and stone buildings in four intensity regions, b seismic damage and capacity indices in four intensity regions

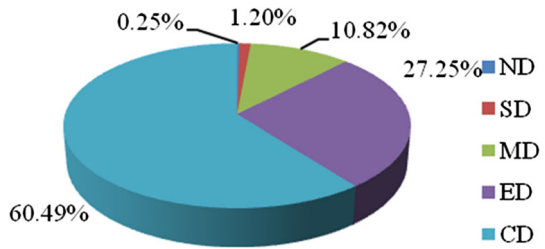
Figure 6 shows the damage percentages of adobe and stone structures expressed in five grades: none (0.25 %), slight (1.20 %), moderate (10.82 %), extensive (27.25 %), and complete (60.49 %).

**Fig. 6** Percentages of adobe and stone structures at five damage grades

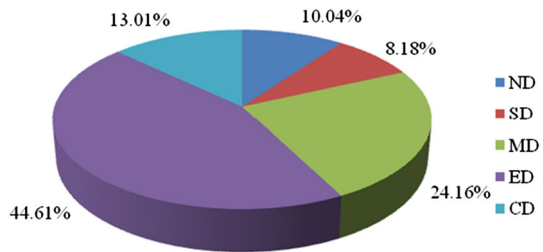
Figure 18 shows the percentages of masonry structures for the five damage grades. The percentage of complete and extensive damage grades accounted for 57.62 %, very close to the 55.42 % for the concrete block structure, but much higher than the 23.53 % for the RC frame structure. The percentages of none, slight, and moderate damage grades are close to those for concrete block structures.

**Fig. 18** Percentage of brick masonry structures at five damage grades

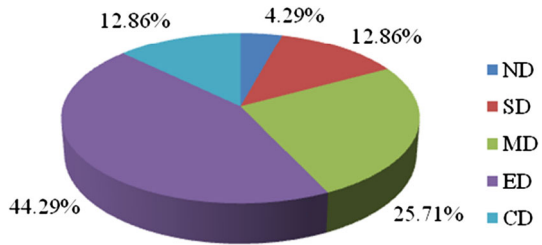
Figure 21 shows the percentages of bottom frame structures corresponding to the five damage grades. The percentage of complete and extensive damage grades accounted for 57.15 %, very close to those of concrete block and brick masonry structures. The percentage for the none damage grade was only 4.29 %, significantly less than those of concrete block, RC frame, and masonry structures.

**Fig. 21** Percentages of bottom frame structures at five damage grades

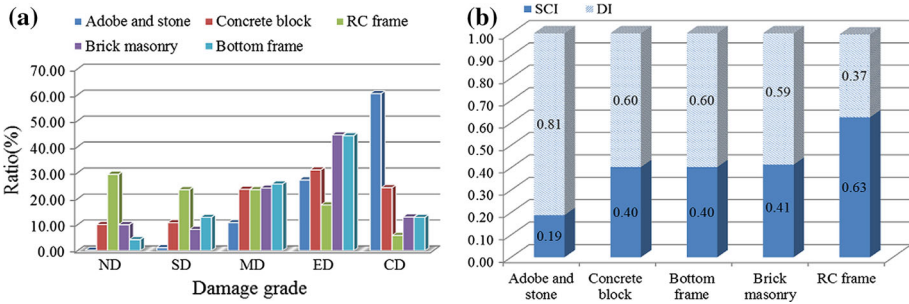
All percentages of structural damage described in the preceding section are shown in Fig. 22a. The seismic damage and capacity indices for each structure type were calculated using a method originally proposed by the authors in earlier studies (Lin et al. 2010, 2011) and are shown in Fig. 22b. Adobe and stone structures had the most severe damage as reflected by their highest percentage of complete damage (60.49 %) and their lowest seismic capacity index (0.19). More than 64 % of the death toll was caused by the collapse of adobe and stone buildings. In the future, such structures should not be built in high-seismic-risk zones due to risks caused by low-strength materials, weak clay–straw covered by tiles, and loose connections among walls, beams, and purlins. Brick masonry and concrete block structures have similar damage intensities with approximate damage indices of 0.59 and 0.60, respectively. These two structural types should exhibit less damage if designed and constructed strictly following the design codes, including providing a sufficient number of belt courses and structural columns as well as by using stronger mortar. Unfortunately, because most buildings representing these two structural types in Jiegu Town did not satisfy these requirements, they had severe damage resulting in many casualties. More than 30 % of the death toll was caused by the collapse of concrete block buildings, while about 2 % were caused by the collapse of brick masonry buildings. The bottom frame structure had the second lowest percentage of no damage (4.29 %). The damage to bottom frame buildings was caused mainly by stiffness discontinuities in the vertical direction. It is thus suggested that this kind of structure should no longer be

**Fig. 22** **a** Damage ratios of the five types of structures, **b** damage indices and seismic capacity indices of the five types of structures

constructed in high-seismic-risk zones or should at least include specific measures to ensure an appropriate distribution of vertical stiffness. The RC frame structure had the best seismic performance in terms of the lowest percentage of complete damage (5.88 %) and the highest seismic capacity damage index (0.63). The main problem was that the “strong-column weak-beam” fortification target of the seismic code had not been achieved in the RC buildings of Jiegu Town. Use of this type of structure should be encouraged in high-seismic-risk zones, especially when superior construction quality can be achieved. The
