# Landslide Hazard in the Nainital township, Kumaun Himalaya, India: the case of September 2014 Balia Nala landslide

**Abstract** Nainital township located in the Kumaun Lesser Himalaya is known to be vulnerable to landslides since past, and it has been reported that half of the area of the township is covered with debris generated by landslide. A disastrous landslide in the Rais Hotel locality on the right side of the Balia Nala struck during September 2014 after the excessive rainfall. Geologically, the area dominantly comprises limestone with shale and slate which are highly crushed and weathered due to the presence of the Nainital Lake Fault that extends into Balia Nala as Balia Nala Fault. Ground-penetrating radar study depicts that these rocks are overlain by thin debris cover of the order of 5–10 m. The geotechnical studies confirm these rocks and the overlying soil as having very low strength. The landslide has triggered because of the excessive rainfall in the area. It has been observed that rainfall in the area has increased since 2010. An increase in more than 100 % intensity of rainfall during the monsoon from an average 33 mm per day (1995–2013) to 68 mm per day in 20

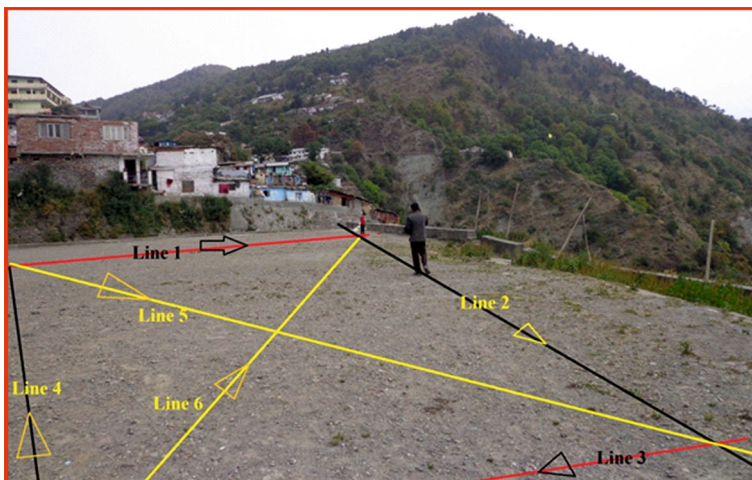
The survey has been carried out on the flat ground in the Rais Hotel colony locality located on the left flank of Balia Nala ( $29^{\circ}22'27''\text{N}$ ;  $79^{\circ}27'56''\text{E}$ , elevation 1872 m). GPR profiling was done at six transacts (Fig. 9) to measure the exact thickness of the overburden. These GPR profiles are depicted in Fig. 10. All the profiles indicate that the soil mass below the ground is highly disturbed and is probably debris from previous slides in the area. The depth of the disturbed mass varied between 2 and 10 m. It is estimated that the interface of the bedrock–overburden on the slope is located at about 2–5 m below the ground. This has also been corroborated with the numerous drill holes data carried out on the SSW-facing slope adjacent to the Nainital Lake for the construction of Nainital Ropeway (CBRI 1983).

**Fig. 9** Six transacts on the flat playground in the Rais Hotel colony where the GPR survey was carried out
