Seismic damage to schools subjected to Nepal earthquakes, 2015

Keywords Nepal earthquake 2015 · School · Directivity effect · Site effect · Earthquake sequence

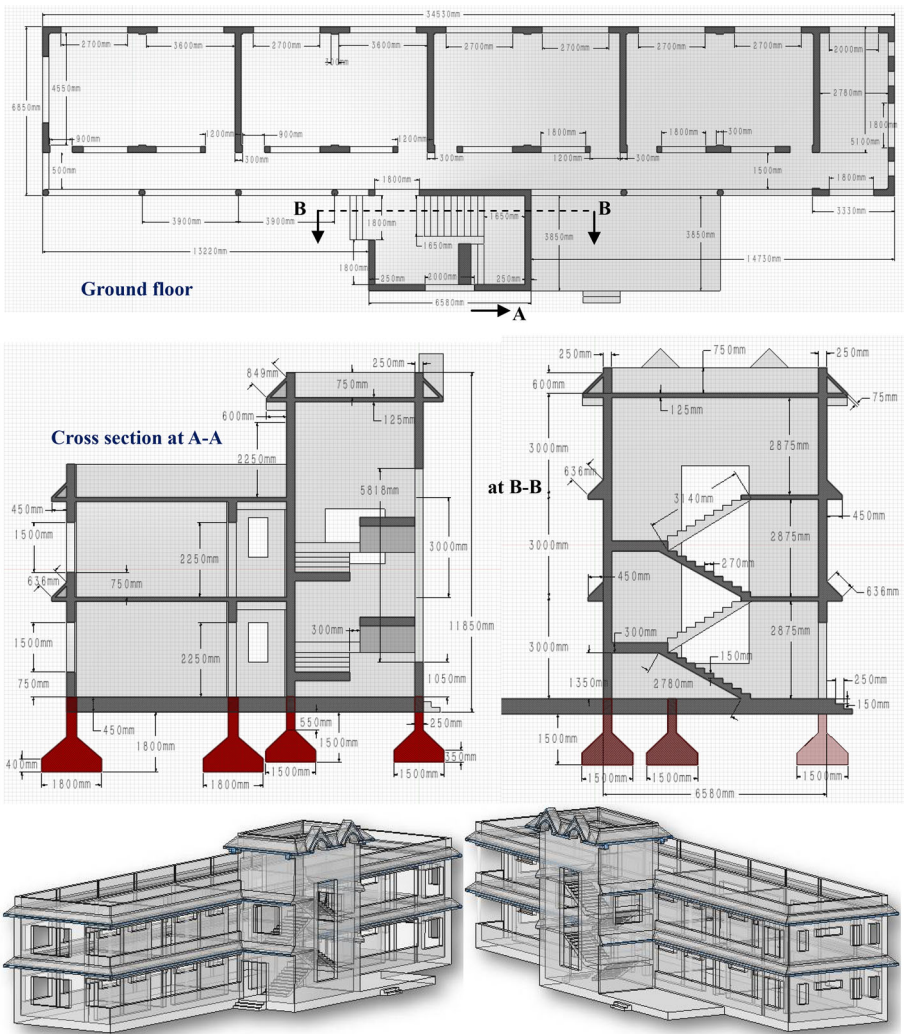
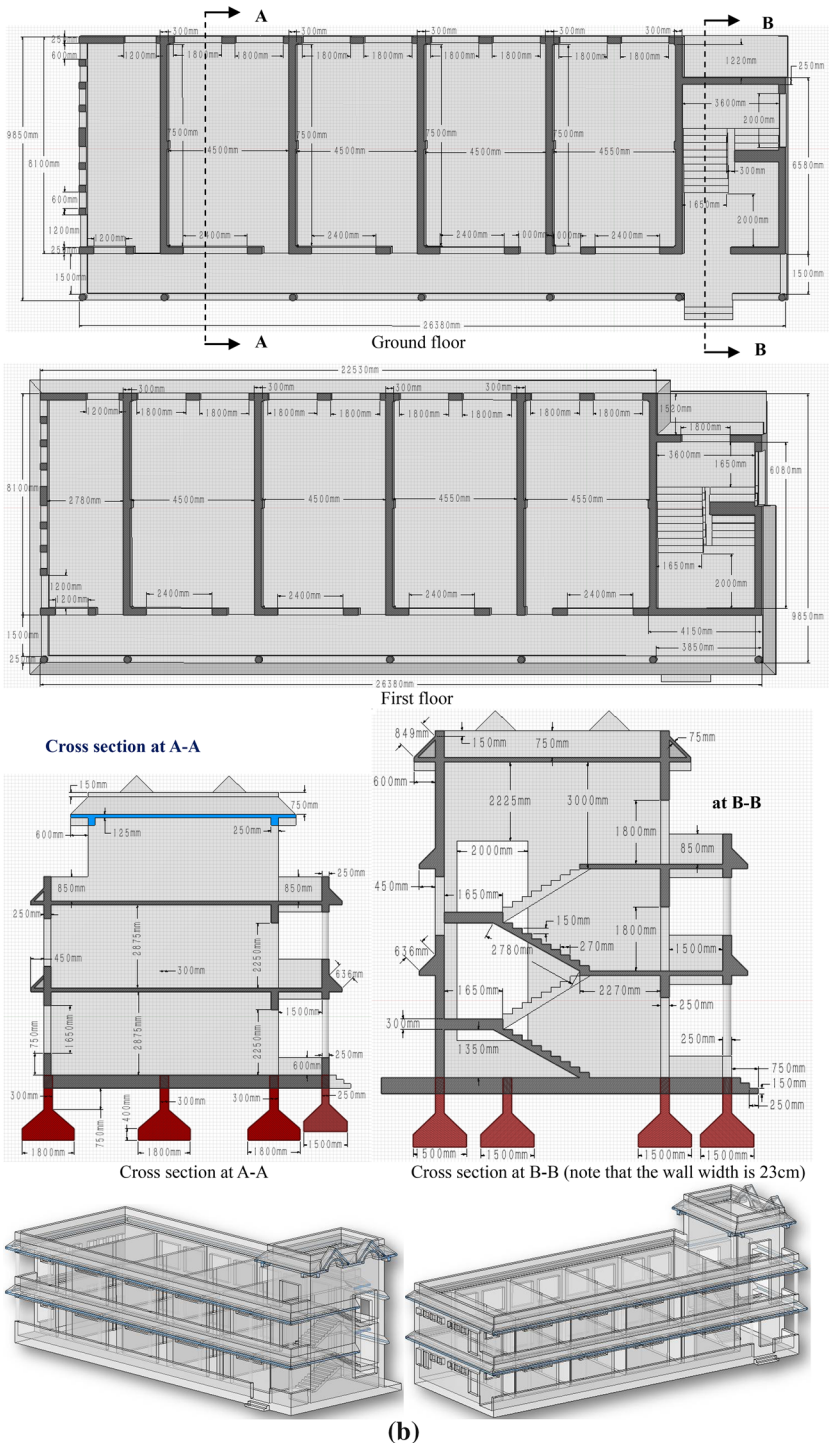
To better study the failure mechanics, the engineering drawings are presented in Fig. 11. Note that the first floor of Building b has the same ichnography as the ground floor, except that the horizontal cut section of the first floor had double runs of staircases. The masonry walls are all 23 cm thick (standard baked-brick length in Nepal) for both buildings.

Fig. 11 Structural engineering drawings of two RC frames in Shree Saraswati Higher Secondary School. **a** Building **b**. **b** Building **a**

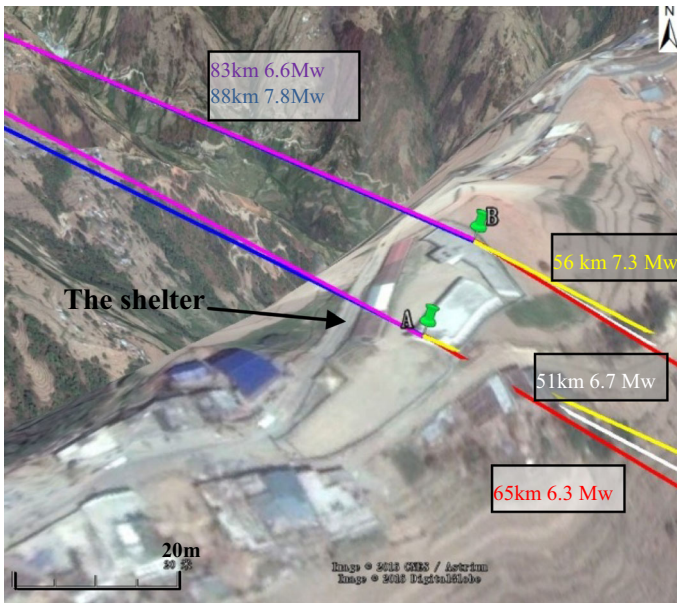
Figure 12 and Table 4 show that the epicentres of five earthquakes larger than Mw 6.3 were almost in one line and coincide with the transverse direction of Building a. It could be proposed that the incoming shear waves affected Building a in the longitudinal direction and Building b in the transverse direction.

Fig. 12 Geological relationship between the school and major earthquakes larger than Mw 6.3 up to 20 June (Google Earth)

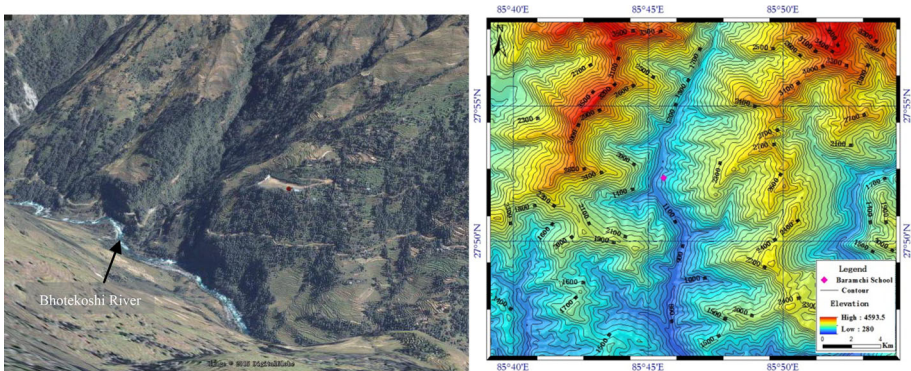
Fig. 20 Topographic map near proposed site for Baramchi School

The proposed site for Baramchi School by local government is at the transition area from the low Himalayas to the mid-Himalayas. The site is on the east side of a gorge, sitting on the secondary landslide of a large, relatively stable ancient landslide. The altitude of the valley bottom is around 1000 m; the altitudes of the ridges beside it are 2500 m (Fig. 20). The range of the slope gradients was 20°–40°. The Bhotekoshi River flows gently on the west side of the site, at which the slope was around 30°–40° (Fig. 21). The ancient landslides on both sides had been well developed before. No new large landslide was observed during the main shock, except for small-scale rockfalls and/or landslides.

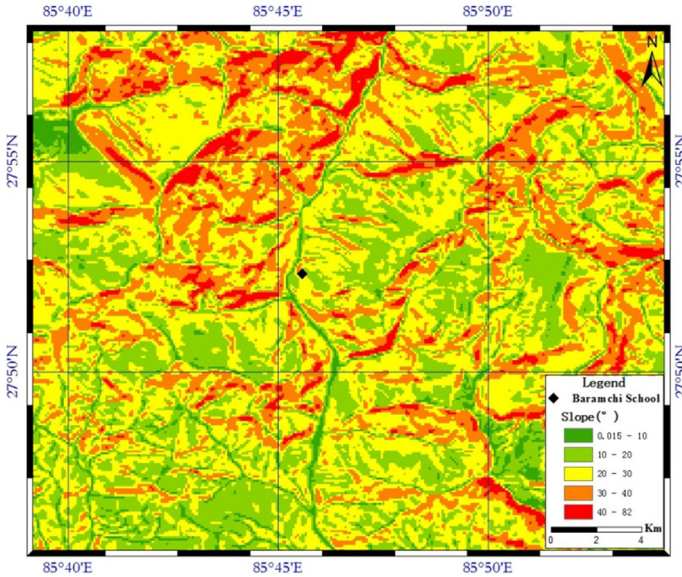
Fig. 21 Gradient distribution around the proposed site

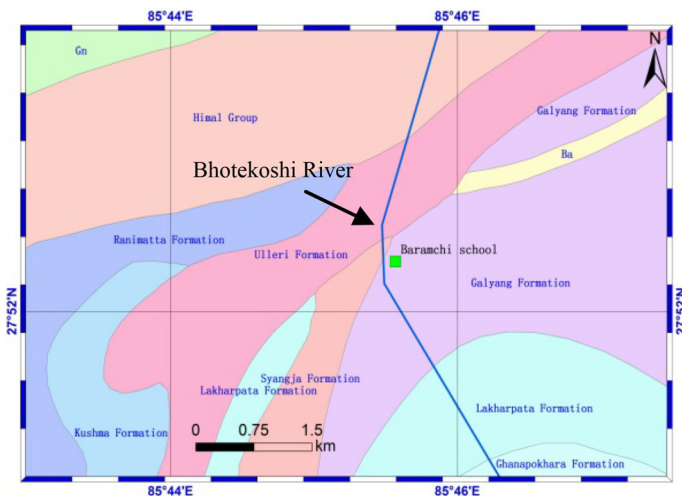
Fig. 22 Geology distribution around the proposed site

The chaotic melange of the ancient landslide was everywhere within 1 km of the school. The newly developed alluvial–diluvia deposition was observed around the river on the west side (Fig. 22). Phyllite and killas rock mingled in the deposit to the north side of the school (Fig. 23). No active fault or fracturing of bedrock was observed in our field study.

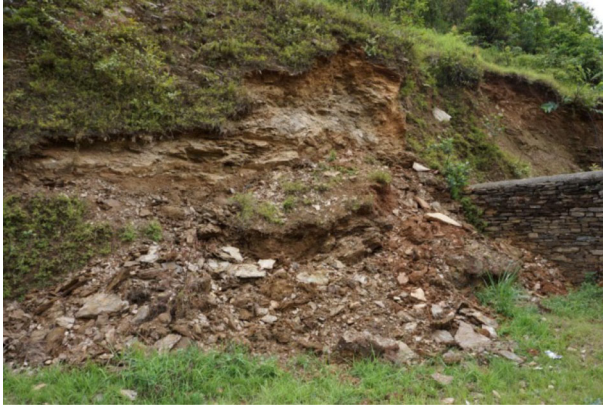
Fig. 23 Phyllite rock was found in the chaotic melange on the west side of the school
