Mechanism and future risk of slope instability induced by extreme rainfall event in Izu Oshima Island, Japan

Abstract

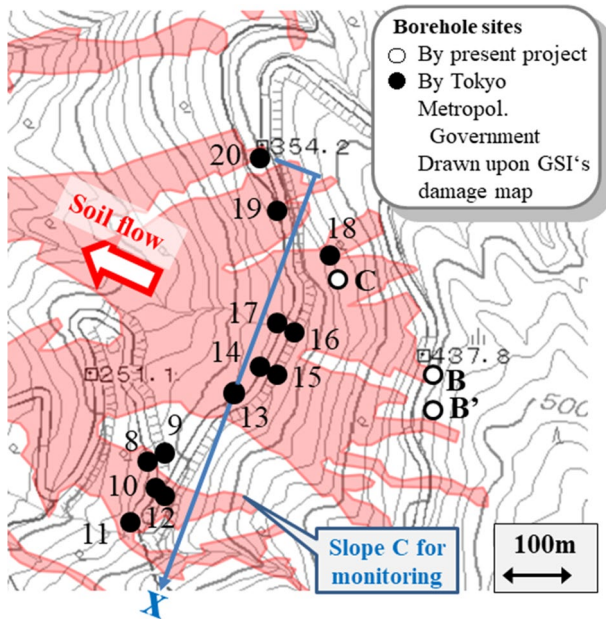
Fig. 11 Area of soil flow and borehole sites in the western slope of Mihara Yama Volcano (drawn on topographic map by Geological Survey Institute)

Figure 11 illustrates the sites of the authors' study in which B, B' and C stand for the borehole sites, while those numbers 8–20 show the sites of borehole drilled by the Tokyo Metropolitan Government. All the holes were drilled after the disaster.

The borehole site C is located on a small mound within the damaged slope (Fig. 11). Herein, the original surface material had been removed by the soil flow and a lava layer was exposed at the surface (Fig. 15). The stratigraphy at C (Fig. 16) appears similar to that of the site B' (Fig. 13) where no failure happened. Note that ABL (autobrecciated lava) in Fig. 17 is a lava that was broken into small pieces during cooling. It is interesting that standard penetration resistance in ABL is quite variable, possibly depending on the extent of breakage and grain size.

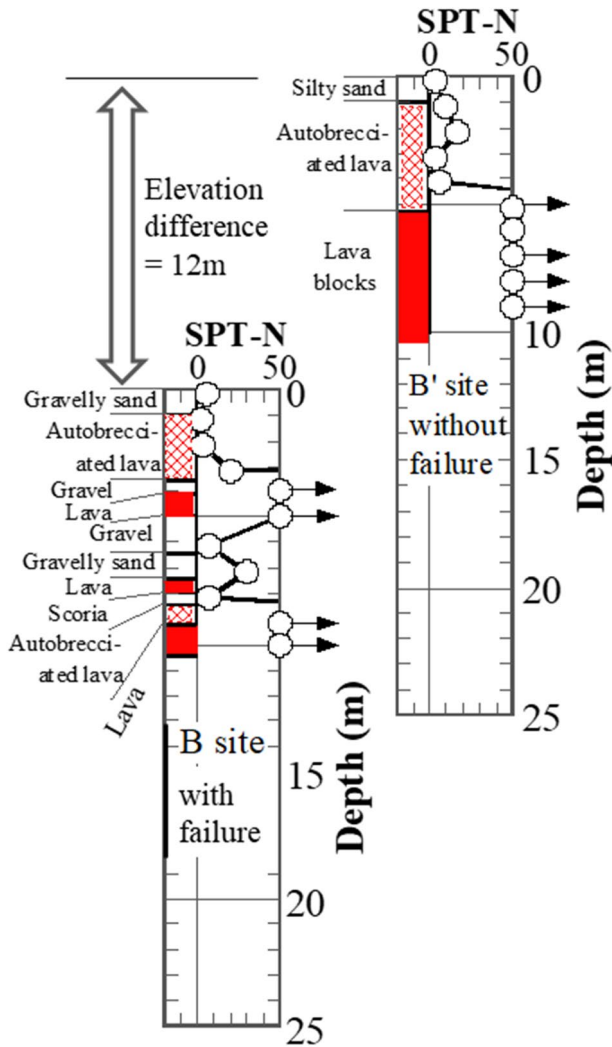
Fig. 13 Borehole profiles at sites with B and without B' slope failure

Figure 12 illustrates the situation of the points B and B' that are located below the top scarp of failure and beside a slope failure, respectively. B was on the failed slope, while B' was on a stable ground. By comparing these two sites, it was expected to find the reason why one part of the mountain slope was stable, while other part was not. Figure 13 compares the obtained subsurface profiles. The autobrecciated lava is a material that is formed by quick cooling and volume contraction. Within the range of drilling (down to 10 m depth), B' site has a thicker lava layer than B that is within the slope failure. Another point is that the unstable slope at B consists of interbedding different materials in which scoria and gravel appear more pervious than lava.

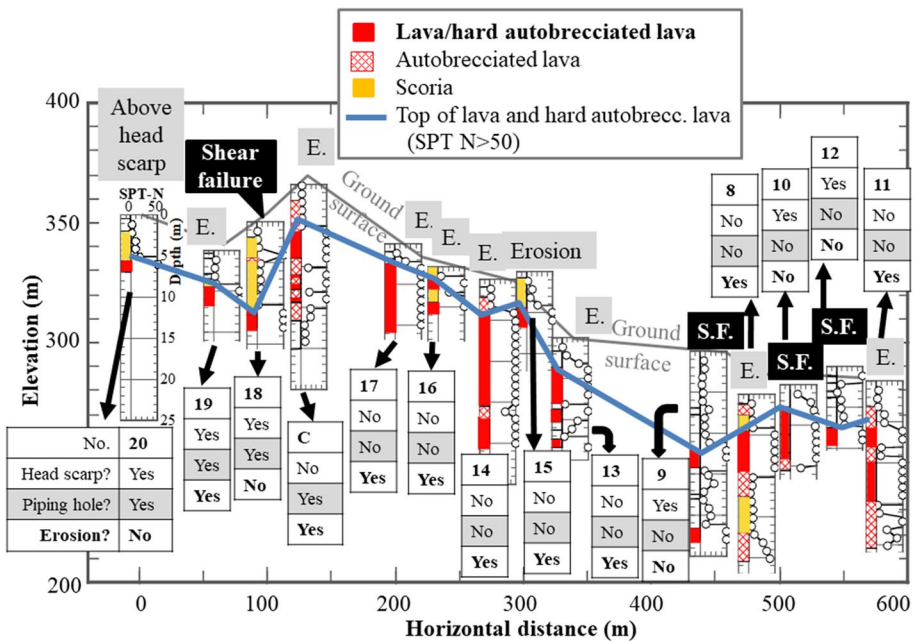
Fig. 19 Cross section of failed slope obtained by interpretation of borehole data and type of damage; horizontal distance in this figure stands for the X coordinate in Fig. 11

Figure 19 is a summary of the interpretation of the post-disaster situation at borehole sites. At each site, three questions such as “Near head scarp?”, “Having piping hole?” and “Affected by erosion failure?” were asked and answers are indicated in the same figure. By paying attention to the field situation (photographs), it was found that most sites were affected only by “erosion” at the surface and that “shear failure” of the subsoil happened at 4 sites. It was then attempted to relate these two types of damage with the borehole profile.

There is a layer of lava and autobrecciated lava in the slope. This lava is a product of the eruption in AD 1338 as stated previously. The autobrecciated lava is classified into two kinds in this figure according to the measured SPT-*N*. When the *N* value is greater than 50, the autobrecciated lava is considered to be stable and combined with the intact lava in illustration. Consequently, the top points of lava and hard autobrecciated lava in studied boreholes are connected in Fig. 19 to visualize the “subsurface topography.”

Figure 19 also illustrates the type of damage which is either “shear failure” or “erosion” as discussed earlier. It is important that there is a reasonable correlation between the height of “subsurface topography” and the type of damage. Erosion damage occurred at the subsurface “ridge,” while shear failure occurred in the buried “valley.” Because the groundwater in the surface soil flows from “ridge” to “valley” during heavy rain, “shear failure” occurred in the “valley” parts: points 9, 10, 12 and 18, while point 8 is probably marginal. Conversely, the subsoil of the eroded parts was situated on “ridge” where groundwater flowed away. Hence, the “ridge” parts were intact until erosion during the disaster. Thus, there is a good reason why “ridge” parts of the slope did not fail during the heavy rain in 2013 and will remain stable during future heavy rains.

After the disaster, efforts were initiated to remove debris from the destroyed community and reconstruct infrastructures therein. In this stage, one of the most important issues was the risk of further slope failure and Fig. 19 is the authors’ suggestion to the local community, further disaster being unlikely on the remaining “ridge” subsurface topography. To ascertain the safety of reconstruction activities, the authors installed an inexpensive early warning system in which tilting angle of sensors was monitored and interpreted. It has been a practice that a warning message is issued if the rate of tilting exceeds 0.1 degree/h. For

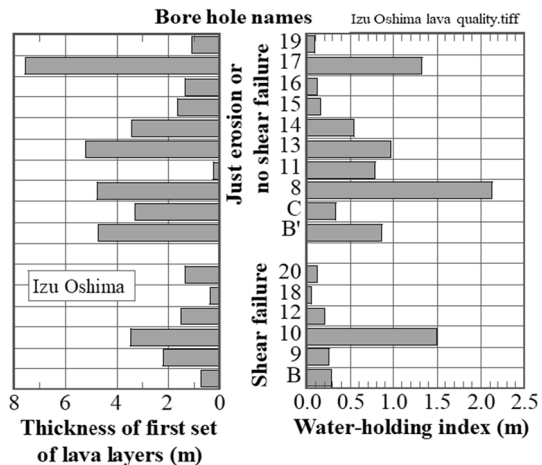
Fig. 26 Thickness and water-holding capacity of first lava layer group

In principle, greater l_{eq} and smaller k_{eq} allow the first lava group to hold more water in soil above it. Hence, l_{eq}/k_{eq} is called “water-holding” index. The two indices are indicated in Fig. 26 in which borehole sites are classified into those with erosion only and those with shear failure. In general, the sites with erosion only have greater thickness of lava (l_{eq}) and higher water-holding capacity (l_{eq}/k_{eq}). Is it then reasonable to state that more rainwater was held in the surface soil at eroded sites and the slope “avoided” shear failure? This is not an acceptable idea because soil mechanics states that water saturation in a slope reduces the factor of safety against shear failure. One alternative idea is that the first lava layer group at eroded sites more efficiently reduced the upward flow of groundwater from deeper elevations and maintained surface stability than at sites of shear failure. However, the site 10 failed by shear in spite of similarly large index numbers, and hence, the above idea is not fully reliable. Thus, discussion should be made further from a different perspective.

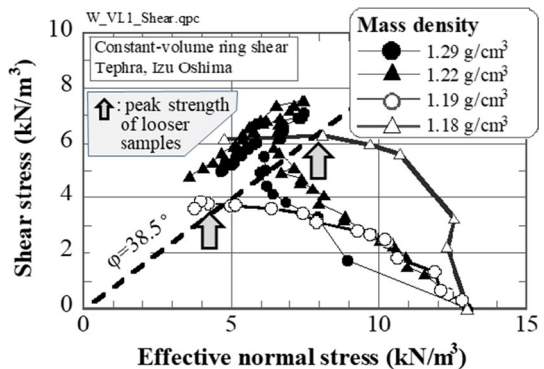
Fig. 27 Stress paths obtained by constant-volume ring shear tests (Wang et al., 2019)

above less permeable loess (aeolian) soil. They collected disturbed samples of tephra from the affected slope and obtained the mean grain size (D_{50}) to be 0.17 mm and fines content = 21%. They also assessed the in situ dry density to be around 1.17 g/cm³. Thereafter, ring shear tests on laboratory-reconstituted specimens (Wang et al. 2019) showed the friction angle, φ , of the failed surface soil to be around 38.5 degrees when materials were less compacted and hence weak (Fig. 27).

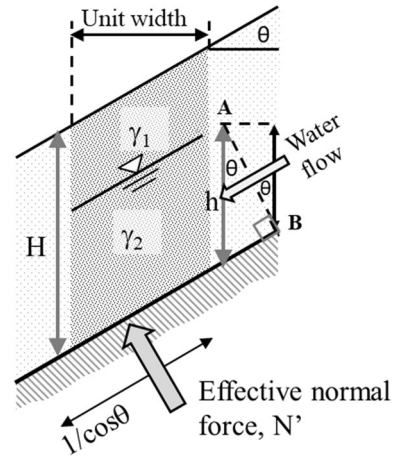
Fig. 28 Infinite slope model for stability analysis

By using this value, a simple stability analysis was conducted on a one-dimensional slope model as shown in Fig. 28. In this model, the thickness of the unstable surface soil is denoted by H , the depth of groundwater above a hypothesized slip plane by h and the slope angle by $\theta = 30.5^\circ$ based on the in situ topography near the head scarp. Furthermore, the unit weights of soil above and below the groundwater level were hypothesized without significant error as $\gamma_1 = 15.0 \text{ kN/m}^3$ and $\gamma_2 = 19.1 \text{ kN/m}^3$, respectively. Note that the common practice of borehole investigation in civil engineering projects hardly collects expensive undisturbed soil specimens and measures directly the unit weight. For stability analysis, the pore water pressure, u , at the slip plane (point B) was determined by making the total head at B equal to the head at the water surface (A). Since pore water pressure at A is zero,

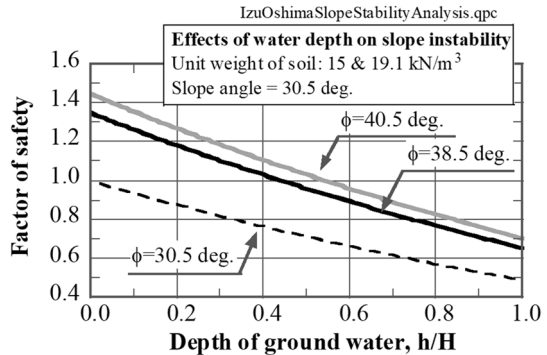
Fig. 29 Effects of groundwater depth on slope stability in an infinite slope model

Equation 6 is plotted in Fig. 29 by using $\varphi = 38.5^\circ$ together with two other hypothetical values (30.5° and 40.5°). This figure indicates that the factor of safety becomes less than unity at $h/H = 0.4$ ($h = 40 \text{ cm}$ when $H = \text{typically } 1 \text{ m}$) when $\varphi = 38.5^\circ$. The value of $H = 1 \text{ m}$ was chosen by referring to the soil thickness in the source area (Fig. 6). Even

for an overestimation of $\varphi = 40.5^\circ$, $h/H = 0.55$ ($h = 55$ cm for $H = 1$ m) is sufficient to make the slope unstable. Such a shallow water depth is likely to occur frequently under the local rainfall environment (Fig. 4). Because the studied slope had been, on the contrary, stable for decades or for centuries in reality, further discussion is necessary.

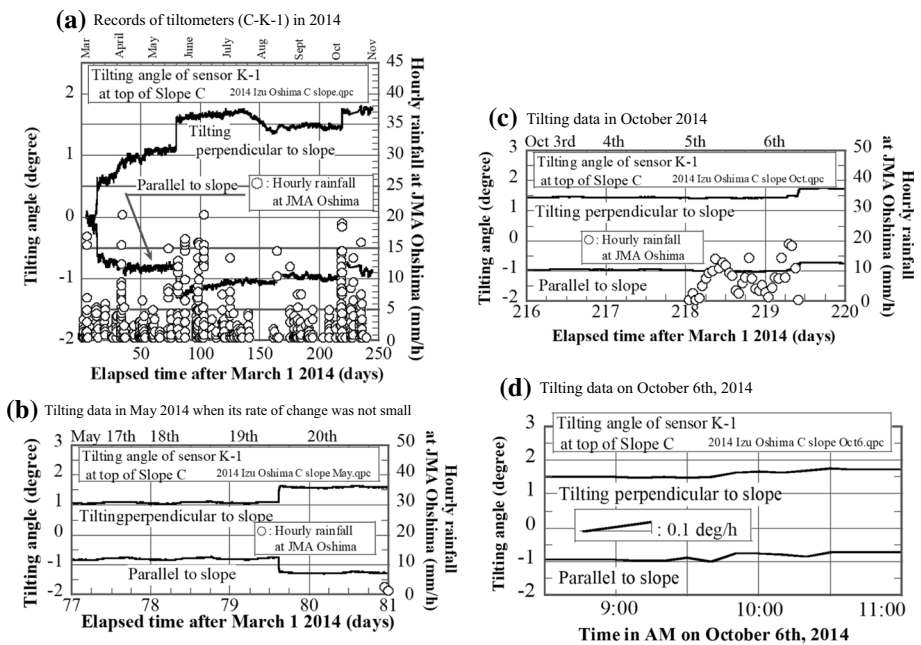
Fig. 36 Monitored records in 2014 at the top of the slope in Fig. 35

Figure 35 illustrates one of the monitored sites that appeared more likely to fail soon than others, which is namely the slope C at the bottom of Fig. 11. The tilting angle of the device was recorded in 2014 as shown in Fig. 36a. Herein, the tilting angle made noticeable increase twice, in May and in October. The event in May occurred without rain, and it was supposed that the device tilted due to such a local disturbance as animal action (Fig. 36b). Therefore, no risk of slope failure was considered. In contrast, the October event occurred after typhoon No. 18 “Phanfone” brought precipitation of 162.5 mm on October 5 and 93.0 mm on 6 at JMA Oshima Station (Fig. 36c); effects of antecedent rainfall on slope instability. Therefore, attention was paid to the rate of tilting which is the key precursor data for safety judgment. Although an alert was prepared when the rate exceeded the warning criterion of 0.1 deg/h for a short while (Fig. 36d), this critical situation did not last for a long time and no slope failure happened.
