RC structural damages observed after October 30, 2020, Seferihisar—İZMİR earthquake and analytical evaluation of existing sample RC buildings

M. Koçer¹ · A. Ünal¹

Received: 18 December 2021 / Accepted: 7 February 2023 / Published online: 19 February 2023
© The Author(s), under exclusive licence to Springer Nature B.V. 2023

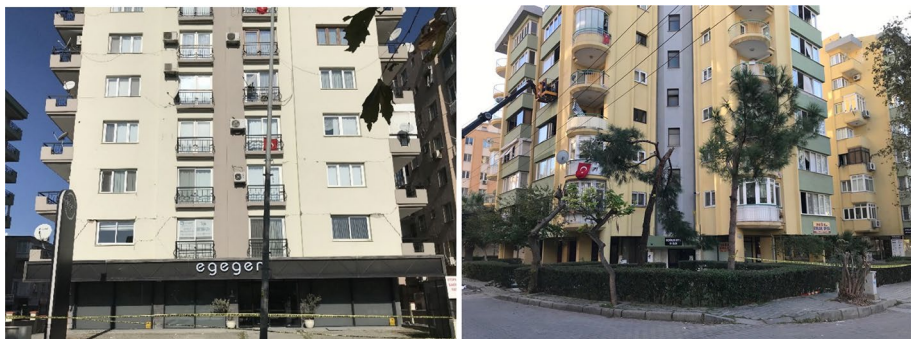
Fig. 8 Typical RC building in İzmir region (images by authors)

with cast-in-situ concrete, one of the major defects of them is corrosion and carbonating. Moreover, there are some productions against zoning (floor addition contrary to project, conversion of ground floors into shops, etc.) in some of these old buildings. In general, since the ground floors of the buildings located on the main streets are designed as work-places, the height of the ground floors of most of these buildings is high with soft and weak floor irregularities. In the region, overhangs have been constructed to increase the building area at the upper floors. In Fig. 8, the typical building examples are shown in order to represent the building stock in İzmir.

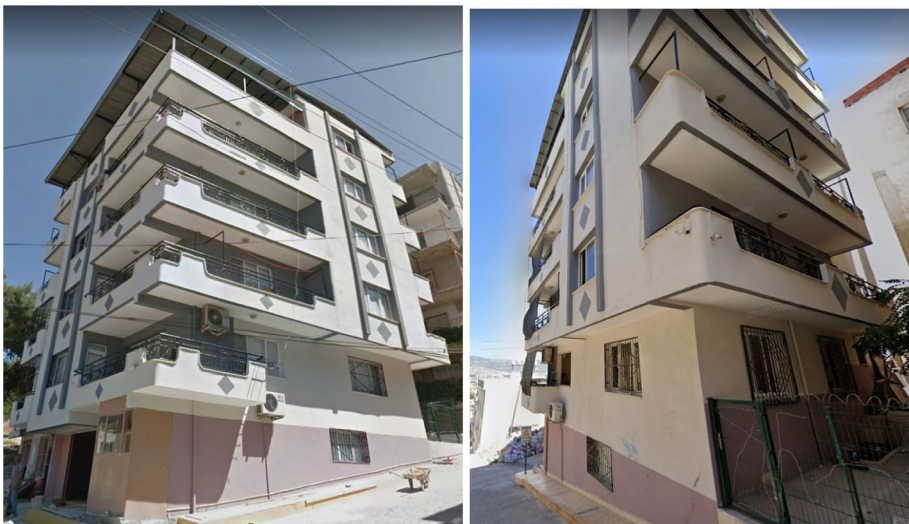
Fig. 21 The current view of the modeled building

building was made as 3-story, it has survived the earthquake by satisfying the immediate occupancy performance level without any permanent damage; this is because the concrete class was above the standards according to that time conditions, the reinforcements used in columns and beams were applied in accordance with all the reinforcement provisions in TEC-1997, the column-beam details were constructed in appropriate to the regulations, the building was formed in accordance with the project. Therefore, the building was modeled in 3D in accordance with its static project by the aid of the ETABS finite elements program, and nonlinear time-history analysis, pushover analysis and linear analyses were made according to the acceleration records of İzmir earthquake. Additionally, the linear analyses of the building were performed according to the earthquake code valid in the construction year and today's current earthquake code.

The existing building considered in the case study is located at the Bayraklı District of İzmir City, which consists of a basement floor three sides surrounded with shear walls, a ground floor and 4 typical floors. The exterior view of the building constructed in 1998 is given in Fig. 21. The load-bearing system of the building has been formed with reinforced concrete frames, and the floor system has been produced with beam-reinforced concrete plate where the slab thickness was 120 mm. Except the shear walls at the basement floor, there was no shear wall in the construction. The cross-sectional dimensions of the columns

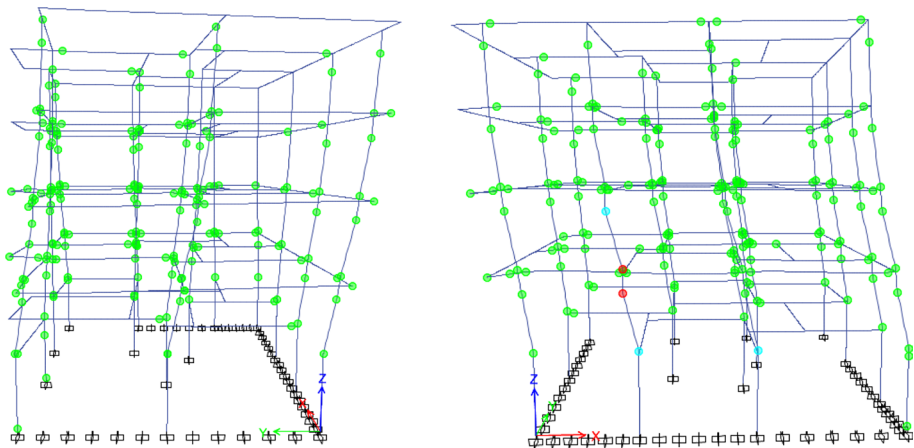
Fig. 26 Plastic hinges occurred in the building

The plastic hinges occurred on the structural members of the building during the top displacement request obtained for the design spectrum are given in Fig. 26, and the plastic hinge damage levels at the column and beams corresponding to the top displacement request in Fig. 27. According to the pushover analysis results of the building in the X direction, 103 of 140 columns (73.57%) had no damage, 32 (22.85%) had minor damage, 4 (2.85%) had severe damage, and 1 column (0.71%) fell within the collapse region. In addition, according to the pushover analysis results in the Y direction, 79 of 140 columns

(56.42%) had no damage, 51 (36.42%) had minor damage, 6 (4.28%) had severe damage, and 4 columns (2.85%) fell within the collapse region.

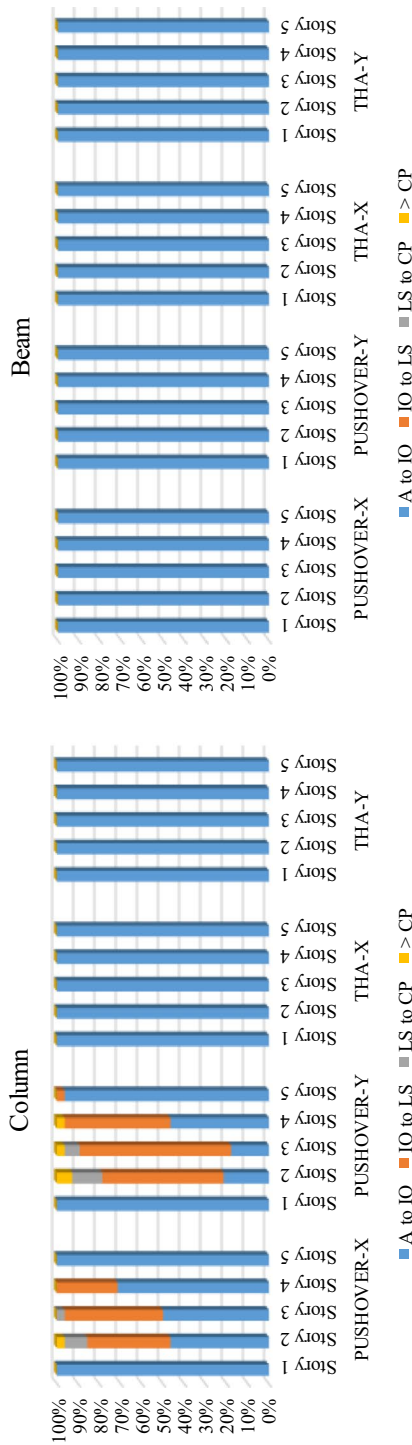
Fig. 27 Plastic hinge damage levels occurred at the columns and beams

The plastic hinges occurred at the structural members during the nonlinear time-history analysis of the building performed according to the İzmir Earthquake acceleration record are shown in Fig. 29, and the plastic hinge damage levels at the columns and beams in Fig. 27. According to the THA results, in the X direction of the building, no damage occurred in 139 of the 140 columns (99.28%) and minor damage in 1 of them (0.72%); in the Y direction of the building, no damage occurred in 135 of the 140 columns (96.43%) and minor damage in 5 of them (3.57%).
