Effects of the February 6, 2023, Kahramanmaraş earthquake on structures in Kahramanmaraş city

Abstract

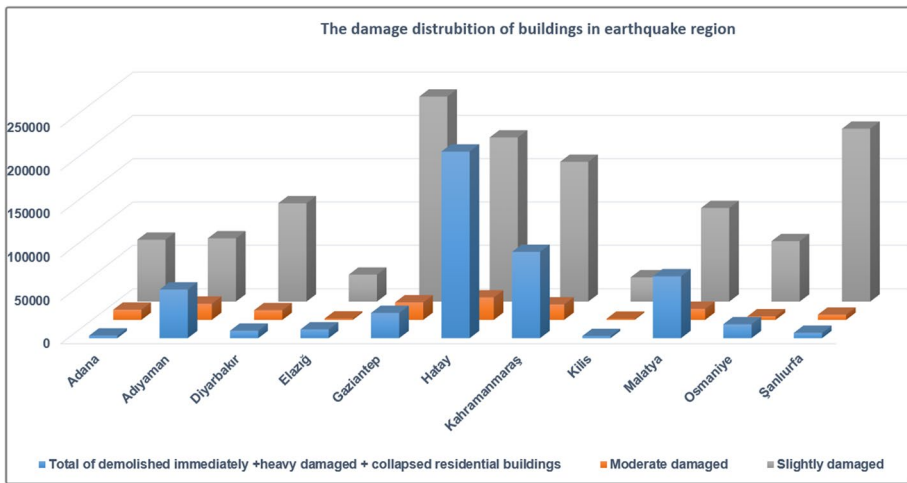
Fig. 6 The damage distribution of buildings (March 06, 2023) (T.R. Presidency, 2023)

According to the results of the damage assessment study carried out by the relevant ministry as of March 06, 2023, the total of demolished immediately + heavy damaged + collapsed residential buildings was determined as 518,009. The number of moderately damaged buildings was estimated to be 131,577 and the number of slightly damaged houses to be 1,279,727 (T.R. Presidency, 2023). This damage distribution for the entire earthquake zone is shown in Fig. 6.

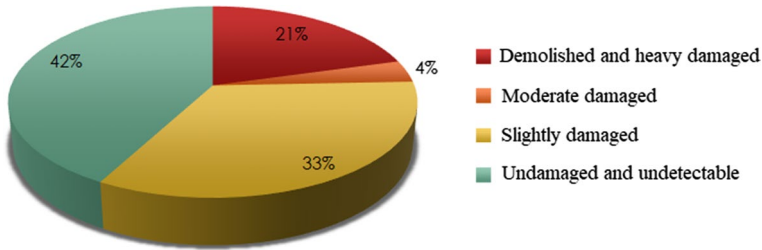
Fig. 7 Damage distribution of buildings in Kahramanmaraş (SBB 2023)

moderately damaged 161,137 slightly damaged buildings were identified. Other structures are either undamaged or it was not possible to determine whether they were damaged or not due to different reasons as shown in Fig. 7.

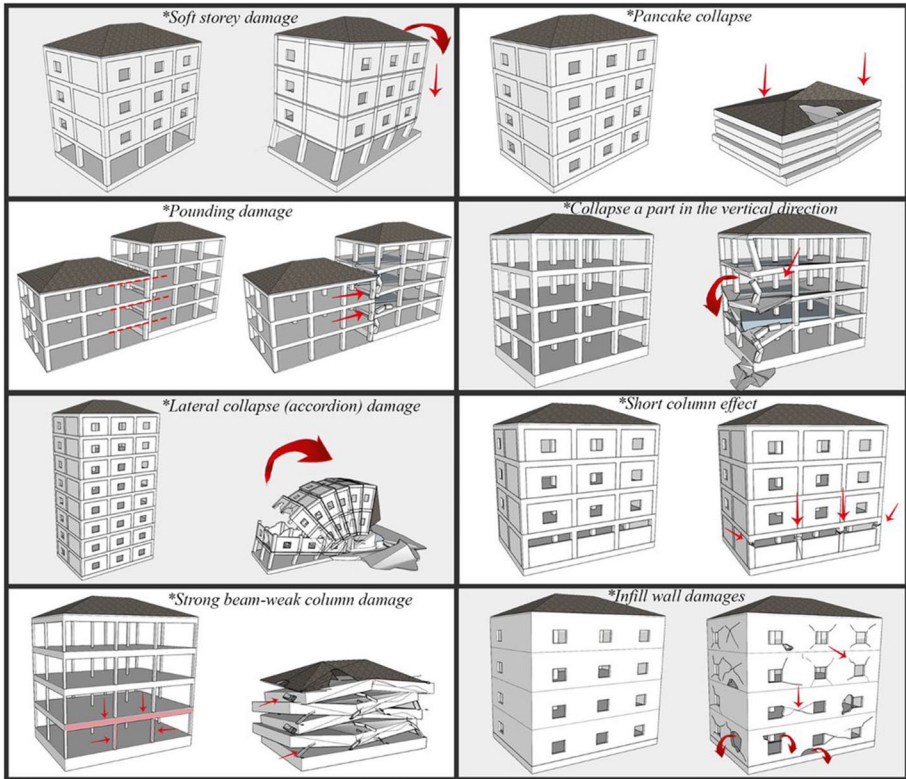
The schematic representations of structural damage observed in reinforced concrete structures in general are shown in Fig. 25.

Fig. 25 The schematic representations of the structural damage in RC structures

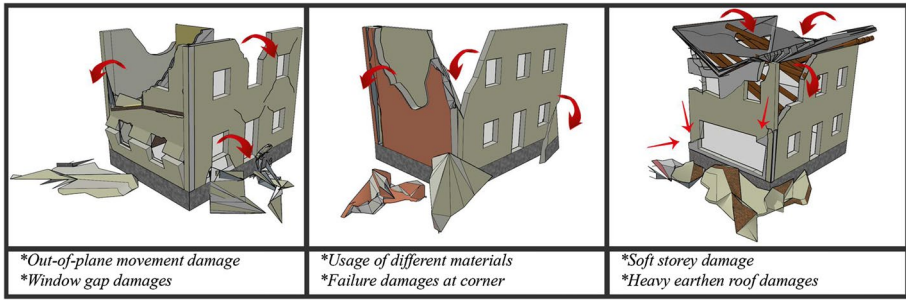
Fig. 32 The schematic representations of the structural damage in masonry structures

The schematic representations of the structural damage observed in masonry structures in general are shown in Fig. 32.
