# The Effects of Air and Underwater Blast on Composite Sandwich Panels and Tubular Laminate Structures

H. Arora · P.A. Hooper · J.P. Dear

**Abstract** The resistance of glass-fibre reinforced polymer (GFRP) sandwich panels and laminate tubes to blast in air and underwater environments has been studied. Procedures for monitoring the structural response of such materials during blast events have been devised. High-speed photography was employed during the air-blast loading of GFRP sandwich panels, in conjunction with digital image correlation (DIC), to monitor the deformation of these structures under shock loading. Failure mechanisms have been revealed by using DIC and confirmed in post-test sectioning. Strain gauges were used to monitor the structural response of similar sandwich materials and GFRP tubular laminates during underwater shocks. The effect of the backing medium (air or water) of the target facing the shock has been identified during these studies. Mechanisms of failure have been established such as core crushing, skin/core cracking, delamination and fibre breakage. Strain gauge data supported the mechanisms for such damage. These studies were part of a research progr

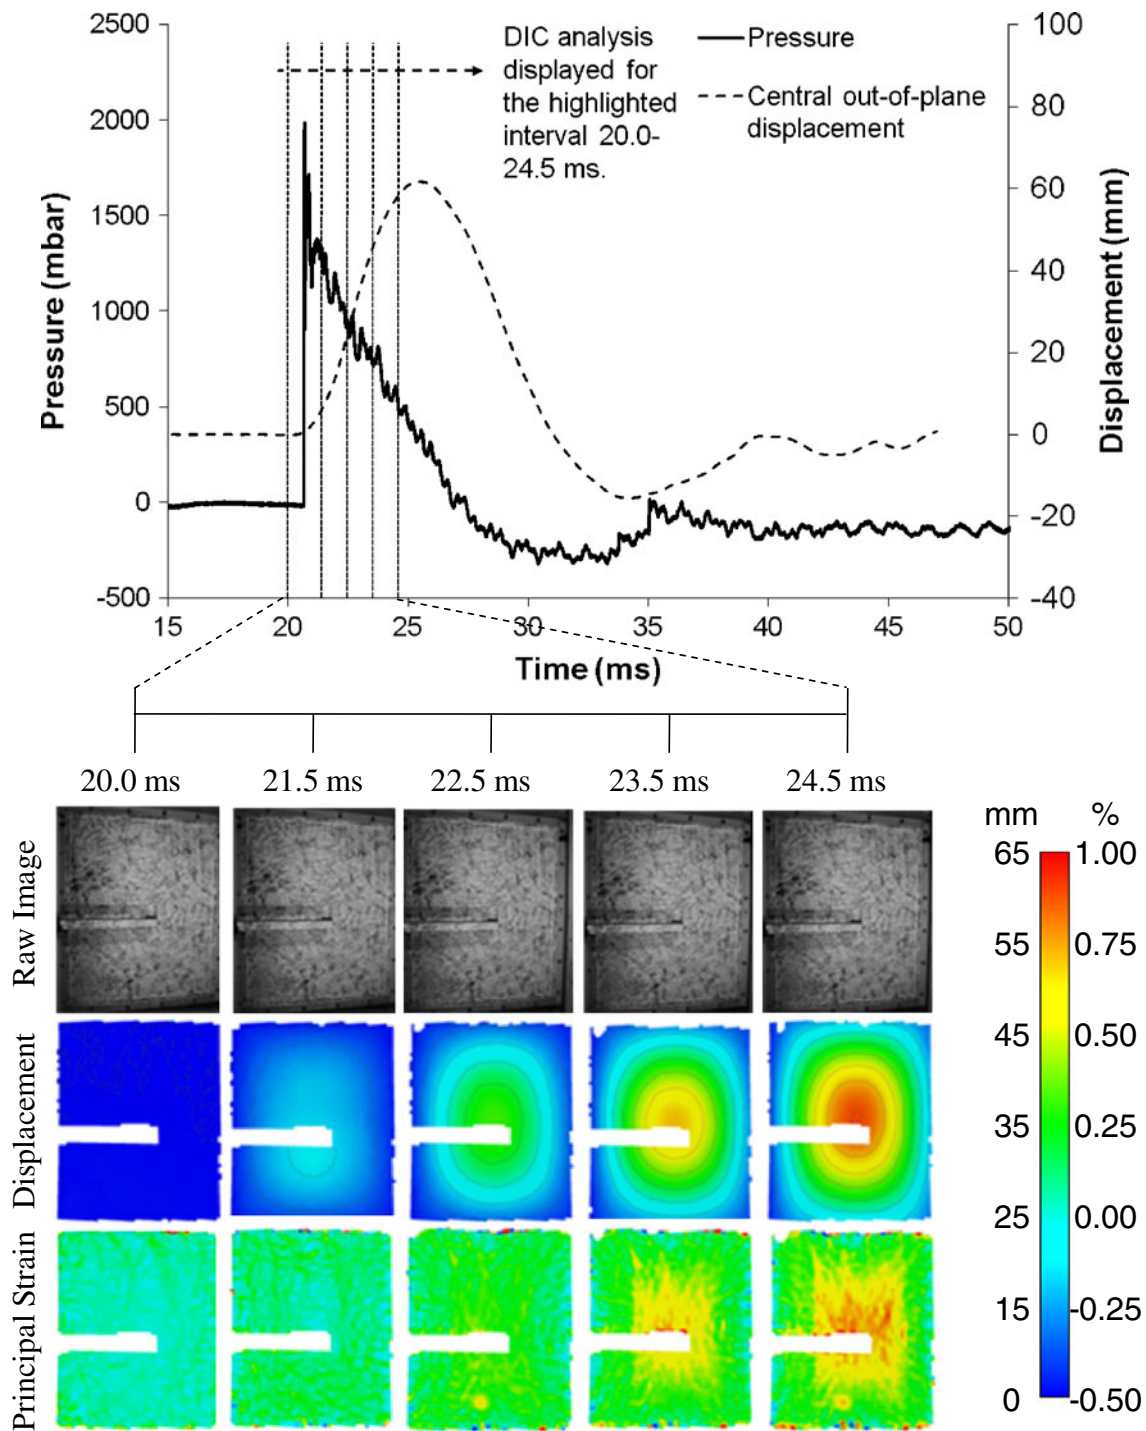
**Fig. 5** Transient reflected pressure recording and the central out-of-plane displacement of panel G1 (core thickness 40 mm) during blast loading (30 kg at 14 m stand-off) showing high-speed images of the back-face of the target with analysed results from ARAMIS. The white line from the left hand edge to the centre is the region of the specimen obscured by the laser gauge (visible in the raw images). Images are displayed from the point of shockwave arrival at the target 20 ms after detonation

Figure 5 shows the central point deflection of G1 subjected to a recorded peak pressure of 2 bar (30 kg of

line from the left hand edge to the centre in the contour plots is the region of the specimen obscured by the laser gauge and its mount. G1 was seen to deflect to a maximum distance out-of-plane of 63 mm (whilst Fig. 6 shows G2 deflected 78 mm). These deflection measurements agreed well with the laser gauge measurements for this single (central) point data, details to be discussed later in [Air blast loading of GFRP sandwich composite panels](#). The level of major principal strain peaked in the region of 1% on the back face for G1. The G1 panel was deformed within a limit such that no visible damage was sustained. There were no obvious signs of damage shown within the DIC analysis for G1.

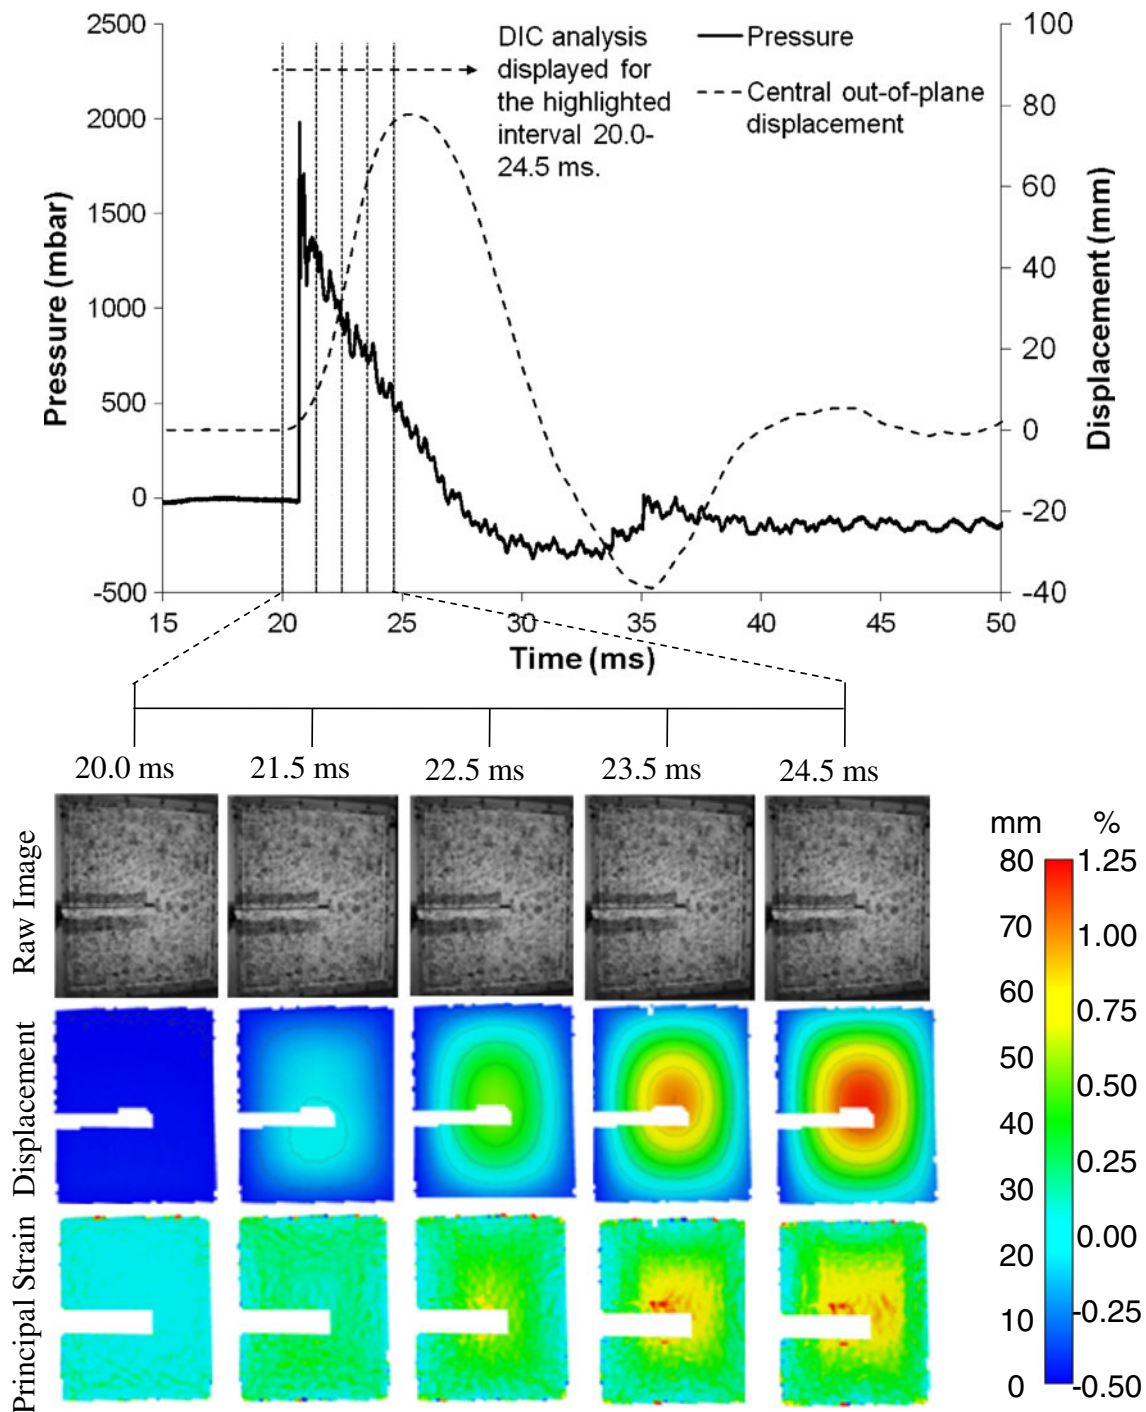
**Fig. 6** Transient reflected pressure recording and the central out-of-plane displacement of panel G2 (core thickness 30 mm) during blast loading (30 kg at 14 m stand-off) showing high-speed images of the back-face of the target with analysed results from ARAMIS. Images are displayed from the point of shockwave arrival at the target 20 ms after detonation

A similar response was exhibited in Fig. 6 for G2 with its reduced core thickness when subjected to a recorded peak pressure of 2 bar (30 kg of C4 at stand-off of 14 m). For G2, surface strains peaked at 1.25% and below the expected failure strains of the fibres. The lower limit (assuming a linear elastic relationship) for fibre strain to failure is 1.4% (as stated in Table 1). Signs were, however, observed within the DIC analysis that mild sub-surface core

cracking had occurred. Early discontinuities in the major principal strain plots indicate possible detachment of the skin from the core i.e. possible cracking. This was confirmed upon sectioning of the panel after the blast.

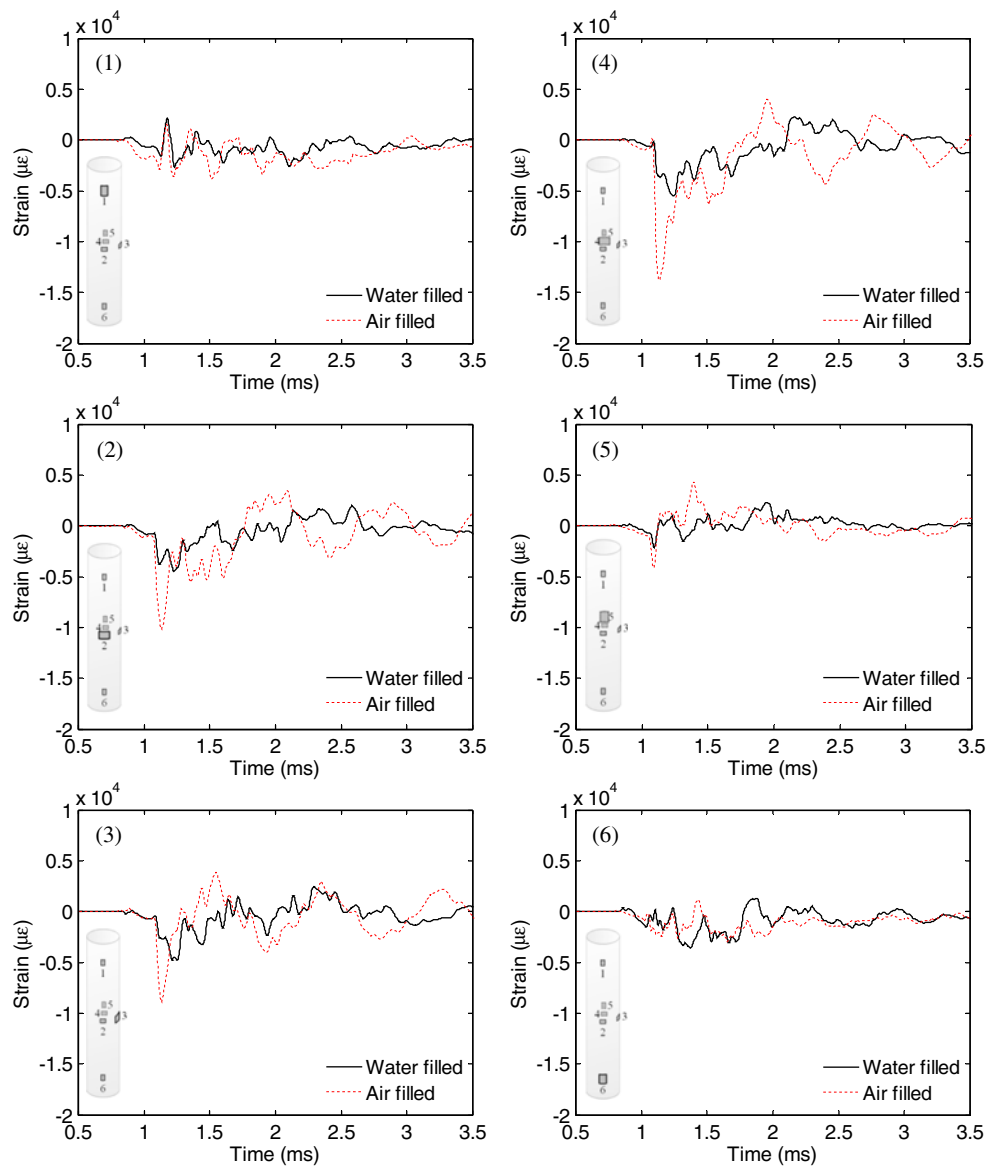
these traces in gauges 2–4 for AF are compared to WF (see Fig. 16), there is a marked difference in response. Using water as the filler fluid causes a damped the amplitude of response, reducing peak strains from 1.5% in AF to 0.5% in WF (see gauge position 4 recording the fluctuation in hoop strain on the back facing side of the tube in Fig. 16).

The tubes were both subject to a pressure of 350 bar (there were two independent recordings of pressure either side of the targets). The damage sustained by AF relative to WF was apparent with no visible damage observed for WF whereas AF shown in Fig. 17 shows axial cracking, most likely caused by shear failure during the circumferential crushing phase of the sample deformation causing cracks to initiate.

**Fig. 16** Strain gauge data is displayed for the first 3.5 ms with peak shock pressure of 350 bar (1 kg C4; depth 6 m; stand-off 1.4 m) for each gauge position on tubes AF and WF, each plot shows the corresponding data for AF (air filled) and WF (water filled) at that particular location

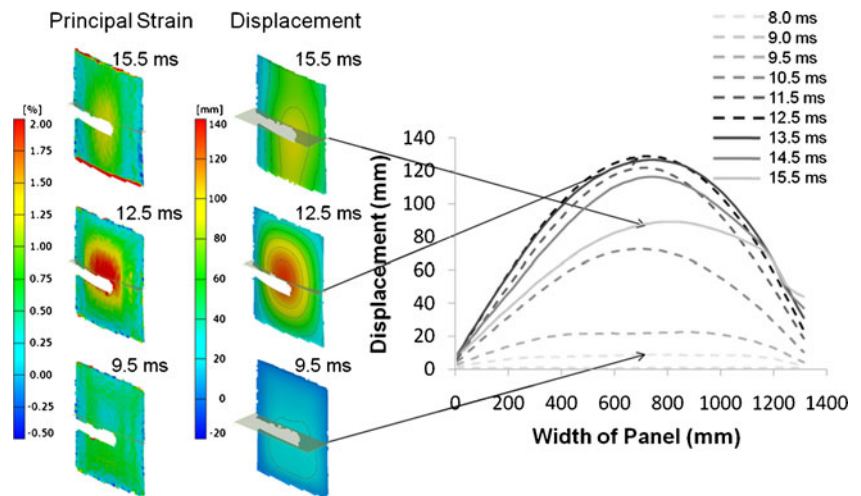
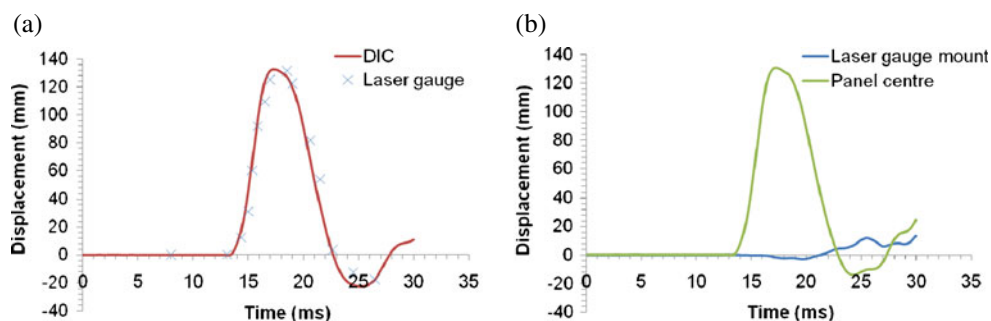
it was recording became compromised. The steel beam structure, comprising the mount for the laser gauge, flexed and vibrated after the (primary) target response reached peak deflection. To clarify when the laser gauge began to move, the steel beam itself was speckled and computed for its movements. It can be seen from Fig. 19(b) that the

position of the laser gauge begins to move at the point where the panel is reaching its maximum deflection. This data shows qualitatively where the reliability of the data deteriorates. After this stage the laser gauge begins to flex and rotate (observed in the video recording) and so the validity of its results breaks down, since it was not at its

**Fig. 19** Comparison of the central point displacement measured by the laser gauge and that recorded by the DIC analysis. The data shown is from the 30 kg at 8 m stand-off air-blast on G1: (a) analysis of the same point deflection during the blast measured by the DIC analysis and by the laser gauge; and (b) point data taken from the DIC analysis showing the relative movement of the laser gauge mount to its original target point on the panel

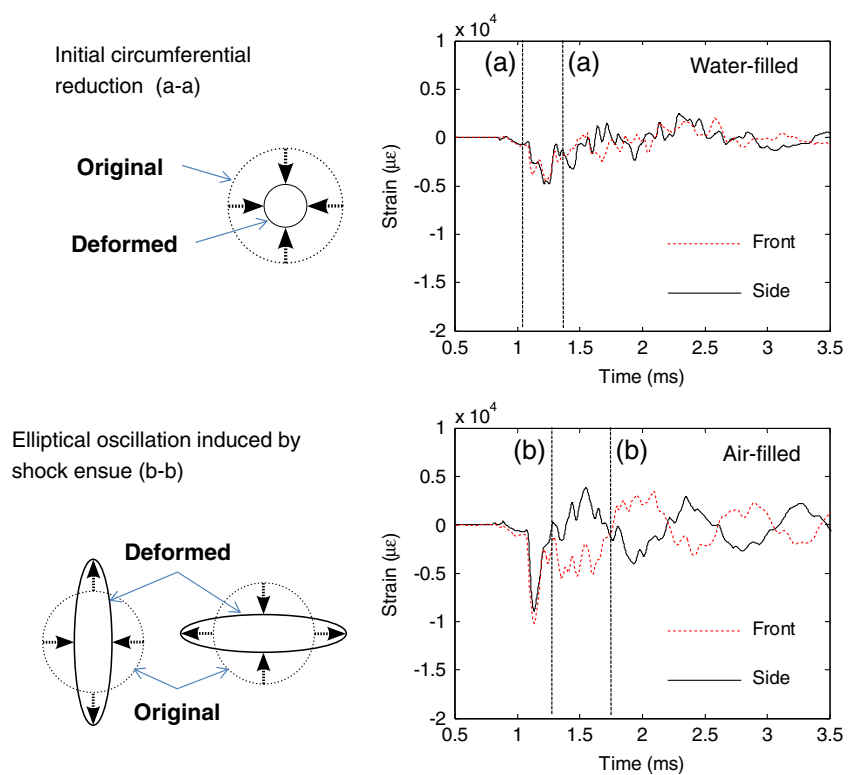
**Fig. 20** Diagram illustrating the 2 main modes of deformation observed, breathing (*top left*) and elliptical oscillation or squashing (*bottom left*) as the relative magnitudes of strain observed in both tube cases, water filled (*top right*) and air-filled (*bottom right*)

inward compression. After the pressure of the surrounding fluid reduces the energy gone into deforming the tube in this manner is released in the mode of oscillatory vibrations with the dominant mode in the form of a circumferential squashing motion. These two modes of vibration were the most dominant of those observed during these trials, however, the most significant result to emerge from this trial is the fact that the backing fluid (filler fluid) made considerable savings with regard to damage sustained by the tube structures (visible in Fig. 17). The denser filler medium (water) made the tube effectively more rigid and reduced the magnitude of surface strains experienced and hence damage sustained. Figure 16 shows that the water filled tube experienced surface strains of half the magnitude of those experienced by the air-filled tube. To analyse this further, having a denser filler medium also dampens the vibrations quicker. After a few milliseconds, the strains in the air-filled tube are still greater than even the maximum strain experienced by the water filled tube. Moreover the water-filled tube seems to also resist the elliptical/squashing mode of vibration clearly observed with the air-filled tube. This is due to the fact that the tube needs to compress the filler medium to oscillate between tension/compression when going through this squashing motion and the energy required to compress the denser filler medium is too great.

Therefore the energy is dissipated within the water filler medium and in mild residual surface vibrations in comparison to the air-filled tube which freely vibrates with large magnitude of strains  $>1\%$  (highlighted in Fig. 20).
