Assessment of prospective hazards resulting from the 2017 earthquake at the world heritage site Jiuzhaigou Valley, Sichuan, China

Abstract: On August 8, 2017, a Ms = 7.0 magnitude earthquake occurred in the Jiuzhaigou Valley, in Sichuan Province, China (N: 33.20°, E: 103.82°). Jiuzhaigou Valley is an area recognized and listed as a world heritage site by UNESCO in 1992. Data analysis and field survey were conducted on the landslide, collapse, and debris flow gully, to assess the co-seismic geological hazards generated by the earthquake using an unmanned aerial vehicle (UAV), remote-sensing imaging, laser range finders, geological radars, and cameras. The results highlighted the occurrence of 13 landslides, 70

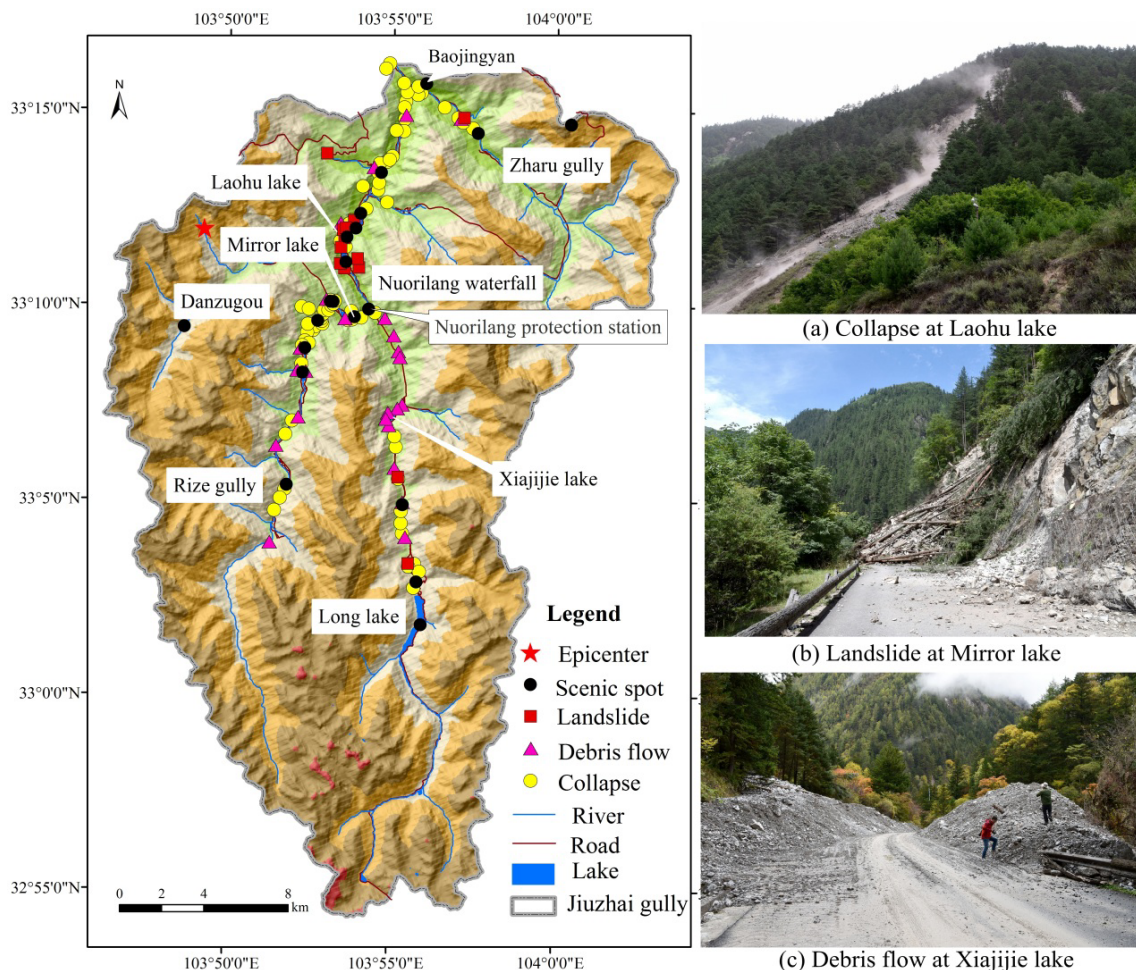
Figure 4 Distribution of 2017 Jiuzhaigou earthquake-induced geological hazards in Jiuzhaigou Valley.

northwest-southeast strike-slip fault (Dai et al. 2017). The hazards were highly concentrated along the White River from Jiudaoguai to Jiuzhaigou Valley, especially in the Rize Gully from Tiger Mouth to Arrow Bamboo Lake, as shown in Figure 4. On-site investigations revealed the severe damage inflicted upon scenic spots, roads, facilities, water, and vegetation.
