# Bifilm Defects in Ni-Based Alloy Castings

JOHN CAMPBELL and MURAT TIRYAKIOĞLU

DOI: 10.1007/s11663-012-9655-1

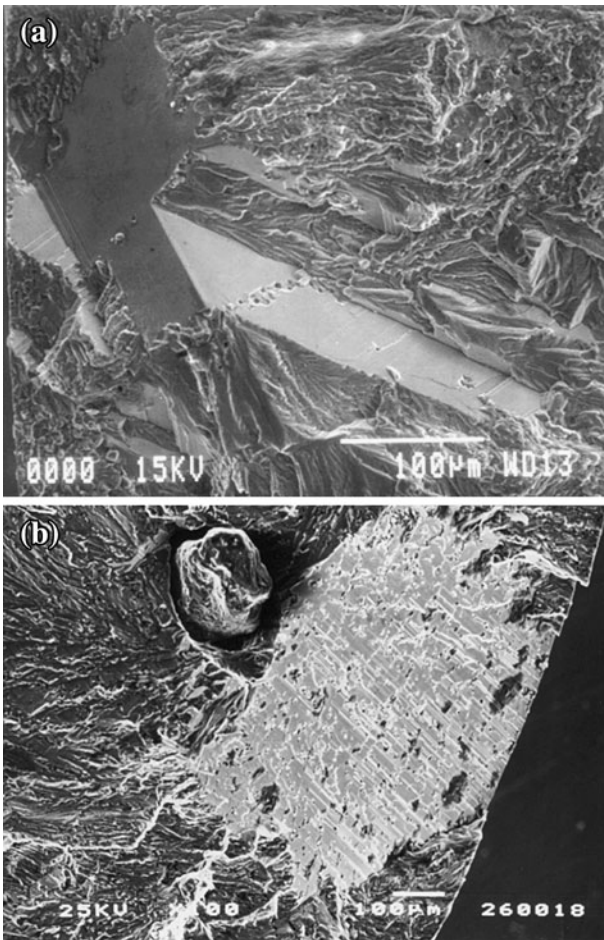
Recently, Tiryakioglu *et al.*<sup>[10]</sup> discussed these two types of facets in detail and concluded that both type of facets can initiate macroscopic fatigue failure. Examples of the two types of facets found in cast Al alloys are shown in Figure 4, where facets (1) with crystallographic orientations formed by a slip plane mechanism initiated by stress concentration at a casting defect<sup>[7]</sup> and (2) that form from the bifilm straightening during solidification. The facets shown in Figure 4 are similar to those observed by Kunz *et al.* The presence of either type of facet is an indication that fracture takes place prematurely because of the presence of a casting defect, which can be avoided by proper melt preparation and pouring techniques.

Fig. 4—A fatigued fracture surface in A356 alloy illustrating (a) a facet generated by a slip plane<sup>[9]</sup> contrasted with (b) a facet generated by a bifilm flattened by dendrite growth<sup>[10]</sup> (Courtesy of *Metall. Mater. Trans. B*).

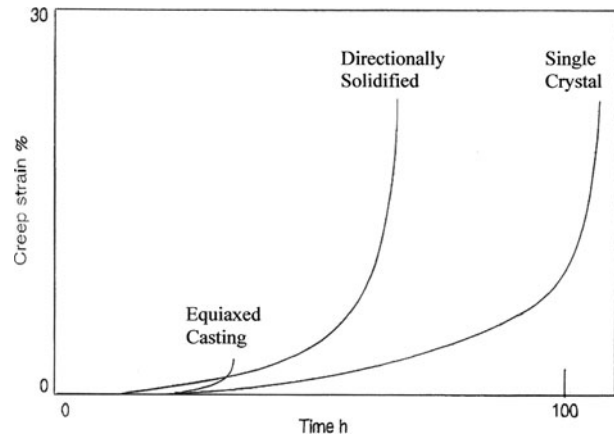
If we accept the logical conclusion that grain boundaries are strong (in most cases practically as strong as the matrix) and the unbonded interfaces (bifilms) are almost totally without strength, it follows that the famous result for the improved creep life of directionally solidified (DS) and single-crystal blades (Figure 6<sup>[25]</sup>) is a direct result of the elimination of bifilms and not the elimination of grain boundaries. This conclusion is to be expected from the fact that the growth of grains in

Fig. 6—The creep-to-failure behavior of equiaxed, directionally solidified and single crystal castings of Mar M200 Ni-base alloy at approximately 1253 K (980 °C) and 207 MPa.<sup>[25]</sup>

equiaxed solidification will trap bifilms from all directions, so that boundaries of equiaxed grains will be predicted to fail early during creep. In contrast, the solidification regimes in DS and single-crystal growth have fortunately adopted favorable vertical growth that permits a significant time for oxides to float upward and so escape, and the remnants that do not float have the chance to be pushed, so that these blades will be significantly cleaner. The fact that they still eventually fail is, interestingly, a sign that they are not perfectly clean; better melt preparation and transfer into the mold would eliminate these final problems to give significantly increased, if not indefinite, creep life.<sup>[26]</sup>

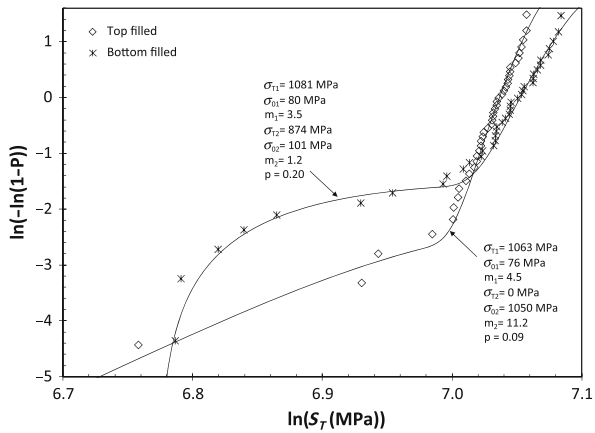
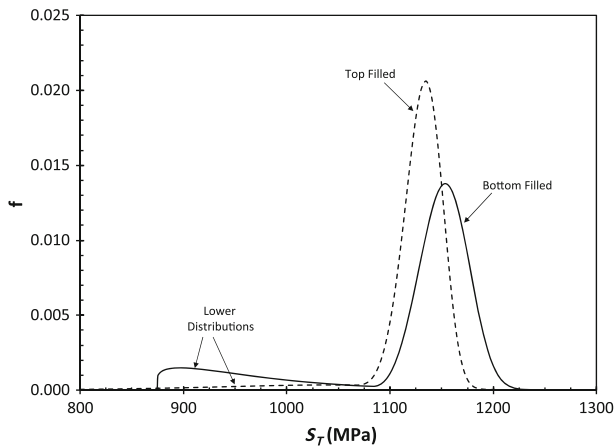
Fig. 7—A Weibull analysis for the tensile strength of vacuum melted and cast top- and bottom-filled IN939 test bars into investment molds: (a) Weibull probability plot showing two distinct distributions in both data sets and (b) plot of fitted distributions.

The subscripts 1 and 2 refer to castings that belong to upper and lower distributions, respectively. For bottom-filled castings, note that the slope steepens at low tensile strength values, indicating the presence of a threshold value.<sup>[27]</sup> The two distributions in both data sets most likely stem from the presence of two different types of defects, both of which resist healing to different degrees during the hot isostatic pressing (HIP) process. In hot isostatically pressed cast aluminum alloys, the lower distribution in both fatigue and tensile specimens was found<sup>[29,30]</sup> to be caused by the presence of “old” oxide bifilms that had formed as a result of previous damage and had subsequently coarsened in the crucible. The upper distribution represented fracture from “young” oxide bifilms that had formed during the mold filling, which partially bonded (healed) during the HIP process. The distributions for top- and bottom-filled IN939 are presented in Figure 7(b). Note that the improvement in quality by bottom filling rather than top-filling is evidenced by the shift of the upper distribution to higher tensile strengths. This is expected because it was found *via* computer simulations and real-time X-ray radiography<sup>[31,32]</sup> that the entrainment of surface that

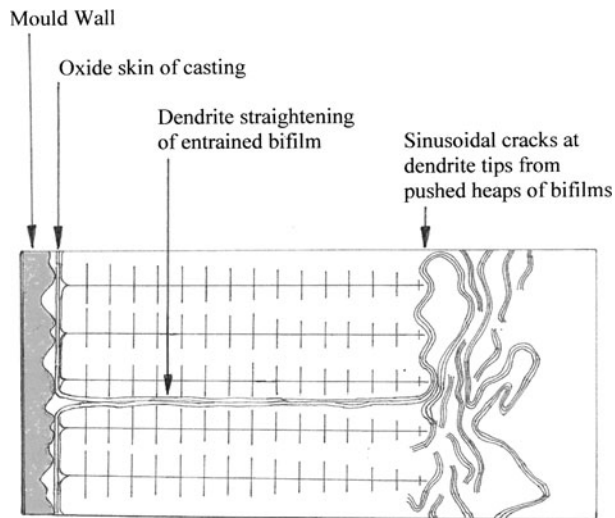
at right angles to the surface, disappearing into the depth of the matrix. It seems likely that these cracks are bifilms straightened by the growth of dendrites as illustrated schematically in Figure 12. This figure illustrates how flat regions of cracks can be formed that are aligned parallel to the generally closer packed 100 or 110

Fig. 12—Dendrite straightening leading to facets plus tip accumulation of bifilms leading to undulating topography of fracture surface.

ahead of the advancing grains as shown at the tips of dendrites in Figure 12. Such sinusoidal fracture surfaces are relatively common in many cast alloys and can usually be definitely associated with the dendrite tip outlines delineated by bifilms. In Figure 13, the traces of cracks disappearing into the matrix of the casting are, once again, typical of this structure.
