Effects of Aging and Environmental Factors on Performance of CdTe and CIS Thin-Film Photovoltaic Modules

Key words: Thin film solar module, PV module failure, delamination, corrosion, module efficiency, module degradation factor

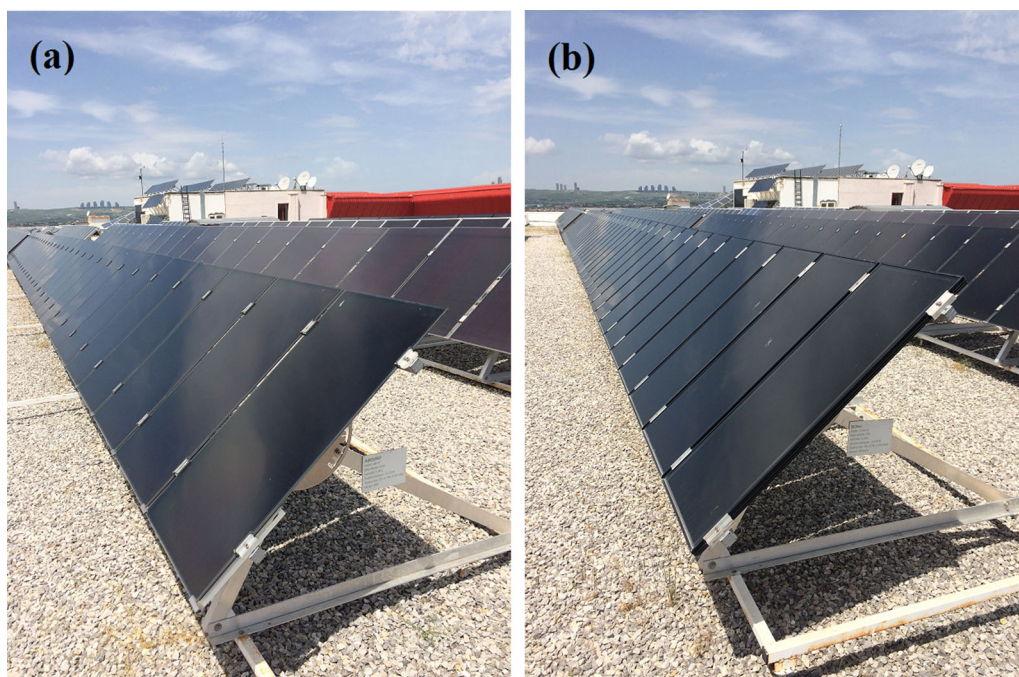
Figure 2 shows the experimental working environment where the PV module strings were installed on the roof of an office building at Gazi University Golbasi Campus Technopark. Both the CdTe and CIS PV strings in Fig. 2 were installed on the same roof with an inclination angle of 40° facing the north–south direction. The electrical parameters of both modules were determined under standard test conditions at 1000 W/m^2 and are tabulated in Table I. The configuration of the strings and the electrical properties of the modules used in the strings are described below.

Fig. 2. Experimental setup at Gazi University Golbasi campus Technopark: (a) CdTe thin-film module string and (b) CIS thin-film module string.

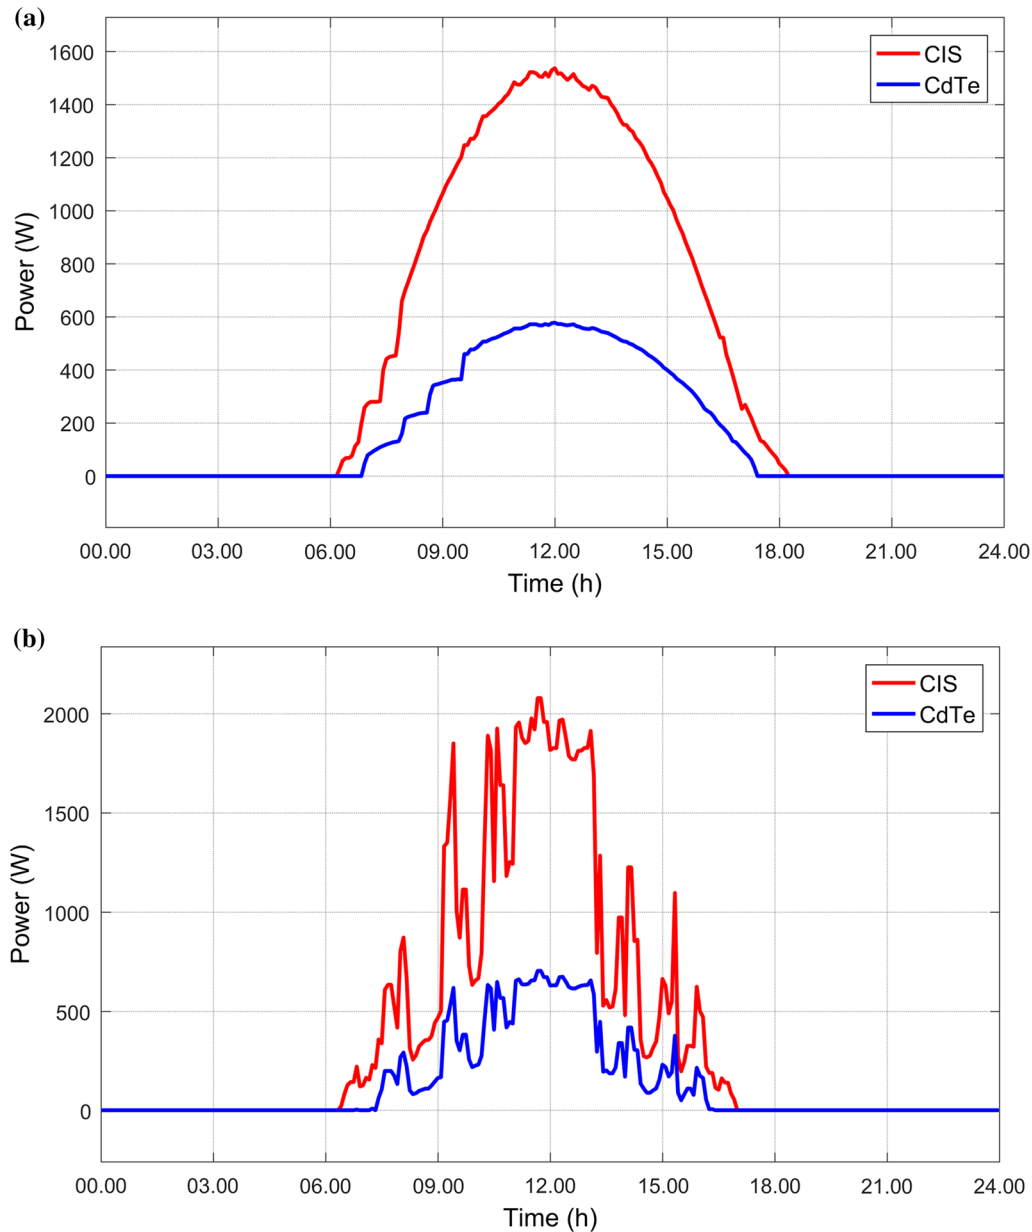
The observed failures caused a reduction in the generated power and decreased efficiency. To analyze the effect of these failures on the overall performance, the module power production capability before and after the failures was evaluated. The power production before the failures was determined for a normal sunny day and a cloudy day to obtain a basis for future comparisons. Figure 4a presents a sample dc power production plot for both strings for a normal day, and Fig. 4b presents the same data for a cloudy day. It is apparent that the CIS modules performed more efficiently than the CdTe modules for the same inclination angle. The CIS modules also generated approximately three

Fig. 4. PV string dc power generation data before module failures: (a) on a normal sunny day on July 1, 2016, and (b) on a cloudy day on October 15, 2016.

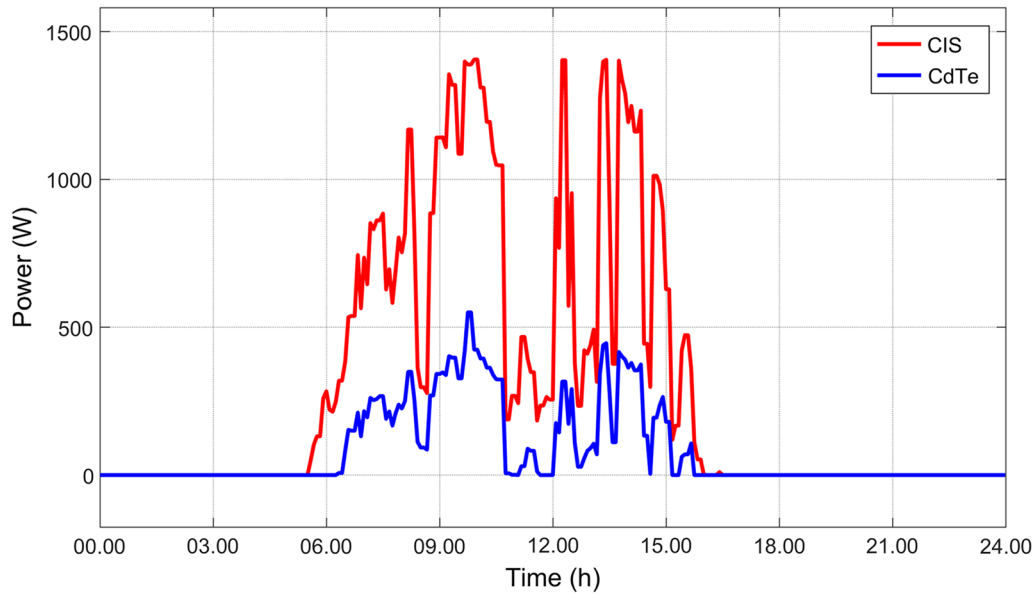
Figure 5 presents a plot of the dc power generation data of the strings after 1 year of operation. A decrease of 21.7% in the power generation of the CdTe string and a decrease of 31.5% in the power generation of the CIS string were observed in the same month within the same time interval after a 1-year period. We can thus conclude that the main reason for the drop of efficiency in the PV modules and corresponding decrease in the power generation was the failures in the modules. Comparison of the measurements over the entire exploration time reveals that the module failures were prominent after August 2017.

Fig. 5. PV string dc power generation with failed modules recorded on October 20, 2017.

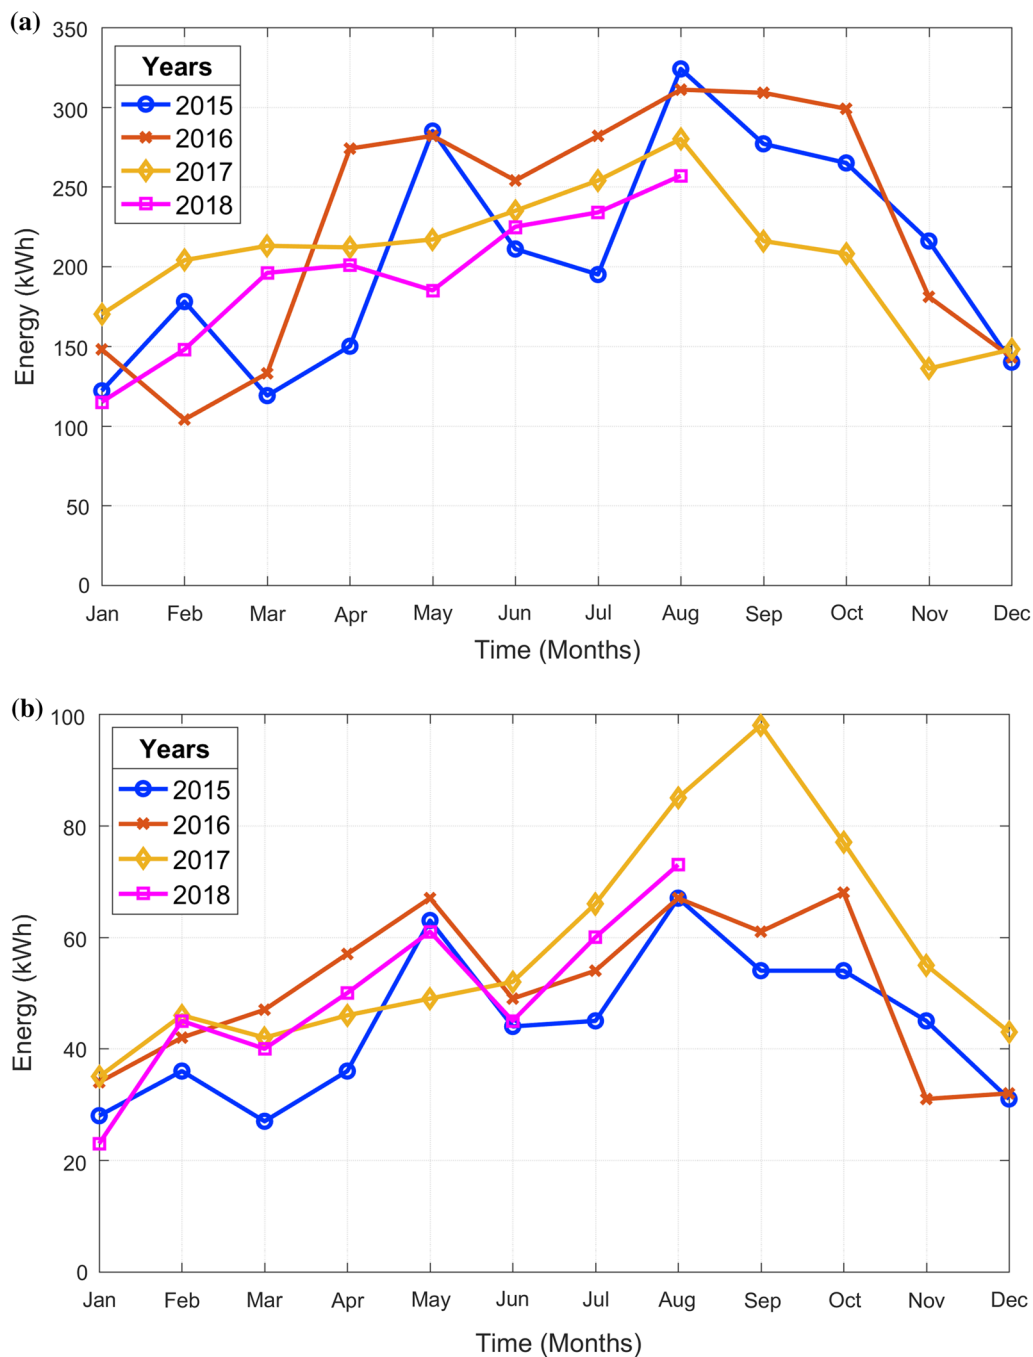
Monthly energy generation data of the CIS and CdTe strings over the 3.5-year period were also collected, and the power generation histories of the CIS and CdTe PV strings are shown in Fig. 8a and b, respectively. A noticeable decrease in the efficiency of the CIS modules was observed in the months after the failures started to occur. The decrease in the efficiency of the CdTe modules with micro-crack failures was relatively less pronounced than that of the CIS modules.

According to the data presented in Fig. 8a, the energy generation performance of the CIS PV modules started to decrease in 2017. A similar decrease in the power generation capability was observed during the first 8 months of 2018. In contrast, as observed in Fig. 8b, the efficiency loss in the CdTe-type modules was much lower, and these modules operated with almost the same efficiency in consecutive years. The total energy production values of the modules over the 3.5-year period were measured to be 12,794 kWh for the CIS modules and 2933 kWh for the CdTe modules. It is important to note that the modules had very similar efficiency specifications according to their catalog information even though the energy production differed substantially in the real working environment. Thus, our findings demonstrate that PV modules with the same theoretical efficiencies can

Fig. 8. Annual power generation data of PV strings: (a) CIS and (b) CdTe.

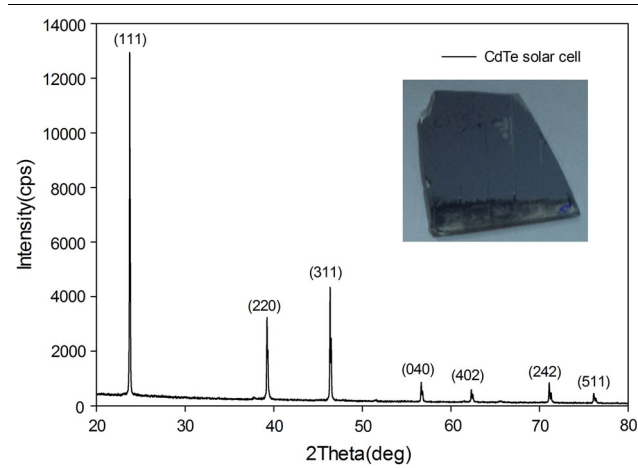
The micro-crack failures of the CdTe modules were analyzed using XRD analysis. A GNR APD 2000 pro diffractometer with Theta–2Theta axis and Bragg–Brentano geometry and a fast detector was used for the XRD analysis. The XRD tube consisted of a Cu source with a wavelength of 1.5406 Å. The XRD results from the undamaged part of the commercial CdTe thin-film array are presented in Fig. 9. The (111), (220), (311), (040),

(402), (242), and (511) peaks of Miller indices are consistent with those of the powder diffraction file (PDF) 96-900-8441, indicating that the CdTe had a cubic structure with a lattice parameter of 6.480 Å. These XRD results can also be compared with those of Ref. 24.

Fig. 9. XRD pattern of an undamaged part of CdTe thin-film PV module as shown in the inset.
