# Failure Analysis of a Cracked Gasoline Engine Cylinder Head

**Abstract** This article presents a failure analysis on a gasoline engine cylinder head made of aluminum alloy, which has been used in passenger cars. During an endurance test, a crack initiated from the interior wall of a hole in the center of the cylinder head and then propagated through the thickness of the cylinder head. The metallurgical examinations are conducted in the crack origin zone. The results show that there are many casting pores due to poor quality of casting in the failed cylinder head which has certainly played a crucial role in initiating the crack. Finite element analysis of the cylinder head is performed to identify the stress components. Modeling of a bolt for the hole shows that the plastic stresses are occurred. Moreover, the lower strength of the material due to high assembly stress caused the failure in the cylinder head.

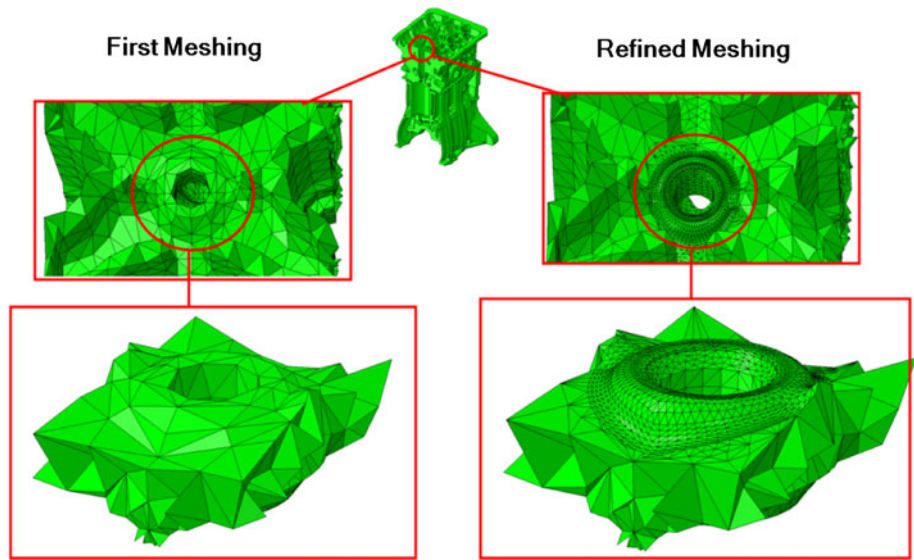
**Fig. 13** The finite element model with and without the refined meshings around the hole of casting process

To model the cylinder head and the engine block, non-linear gasket elements and sliding contact definitions were used (Fig. 13). The full model size was reduced to 1/2 that of the model, and linear material models (Fig. 14) were utilized to simplify the calculation procedure. To model the bolt force, an external displacement of 0.235 mm on the 1/3 top of the bolt length was applied to the hole as shown in Fig. 15. The resulting Von-mises stress around the hole is shown in Fig. 15, which includes plastic deformations. The stress component in the  $x$ -direction (crack growth direction) and the maximum principal stress are shown in Fig. 16. As seen in the figure, by considering the bolt model, both stresses ( $x$ -component and maximum principal ones) increase.
