Transverse Cracking of HF-ERW Pipes

Abstract Transverse to pipe axis cracks across the weld line of high frequency-electrical resistance weld (HF-ERW) pipes of IS 10748 Grade 2 and size 406.4 mm outside diameter and 7.75 mm wall thickness were observed. Analytical techniques such as ultrasonic testing, optical microscopy and scanning electron microscopy with energy-dispersive spectroscopy were used for analysis and determination of the root cause.

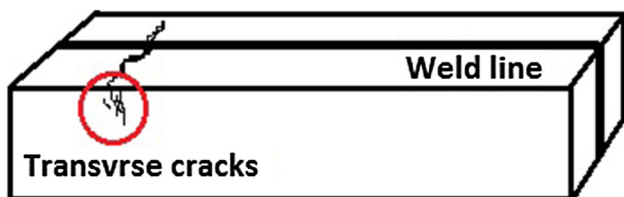
Fig. 2 Schematic diagram of transverse crack

Figure 2 shows the schematic diagram of the transverse crack appearing across the weld line in the HF-ERW pipe.

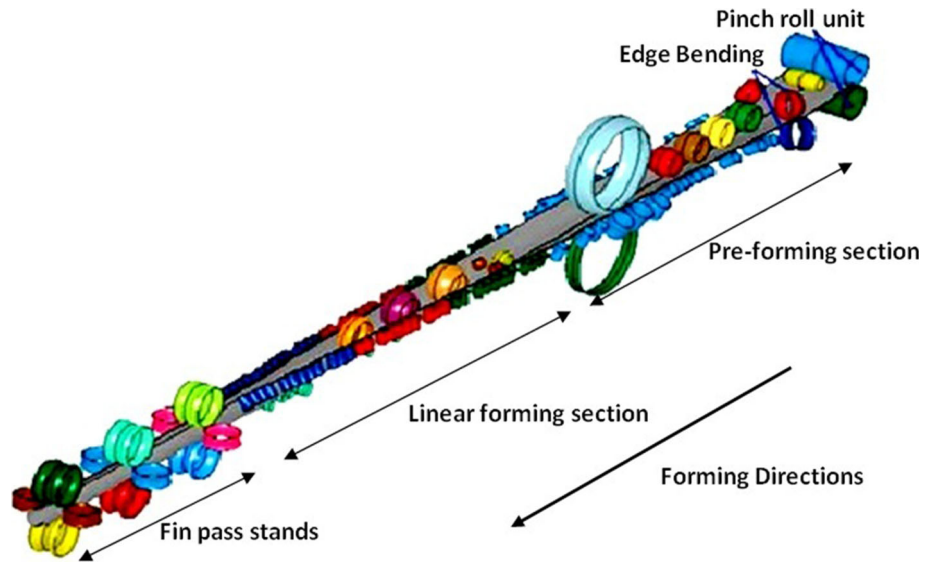
Fig. 7 Cage roll-forming mill [1]

In the cage roll-forming process (Fig. 7) of ERW pipes, a metal sheet is continuously deformed into a round pipe by

using a set of small cage rolls arranged along the outer surface of the steel strip. Those small cage rolls can realize a bending process by applying the downhill forming before the fin-pass stands. The pre-forming section consists of two outer forming roll groups, inner forming tools and a breakdown stand. The linear-forming section serves for further forming of the strip before the fin-pass stands. The fin-pass stands are the last roll-forming sections before the shaped metal sheet welded and each fin-pass stand comprises an upper roll, a lower roll and two side rolls [1]. After fin-pass, shaped edges are heated by electro-resistance and forged together using squeezing rolls to get the continuous weld line. Welded pipes are subjected to cold sizing to achieve required dimensional tolerances.

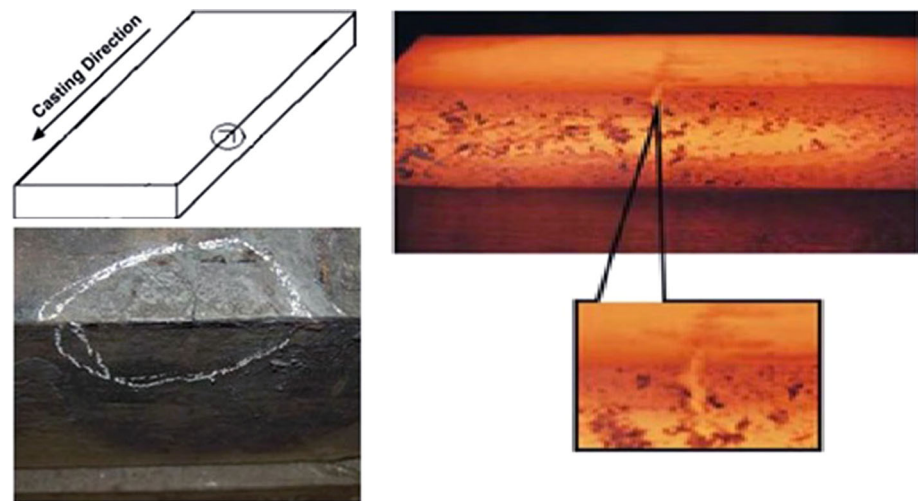
Fig. 8 Schematic diagram and pictorial view of edge cracks in slab [2]

longitudinal direction and of the order of some millimeter (up to 50 mm) in crack-length (transverse) direction (Fig. 8) [2].

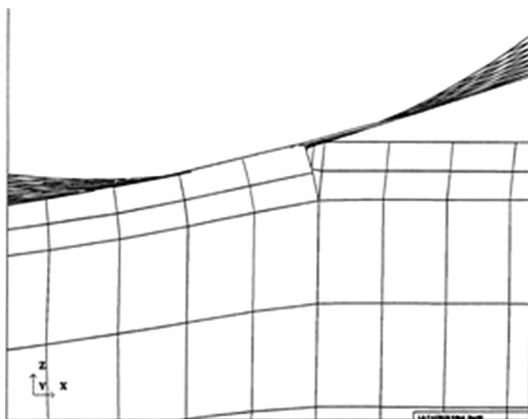
Fig. 9 Widening of crack during entrance in roll gap [4]

During hot rolling of such slab, two phenomena occur and counteracting each other. At the entrance to the roll gap, the transverse crack widens as shown in Fig. 9. The explanation for the phenomenon is that when the front edge of the transverse crack gets into contact with the roll it is dragged toward the gap at the same time as its velocity is rapidly changed from horizontal to become parallel to the tangential velocity of the roll. If this phenomenon did not occur, the risk for the creation of a permanent oxide flake should be big [4].
