# Maintenance Error Detection Procedure and A Case Study of Failure Analysis Locomotive Diesel Engine Bearings

Submitted: 19 September 2017 / in revised form: 9 January 2018 / Published online: 15 February 2018  
© ASM International 2018

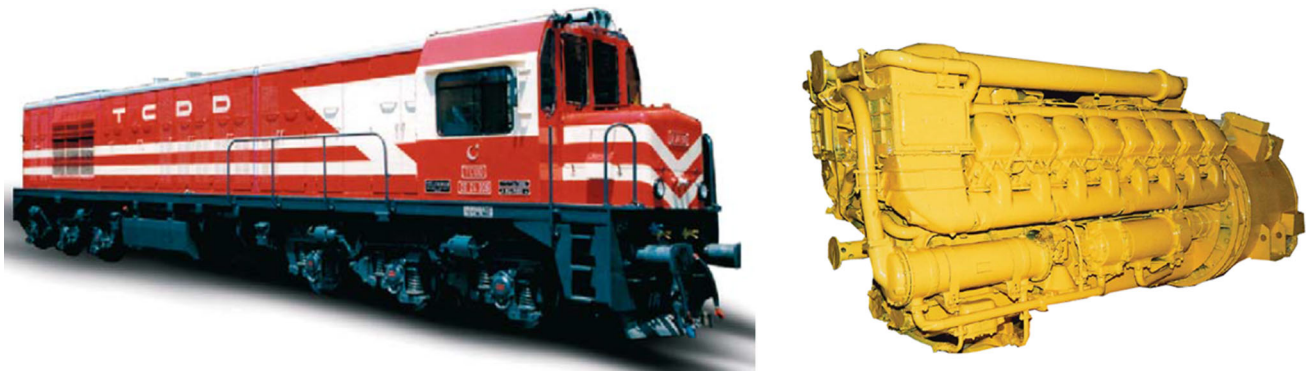
**Fig. 2** Locomotive and examined diesel–electric engine

Failure time is just after maintenance, so maintenance procedures were investigated. Possible assembly errors were checked. Then, technical assessments were started to determine the cause of engine failure. Engine's bearings were chosen for further examination based on visual assessment and transportation ease. Then, the engine's bearing was cut into pieces to represent observed different wear types. Finally, the contaminants were collected from the oil filters. The examination was performed with using SEM and energy-dispersive X-ray spectroscopy (EDS) analysis. Investigated locomotive end diesel–electric engine is shown in Fig. 2.
