Root Cause Failure Analysis of Pinch Roll Bearing at Hot Strip Mill

Kaushal Kishore · Goutam Mukhopadhyay

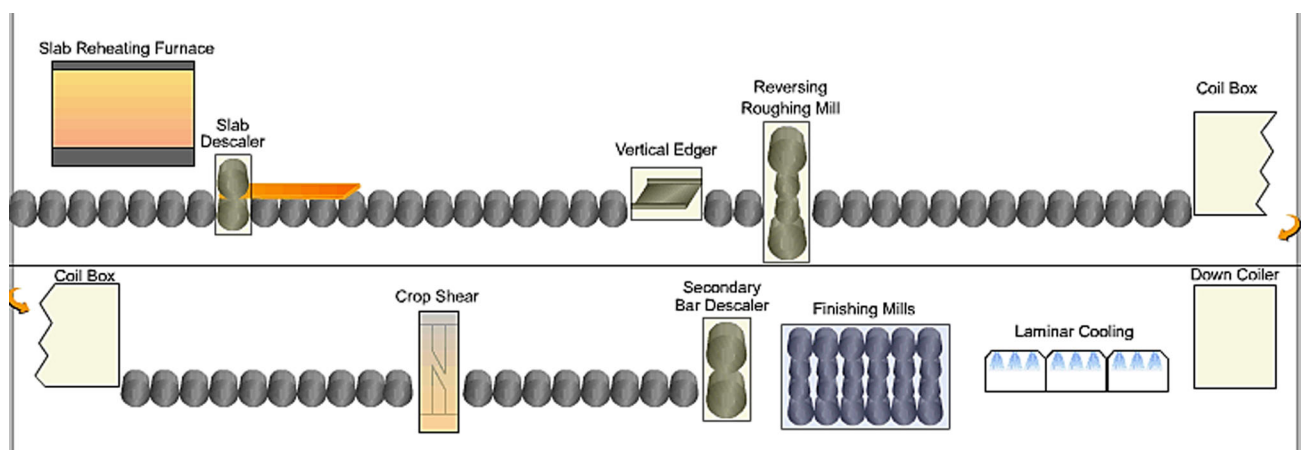
Fig. 1 Schematic of hot strip mill showing overall process flow

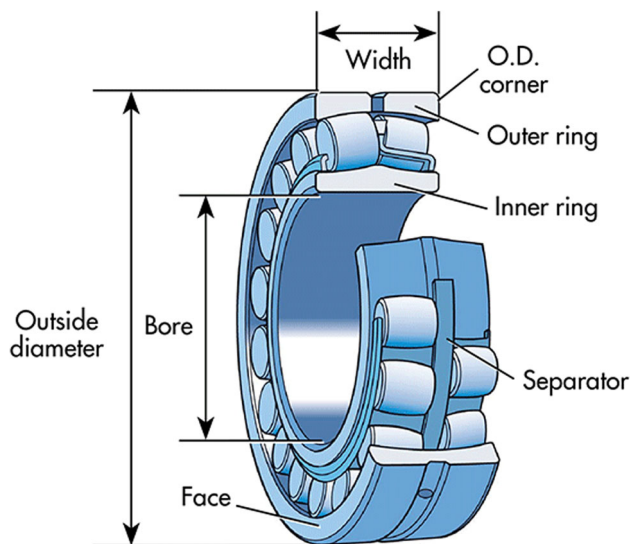
Figure 3 shows a schematic of a pinch roll bearing used in HSM. It has three major elements, namely outer ring, inner ring and barrel-shaped rollers. There are two sets of rollers partitioned by a separator as shown in Fig. 3. The mechanism of operation of the bearing is such that rollers roll around the inner race like a car wheel, but traverse around the circumference much slower than the inner race. The outer ring is stationary, whereas the inner ring revolves which drives the shaft. There was an important finding during the on-site observation. It was observed that rollers on the near end of the actual roll were broken and were found to be in severely damaged condition, whereas those located toward the near end of the shaft remained in an

Fig. 3 Schematic of a pinch roll bearing used in HSM [7]
