# Failure Analysis of a Fighter Jet Engine Compressor Blade Due to Foreign Object Damage and High-Cycle Fatigue

R. A. Marín · J. A. Escobar · J. Loboguerrero

Submitted: 26 April 2021 / Accepted: 25 June 2021 / Published online: 20 August 2021  
© ASM International 2021

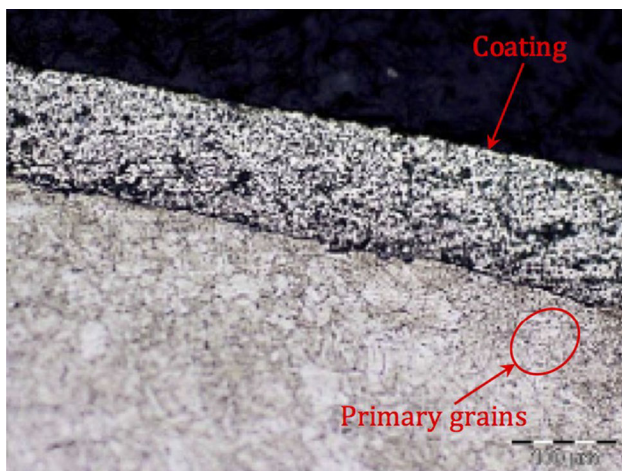
**Fig. 10** Image (200×) of the leading edge of the reference blade, showing some primary grains and a coating with no erosion damage

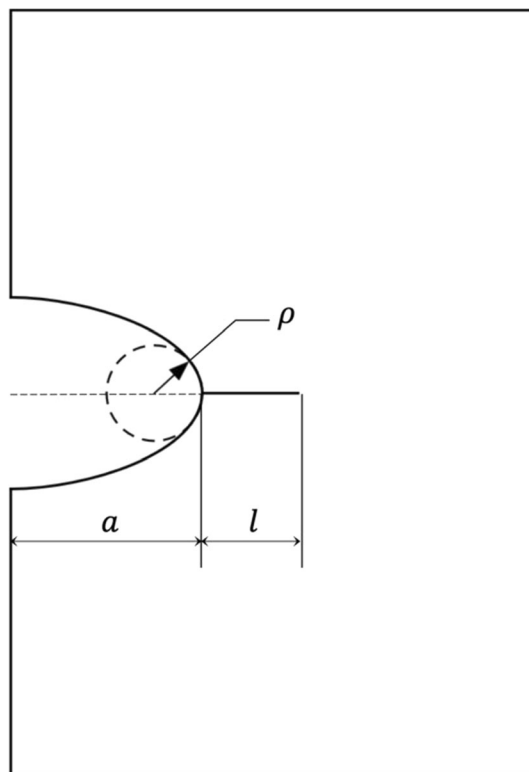
**Fig. 15** Notch with crack geometric model

The goal of the WCN model is to calculate the minimum crack propagation threshold stress as a function of the FOD notch geometry. This calculation is based on a crack propagation model developed for short cracks emanating at the root of a semi-elliptical shaped notch [15]. Such a crack model is shown in Fig. 15, where  $a$  is the notch depth,  $\rho$  is

the notch radius and  $l$  is the crack length. The minimum crack propagation threshold stress is the stress level at which the onset of HCF can occur. It is denoted by  $\Delta S_{th}$  and

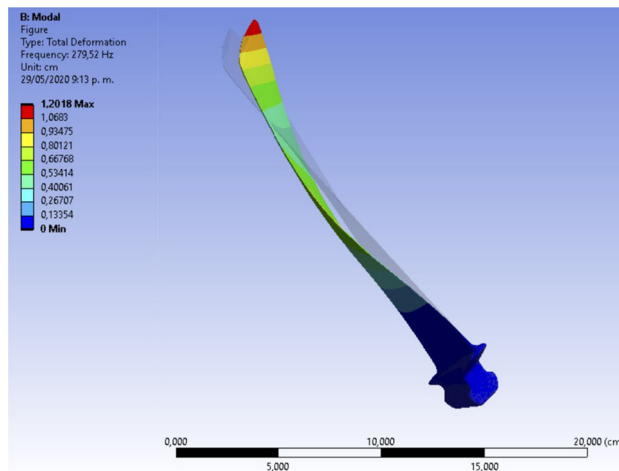
Fig. 17 The first vibration mode of the blade

Although in the modal analysis we calculated the first five natural frequencies and vibration modes of the blade, the most important is the first one, since in this mode the blade will present the largest deformations and the largest stresses. The first natural frequency was at 279.52 Hz. The first vibration mode is shown in Fig. 17. In the figure, the absolute value of the deformations shown is not important.

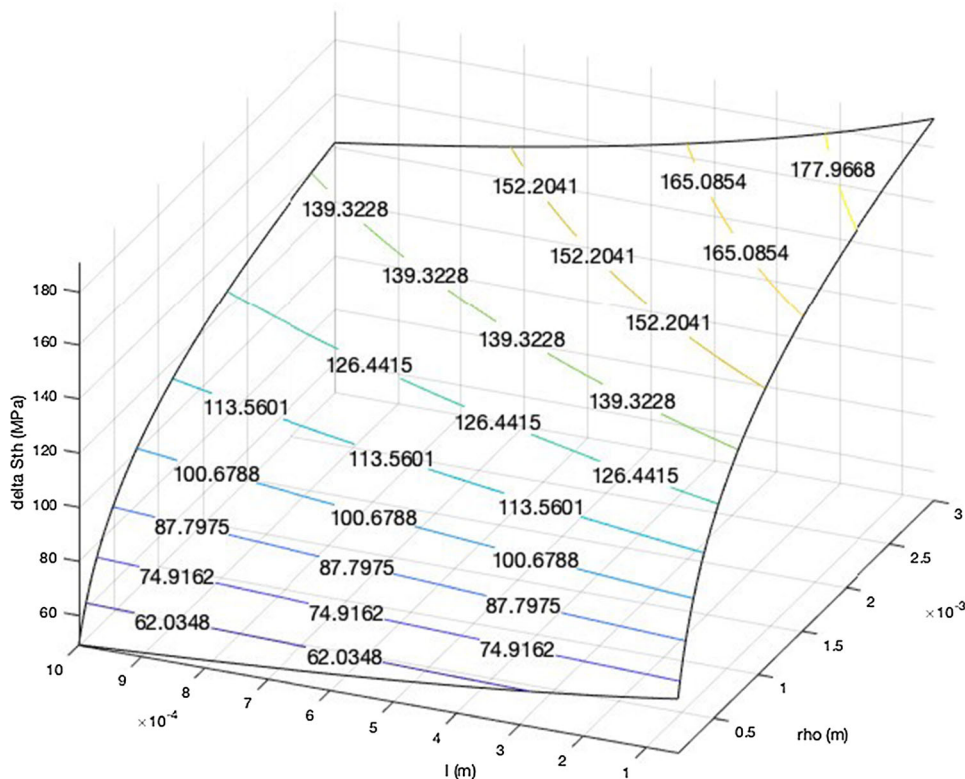
Fig. 16  $\Delta S_{th}$  as a function of notch bottom radius  $\rho$  and crack length  $l$

At this point, we are ready to compute  $\Delta S_{th}$  from Eq. 1, for a range of notch radii  $\rho$  and crack lengths  $l$ . The notch depth  $a$  is fixed at 0.65 mm, which was measured on the failed blade sample. The chosen ranges, in mm, are  $0.1 \leq \rho \leq 3.0$  and  $0.05 \leq l \leq 1.0$ . The result is shown in Fig. 16. As expected,  $\Delta S_{th}$  increases as  $\rho$  increases and decreases as  $l$  increases.

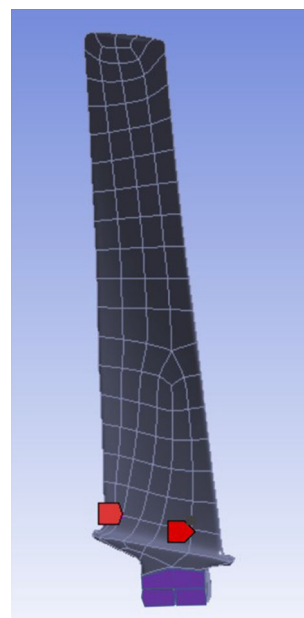
**Fig. 18** Boundary conditions for the harmonic response analysis

boundary conditions of that analysis are shown in Fig. 18. The purple surfaces are completely immobilized, as well as the ones directly on the opposite side of the blade. An oscillating force is applied perpendicular to the surface of the blade along the line between the two vertices with a red flag. The force is applied at a frequency of 250 Hz, so that it will excite primarily the first vibration mode of the blade.

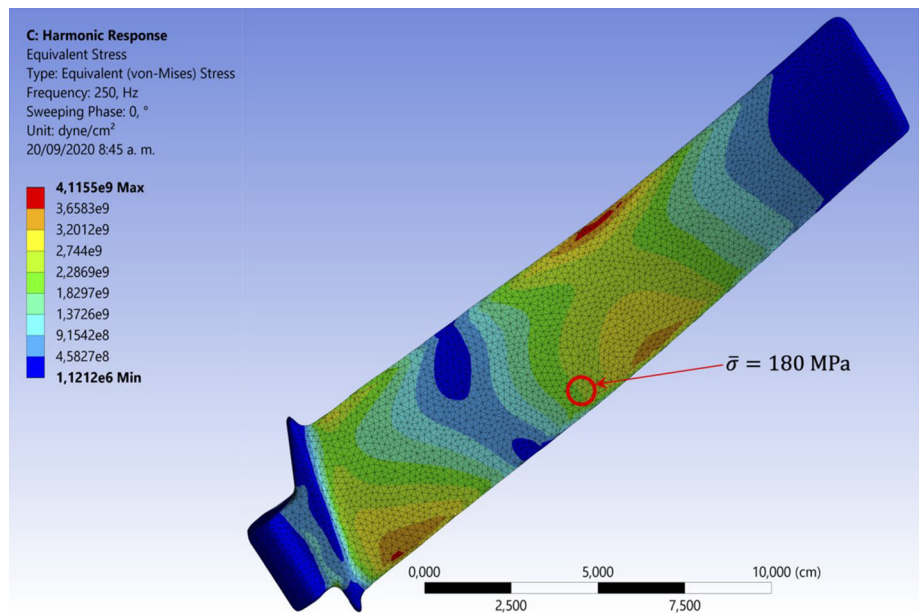
**Fig. 21** Vibration amplitude associated with a stress of 180 MPa at the FOD location

The foreign object impact occurred approximately at the location highlighted with a circle in Fig. 19. Having identified the failure location in the mesh, we will use the finite elements model of the harmonic response to determine the amplitude of the vibration needed to produce the threshold stresses predicted with Equation 1 in the range between 54 MPa and 180 MPa. The result is that to obtain a stress of 54 MPa at the FOD location, the vibration amplitude must be 0.52 mm, and to obtain a stress of 180 MPa at the same location, the vibration amplitude must be 2.90 mm. Figure 20 shows the stress distribution in the blade surface such that at the FOD location the average stress is 180 MPa. On the other hand, Fig. 21 shows the vibration amplitude observed when the stress at the FOD location is 180 MPa.
