Earthquake damage and related factors associated with the 2016 $M_L = 5.8$ Gyeongju earthquake, southeast Korea

Key words: Gyeongju earthquake, earthquake damage, focal depth, damaged building, local geological conditions, ground motion propagation

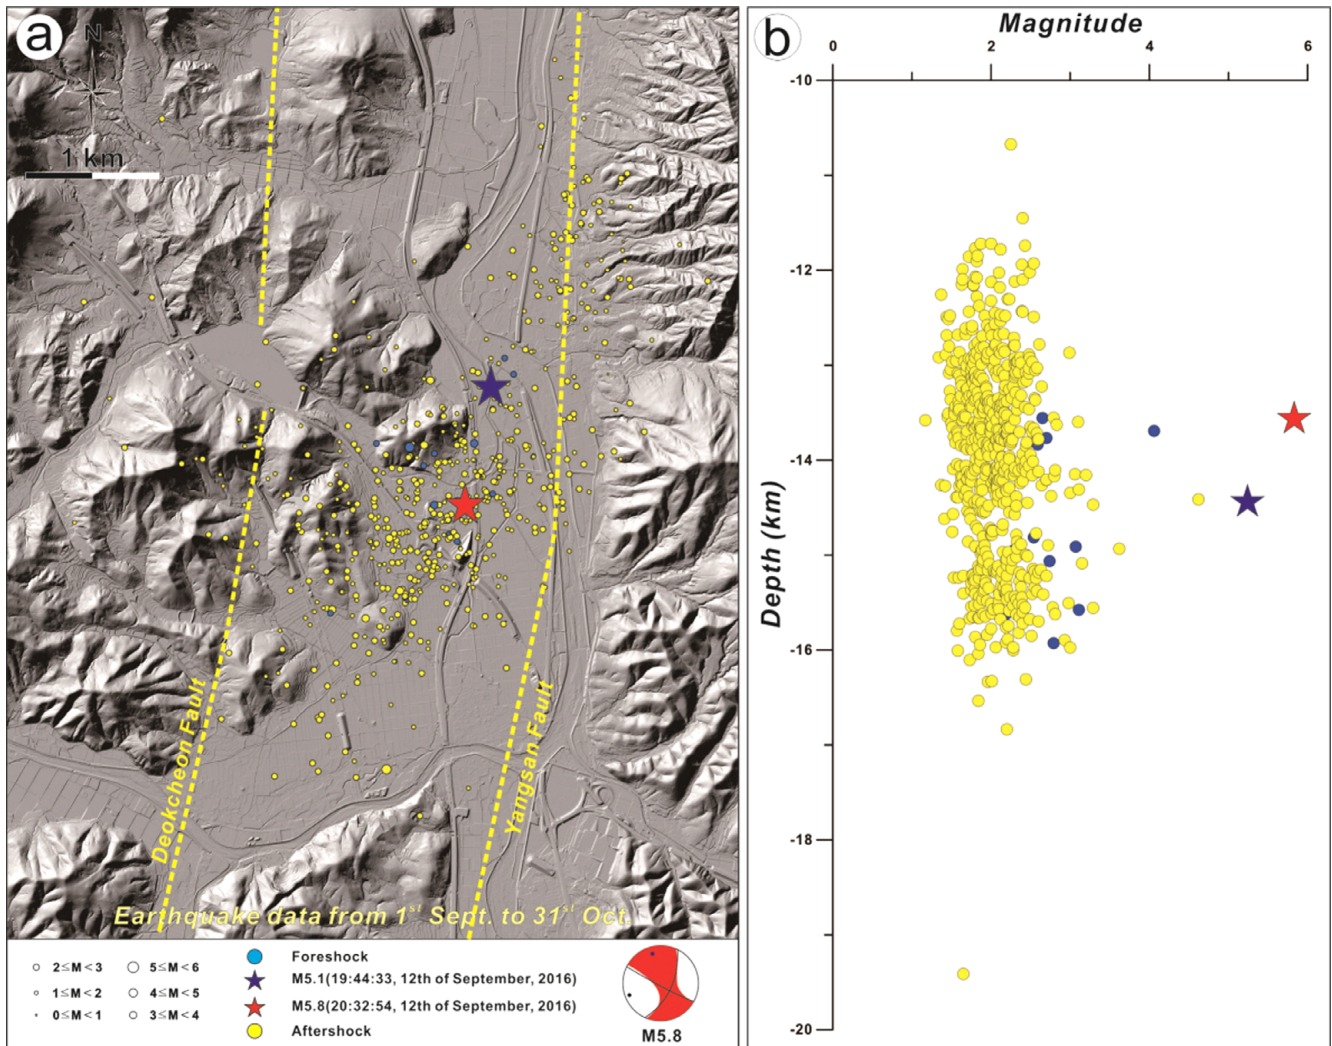
on focal mechanisms (Fig. 6; Kim et al., 2016). The aftershocks of the earthquake occurred at depths around 12 to 16 km for more than two months (Fig. 6). The foreshocks, mainshock and aftershocks were concentrated in a small area between two faults (Yangsan and Deokcheon faults) indicating a close relationship with the linking damage zone (Kim et al., 2017).

However, the distribution of damaged buildings was not concentrated around the epicenter, but it was instead relatively scattered over a 17 km radius, almost the same distance as the focal depth (Fig. 2). Furthermore, according to media reports, the earthquake was felt throughout South Korea and even in China and Japan. Therefore, we suggest that the broad distribution of damage and shaking associated with the 9.12 Gyeongju earthquake is related to the relatively deep focal depth. This indicates that the focal depth is closely related to the distribution area of the

The foreshocks, mainshock, and aftershocks were concentrated in a small area between the NNE-SSW trending Yangsan and Deokcheon strike-slip faults within the Yangsan Fault Zone (Fig. 6). The focal mechanisms of the 9.12 Gyeongju earthquake indicate predominantly right-lateral strike-slip movement along the NE-SW trending fault, indicating a connecting fault within the linking damage zone of the two faults (Fig. 6a; Kim et al., 2017).
