Mechanism of mine water inrush from overlying porous aquifer in Quaternary: a case study in Xinhe Coal Mine of Shandong Province, China

Huiyong Yin¹ · Han Zhao¹ · Daolei Xie¹ · Shizhen Sang¹ · Yongli Shi¹ · Maohu Tian²

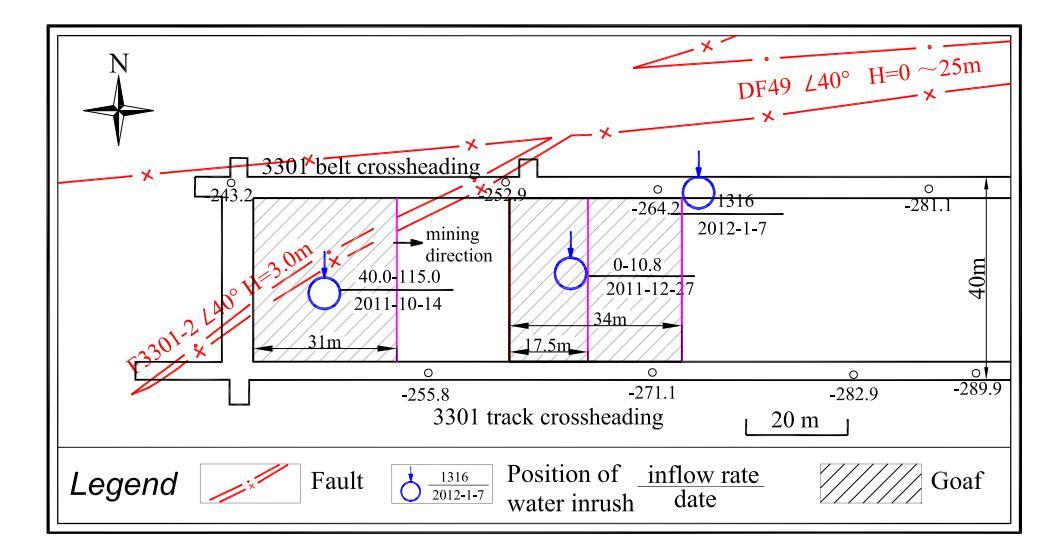
the maximum of 115 m^3/h at 10 o'clock, and then gradually decreased. Water quality test results show that the water is from the sandstone aquifer at the CB3 roof. By October 25, the water flow rate declined to 40 m^3/h .

The working face continued mining on December 23, 2011, and the roof pressure was basically stable. At 13:30 on December 27, 2011, the mine water discharged from the CB3 roof after the track along the chute out. The total discharge rate was 45.7 m^3 /h and remained stable from 16:00 December 27 to 18:00 December 28. The water discharge increased to 53 m³/h when the working face advanced 23 m on January 2, 2012. The amount of mine water varied from 60 to 121 m³/h from January 3 to 6. The water quality test result verified that the water was still from the sandstone aquifer at the CB3 roof. At 17:00 January 7, the fore-field coal wall

suddenly collapsed 3 m from the belt crossheading along the roof and then the amount of mine water increased rapidly from to 1254 m³/h by 22:00 the same day. The maximum flow rate was 1316 m³/h at 12:00 pm January 8. After that, the water inflow rate dropped rapidly. The flow rate varied from 170 to 200 m³/h on January 17. On January 24, the water flow rate decreased to 150 m³/h.
