Micro-environmental change as a trigger for granite decay in offshore Irish lighthouses: implications for the long-term preservation of operational historic buildings

P. A. Warke · B. J. Smith · E. Lehane

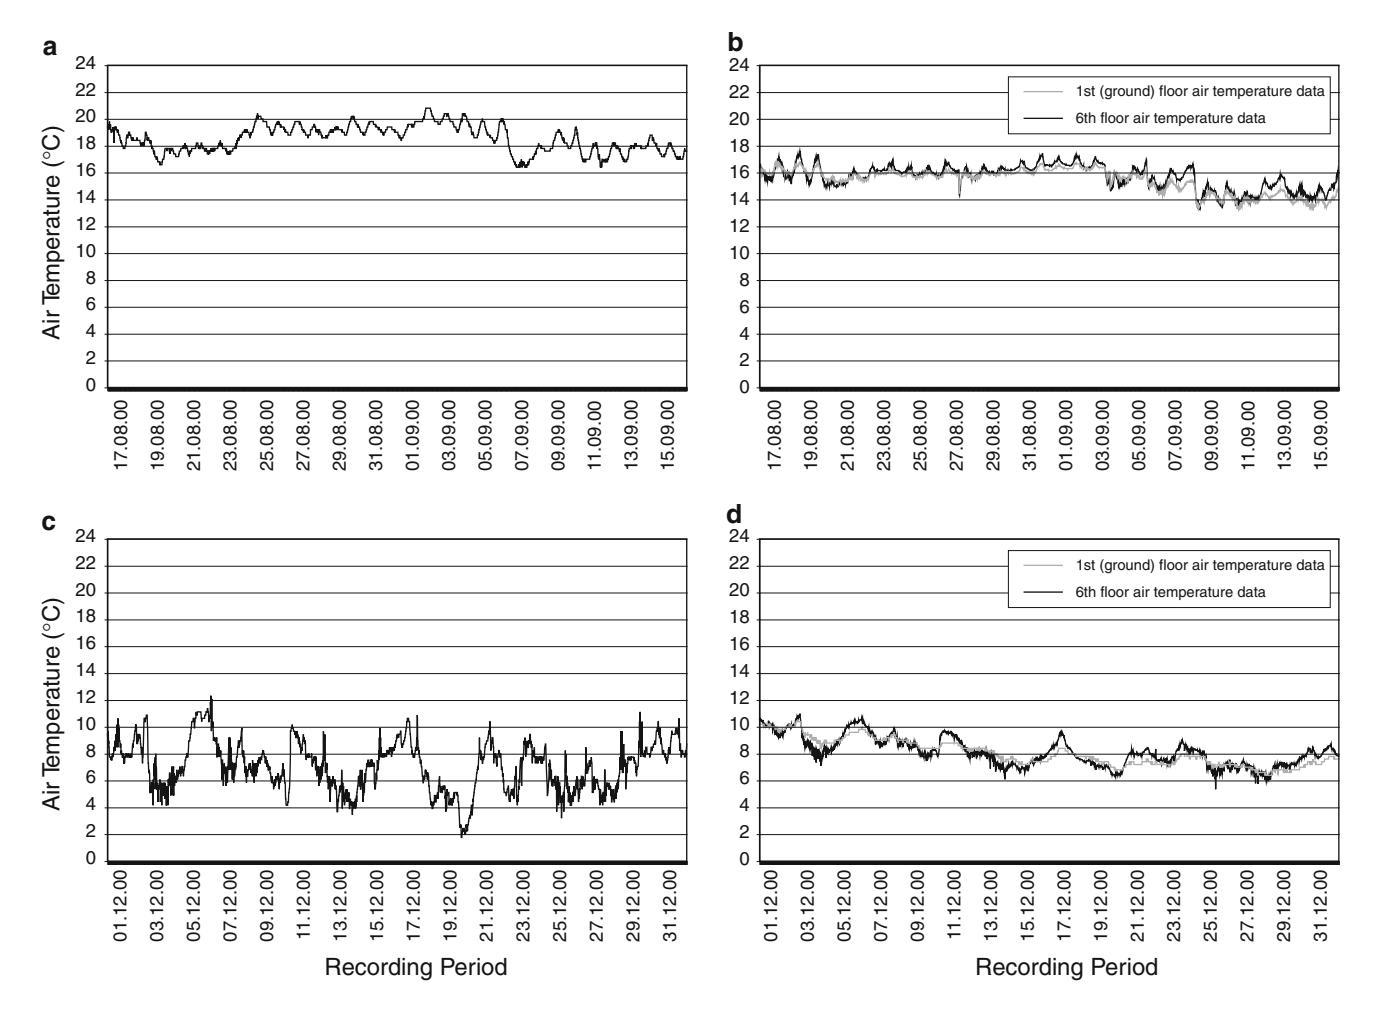
Throughout the 12-month recording period, on a diurnal scale, air temperature data within Eeragh exhibited smallscale fluctuations of between 1 and 3°C. These diurnal fluctuations decrease with increasing height in the tower and may reflect the influence of rising warm air within the tower (Fig. 9a, b). Air temperature data from Eagle show slightly larger diurnal fluctuations with comparatively higher summer and winter temperatures than those recorded at Eeragh (Fig. 9c, d). These warm conditions are attributed to the combined effects of a large storage heater and the comparatively small size of the tower, which is more effective at retaining heat.

Fig. 9 Summer and winter air temperature data from within the Eagle Island and Eeragh lighthouses. a Eagle Island (Summer), b Eeargh, North Aran (Summer), c Eagle Island (Winter), d Eeragh, North Aran (Winter)

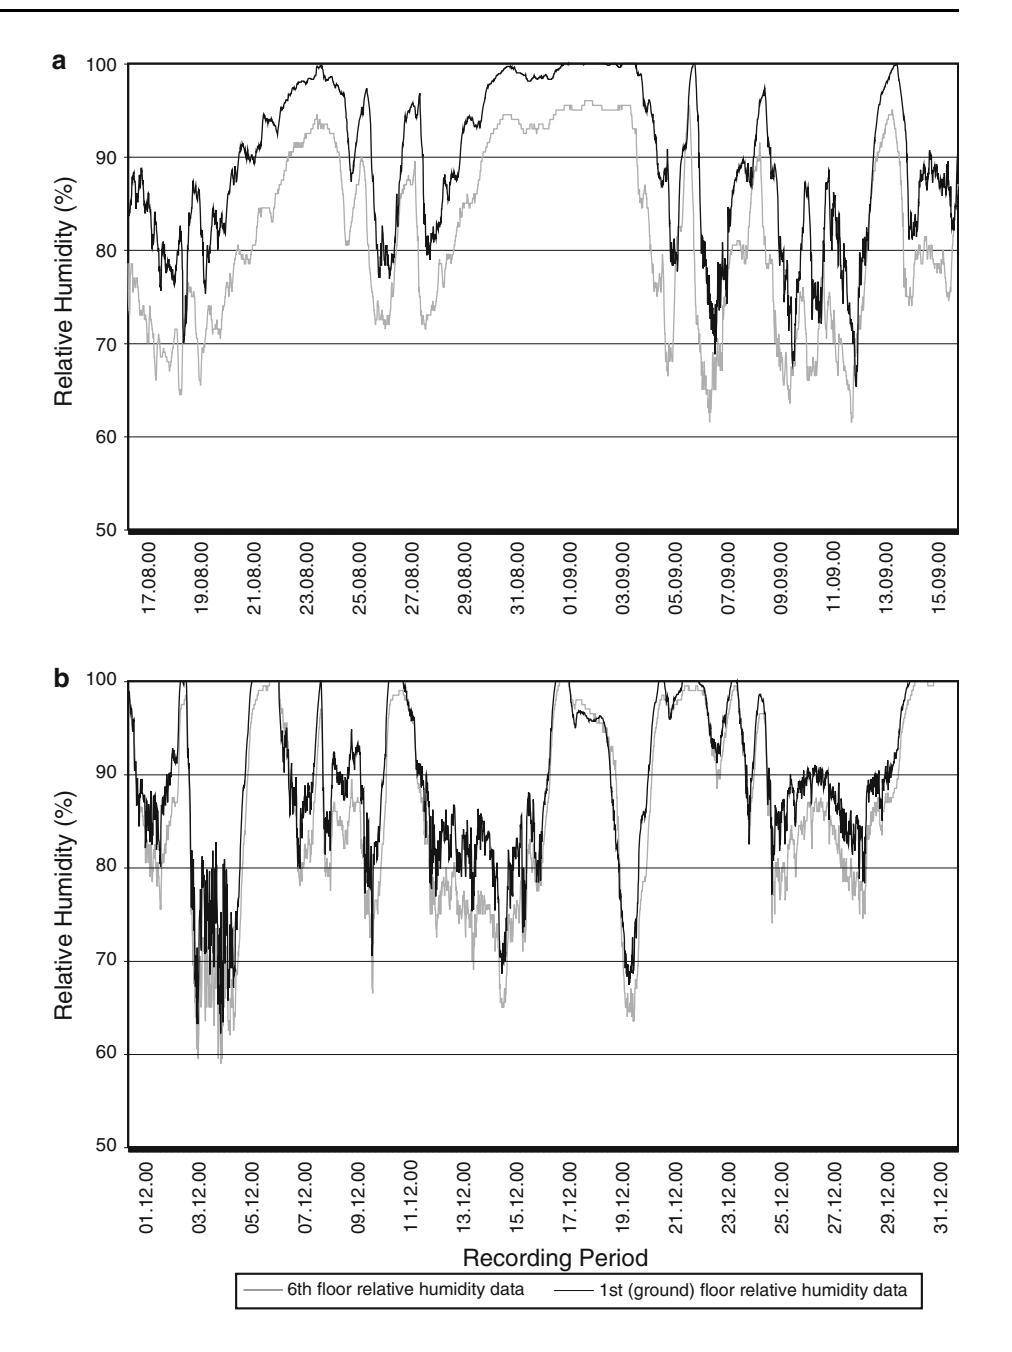
At Eeragh the most notable feature of relative atmospheric humidity (RH) data were the high values recorded in the lower two levels of the tower with values exceeding 70% for much of the 12-month recording period. Higher up within the tower, RH tends to be some 10-20% lower reflecting the higher air temperatures recorded here (Fig. 10a, b). RH conditions within both Eeragh and Eagle are characterised by short-term diurnal cycles with superimposed longer-term cycles lasting some 2-3 days and associated with external meteorological events. For example, RH values may exceed 70-80% during the passage of a frontal system and fall below this during more stable anticyclonic conditions although this will be spatially variable within the towers. It is important to note that at Eagle, the effect of the storage heater significantly affected RH data with the amplitude of both short- and long-term fluctuations being much greater and more frequent than those recorded at Eeragh (Fig. 11a, b).

Fig. 10 Summer and winter relative atmospheric humidity date from different levels within Eeragh lighthouse. a Eeragh, North Aran (Winter), b Eeragh, North Aran (Summer)

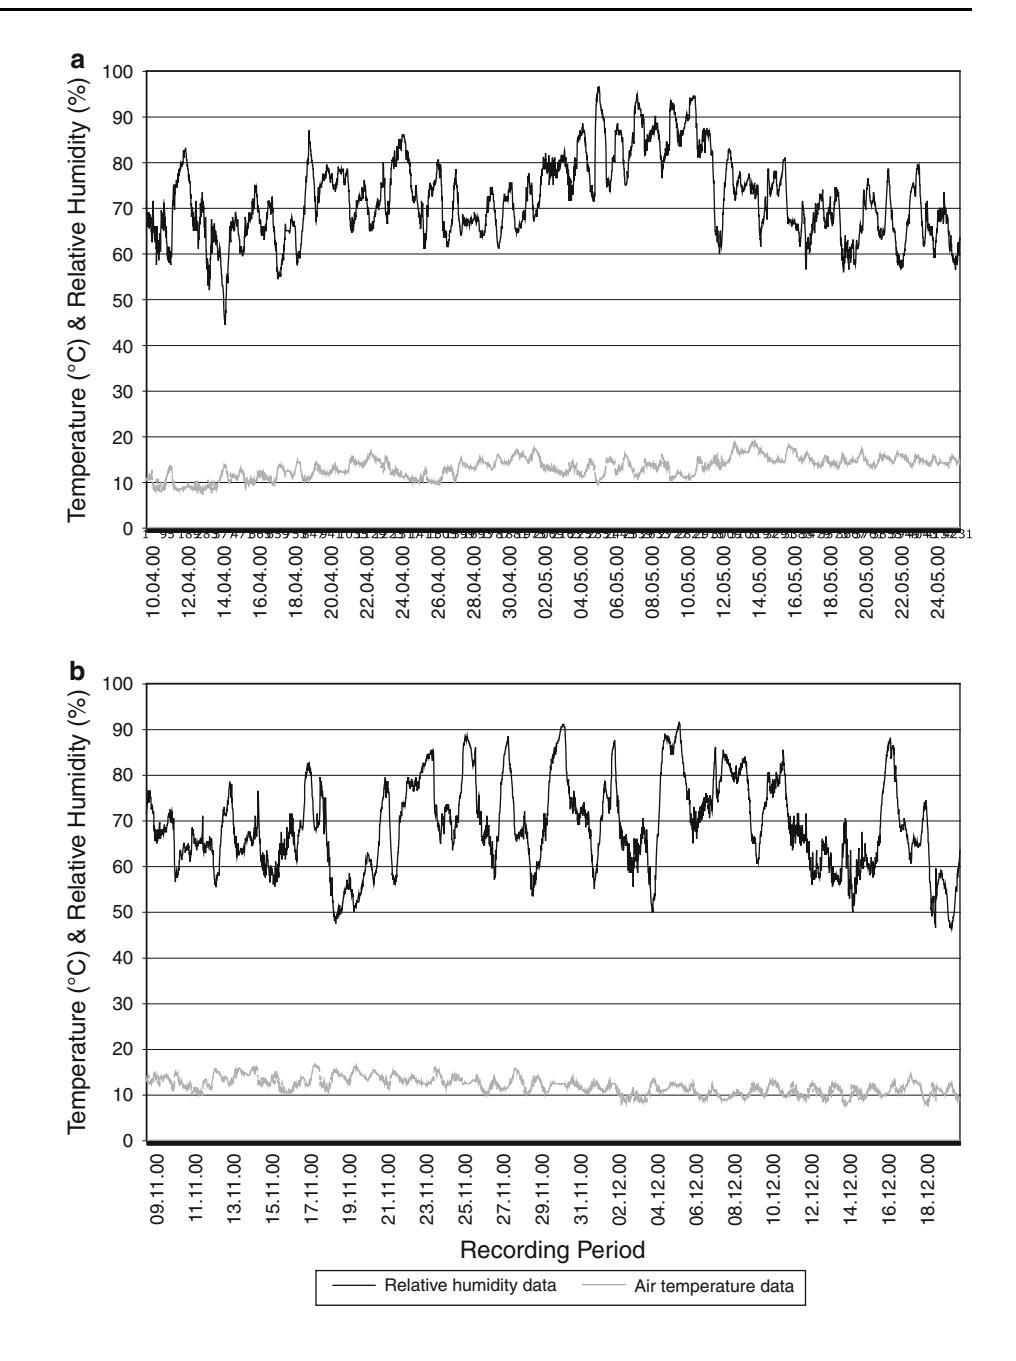
At Eagle, the whole tower corresponds to the lower three levels of Eeragh and is therefore best characterised as a zone of salt accumulation. At Eagle, however, salt efflorescence occurs in patches throughout the tower and may reflect the effectiveness of the storage heater, which increases heating and hence air temperatures within the tower. When this is activated it creates conditions conducive to the drying of stone surfaces but when not active the high stone surface concentrations of halite in particular deliquesce as air temperature decreases and RH values rise.
