A holistic approach to the assessment of the groundwater destructive effects on stone decay in Edfu temple using AAS, SEM-EDX and XRD

M. A. El-Gohary¹

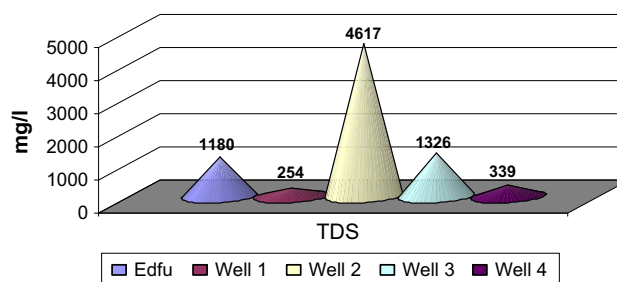
Fig. 6 TDS relations between result of groundwater analysis of Edfu temple well and the wells in surrounded area

resulted from rich chemical compounds that reach the floor and stones under the temple crossing the clay shale layer as represented in Fig. 2c. Within the same context, chemical analyses presented in Table 2 show that there is richness of mineral compounds as their TDS which is quite high (in fact in some sample it is more than 1000 mg/l) (Fig. 6). This aggressive percentage creates harsh deterioration mechanisms, these mechanisms and their related forms may be due to two main factors.
