Failure of a rock slope 16.5 years after excavation in repeated strata of sandstone and mudstone

Abstract The present study focuses on failure of a rock slope excavated in the autumn of 1997 and located in the repeated strata of sandstone and mudstone in Chongqing of China. The rock slope failed suddenly on April 28, 2014. The elapsed time from excavation to failure is about 16.5 years. The failure was sudden and unexpected seemingly, but it was mainly resulted from the initial excavation and the subsequent weathering in the long term. The initial excavation in 1997 as a reason why the rock cut slope failed was undoubted, because the excavation broke original ground stress balance, resulted in inducement or expansion of cracks and induced deformation and looseness of local rock masses. The weathering process, especially physical weathering process in the long term

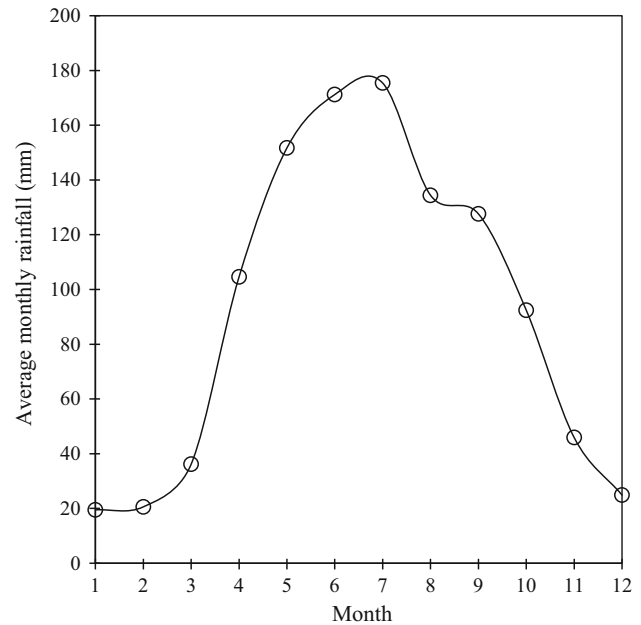
Fig. 10 Distribution of average monthly rainfall in Chongqing from 1971 to 2000

Although the failure of the rock cut slope took place in spring rainy season, in our opinion, the rainfall wasn't the most important factor inducing the failure because the rainfall in April wasn't the maximum in a year. Based on the climate data of Chongqing of China from 1971 to 2000, average annual rainfall in Chongqing is about 1104.4 mm. Figure 10 shows the distribution of average monthly rainfall from the climate data of Chongqing from 1971 to 2000.

It is clear that the distribution of average monthly rainfall is unbalanced in the term of a year. The month with the maximum of average monthly rainfall is July. The rainfall in April, about 104.6 mm, is only about 60% than that in July, about 175.4 mm.

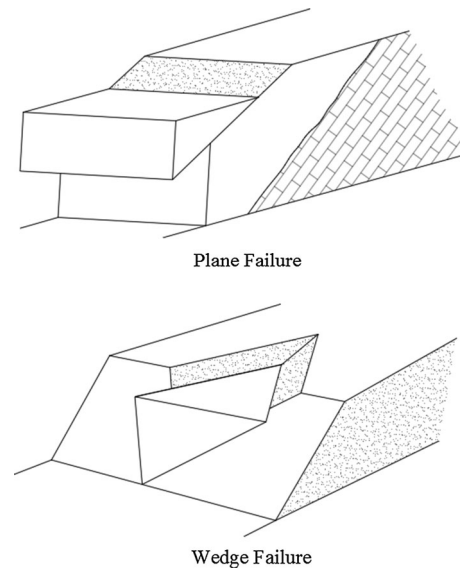
Fig. 11 Planar and wedge failure envelope

According to the Markland's test, a plane failure is likely to occur when a discontinuity dips in the same direction (within 20°) as the slope face, at an angle gentler than the slope angle but greater than the friction angle along the failure plane (Hoek and Bray 1981). In this failure mode, sliding object overcomes not only the resistance at the bottom, but also the resistance on both sides. In soft rock mass, if the angle of bottom is far greater than that of internal friction, the failure of the rock itself can relieve the side constraint and plane failure will occur. For hard rock, if the top of the slope is cut by discontinuities crosswise and both sides of the rock are separated, plane failure could also occur (see Fig. 11). A wedge failure may occur when the line of intersection of two discontinuities, forming the wedge-shaped block, plunges in the same direction as the slope face and the plunge angle is less than the slope angle but greater than the friction angle along the planes of failure (Hoek and Bray 1981) (see Fig. 11). A toppling failure may result when a steeply dipping discontinuity is parallel to the slope face (within 30°) and dips into it (Hoek and Bray 1981).

In the present study, the kinematic analysis method was used to analyze the possible failure mode of the rock slope in future. Stereonet is circular graph used for plotting planes based on their orientations in terms of dip direction, which are widely used for graphical kinematic analysis. Figure 12 shows the kinematic analysis of the investigated rock slope. It shows that the plane failure along the sandstone–mudstone interface (Interface #A) and the wedge failure along the Joints #B and #C are possible in future. In

For the possible plane failure along the Interface #A, the value of F_s is calculated based on the engineering geologic profile shown in Fig. 5 and the shearing strengths of the mudstone–sandstone interface listed in Table 3, and it is 1.15 under natural conditions and 1.04 under saturated conditions. For the possible wedge failure along the Joints #B and #C, the value of F_s is also calculated based on the attitudes of the Joints #B and #C shown in Fig. 12 and the shearing strength of the argillation intermediate layer in the joints of the upper sandstone layer listed in Table 3, and it is 1.09 under saturated conditions. The calculated values of F_s exceed 1.0, and this means that the slope is considered stable. But the calculated values of F_s are very near to 1.0, in particular those under saturated conditions, and this means that the further failure of the rock slope in future is very possible under coming weathering process. For the safety, stabilization to the rock slope should be necessary.
