# Characteristics of seismic disasters and aseismic measures of tunnels in Wenchuan earthquake

**Keywords** Tunnel · Earthquake resistance · Seismic damage · Disaster investigation · Wenchuan earthquake

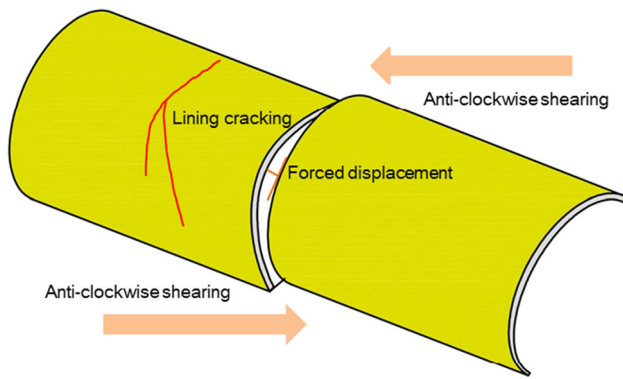
**Fig. 12** The forced placement and anticlockwise shearing due to internal force

As the commonest tunnel seismic damage, lining cracking mainly results from earthquake inertia force (general in section of tunnel portal) and forced displacement (near the interface of soft and hard rock at tunnel portal), as shown in Fig. 12. Concrete exfoliation is always accompanied by reticular fracture or lining crush. The directional lining cracking often occurs due to tension and shear action, flake-like crack is always caused by bending and deformed lining, and reticular crack results from the pressure and shear under the earthquake action as well as repeated movement (Pei et al. 2015).
