Behavioral characteristics and structural stability of the walls in the ancient Korean Royal Tombs from the sixth century Baekje Kingdom

Abstract

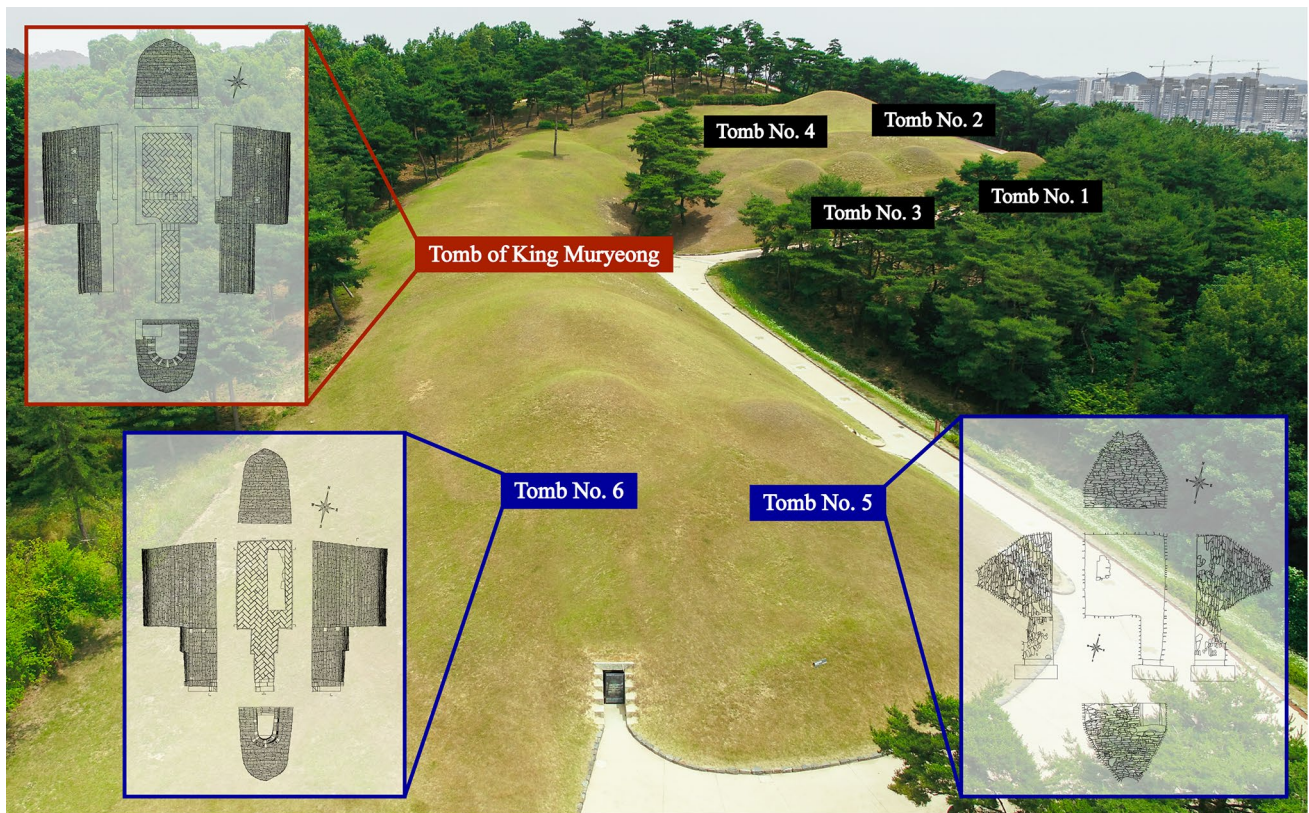
Fig. 2 Field images of the Royal Tombs at Songsanri in Gongju

are arranged in a row approximately 20–30 m apart in the northeast section of a small valley. Tomb nos. 5 and 6 and the Royal Tomb of King Muryeong, the focus of the present study, are arranged in a triangle on the west side of the same valley (Fig. 2). The area locating the Royal Tombs at Songsanri belongs to Gongju basin comprising sedimentary rocks and has a large fault along the boundary between sedimentary rock and migmatitic gneiss on the geological map. In some places, basal conglomerate comprising breccia, agglomerate, and tuff is distributed.

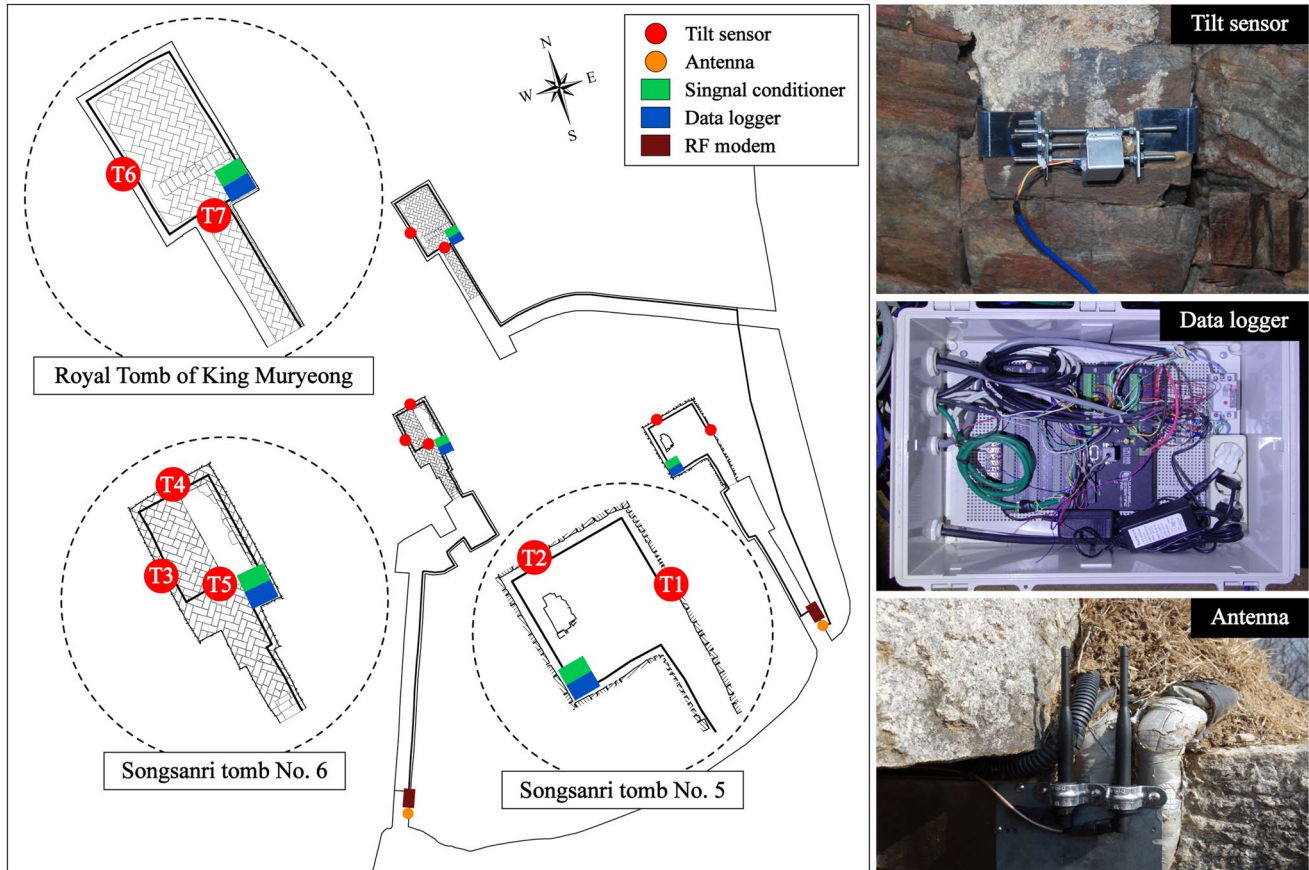
Fig. 4 Schematic diagram showing automatic measuring system installed Royal Tombs at Songsanri

sensors, data loggers, modems, and computers was utilized to monitor the tombs for 23 months from December 8, 2013 to November 8, 2015. To minimize the strain on the walls, seven small, lightweight, single-axis tilt sensors (Model 84053 Ceramic Sensors, Jewell Instrument Company) were installed, as specified in Table 1 and Fig. 4. Waterproof covers were made to protect the sensors from water damage. The displacement of the walls was measured in terms of tilt in toward the interior of the tomb (negative values) or out toward the exterior (positive values). The displacement of the ceiling of tomb no. 6 was measured along the east-to-west direction with positive values representing westward displacement and negative values representing eastward displacement.
