Characterizing Diesel Particulate Filter Failure During Commercial Fleet Use due to Pinholes, Melting, Cracking, and Fouling

Kun Yang¹ · John T. Fox¹ · Robert Hunsicker²

Abstract Diesel particulate filters (DPFs) are essential particulate matter emission control devices. Some diesel particulate filters have been observed to fail during industrial-fleet vehicle use. DPFs that fail during vehicle use compromise particulate matter emission capture. Herein, failures in cordierite DPF substrates observed during commercial fleet use were characterized as pinhole failure, melt failure, crack failure, and fouling failure. The observed failures were correlated to particulate matter chemical composition and physical changes in the cordierite substrate of the exhausted DPFs. The physical-chemical characteristics of pinhole failure, melt failure, crack failure, and fouling failure were determined by applying scanning electron microscopy-energy dispersive spectrometry (SEM-EDS), X-ray photoelectron spectroscopy (XPS), and X-ray diffraction (XRD). Results indicate that the chemical composition and crystalline structures of cordierite DPF substrate changed according to the failure characterizat

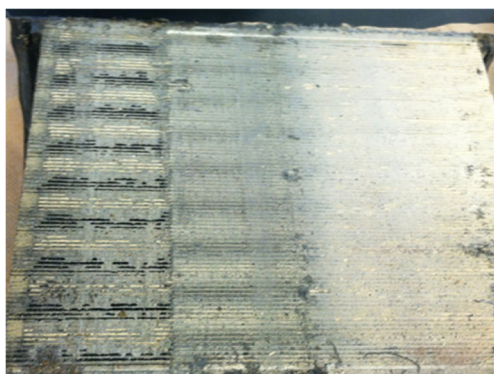
Typical soot loadings and typical ash loadings in the exhausted urban transit bus DPFs were measured post-mortem at 4–5 g soot/L substrate and 25–30 g ash/L substrate, respectively. These are moderately high soot and ash loadings for a DPF, but within the DPF substrate design parameters [13, 20]. Volumetric parameters of the DPFs are depicted in Table 1, and a cross-section photograph of an exhausted urban transit bus DPF is shown in Fig. 1. This figure demonstrates that the dark-colored DPF soot appears to be deposited on the inlet of the DPF.

Fig. 1 Cross section of a DPF, showing inlet (*left side*) and outlet (*right side*)
