Structural Performance of Masonry Buildings Under Harsh Climate and Seismic Loads

Abstract

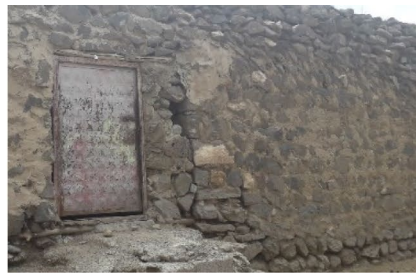
**(e)** Mixed style masonry wall (Ashlar corners, coursed base, coursed and random body, herringbone top)

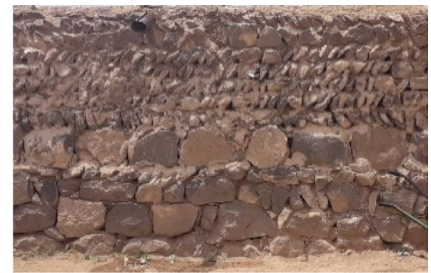
**(f)** Mixed style masonry wall (Coursed-random bottom and herringbone top)**Fig. 5** Different wall design

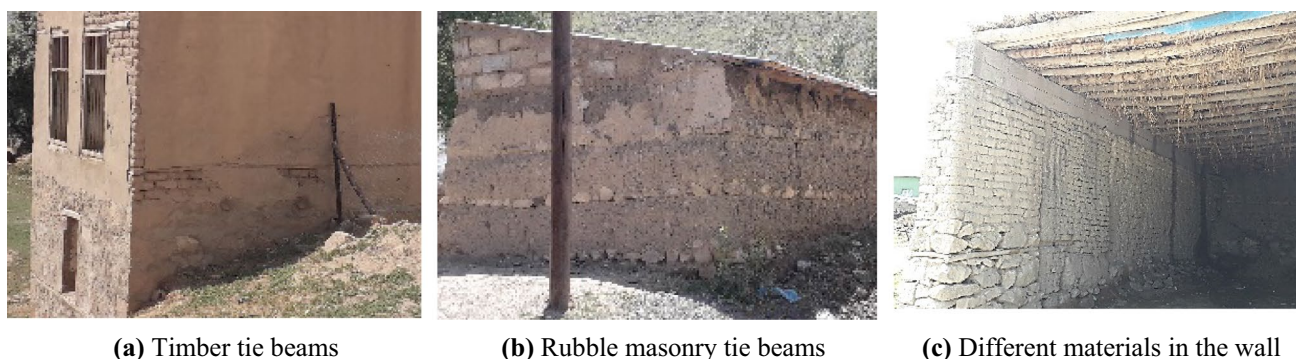
Fig. 6 Different tie beams and wall materials

due to the out-of-plane bending and also the cracking load increased significantly when timber laced masonry was subjected to diagonal compression (Vintzileou 2008; Karantoni et al. 2016; Mouzakis et al. 2018). Although wooden tie beams are common all over the world, the rubble masonry tie beams are rare. The building shown in Fig. 6b has two rubble masonry tie beams in the external walls.

Besides the construction technique, the walls in some buildings were built using different materials. Figure 6c shows a wall which has rubble masonry at the bottom, adobe at the body and lightweight pumice blocks at the top.

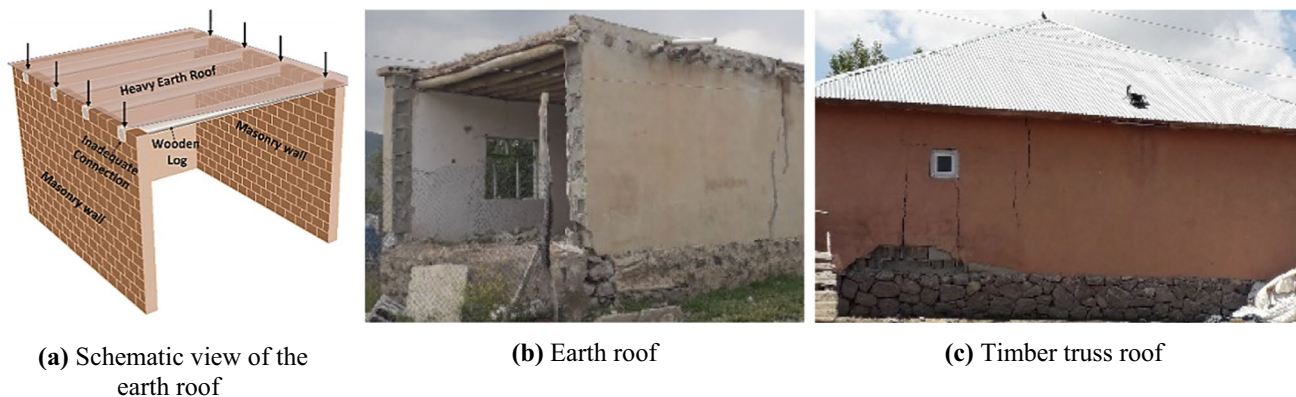
Fig. 7 Different roof design

the heavy snow on top if not plowed. That heavy snow and earth make the wooden logs displaced downwards continuously. Since the mid span has more displacement, each time residents place more earth and thickness at the midspan increases regularly. This is a vicious cycle because as the load at the midspan increases so the displacement and as the displacement increases at the midspan it creates a pit and that pit is filled with additional earth.

Besides the earth roof, some new buildings especially less than 15 years old and built from lightweight pumice blocks have timber truss roof with metal sheet covering (Fig. 7c). Since this roof is inclined, the maintenance cycle is low and no need to deal with snow. In addition, since this roof is light in weight, the axial load transferred to the walls is low. However, the number of this roof type is rare because it is rather expensive in the region.

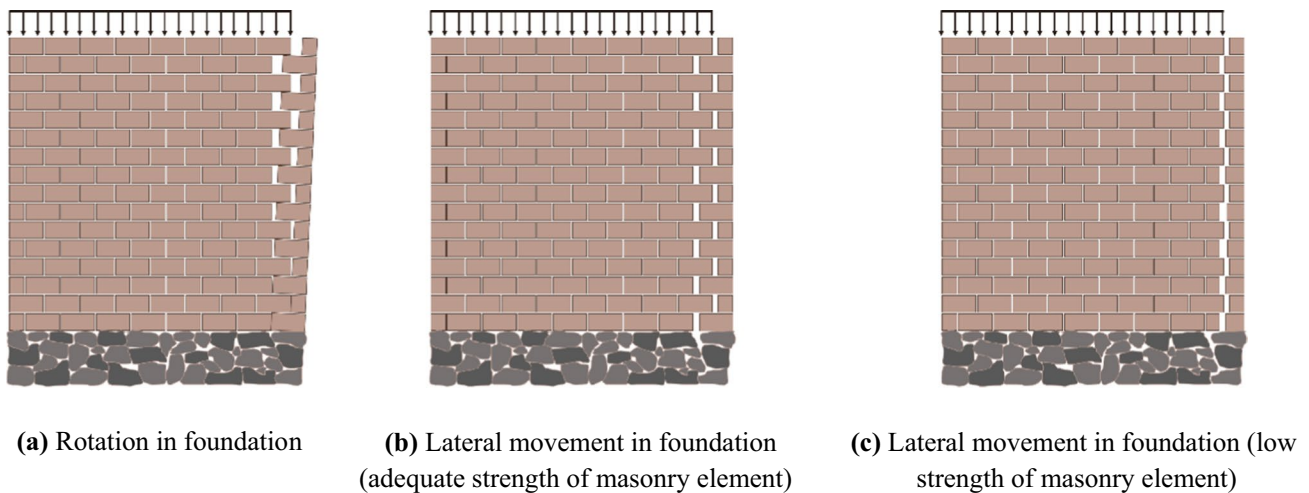
Fig. 10 Damage illustrations due to foundation movement

rotate, they force the base of the wall to displace out-of-plane. The out-of-plane displacement creates tensile stresses and if the wall fails to carry the tensile stresses either cracks develop in the mortar providing that the masonry element is strong (Fig. 10a and b), or cracks penetrate through mortar and masonry elements when both materials have similar strengths (Fig. 10c).

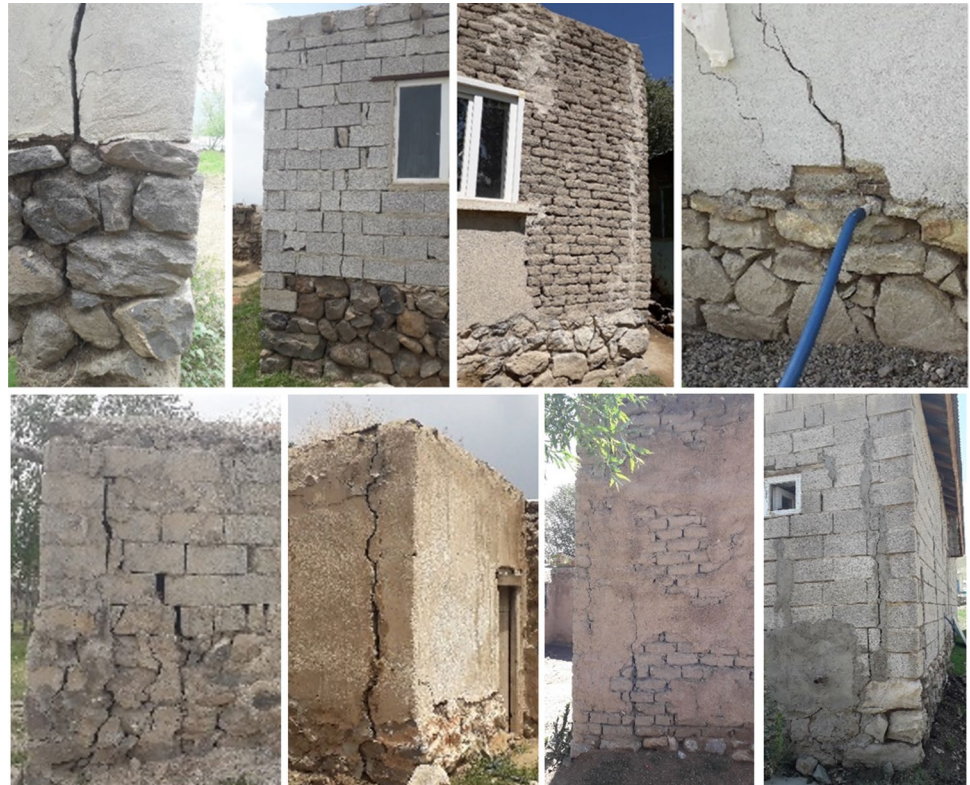
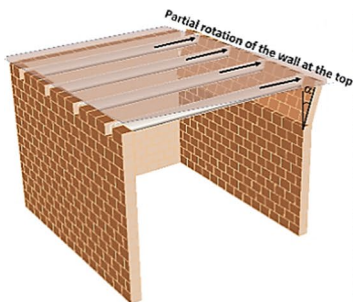
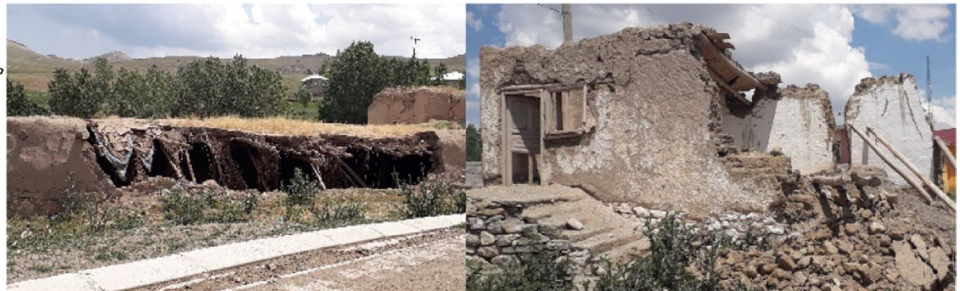
As previously noted, heavy roofs on the walls were built from wooden logs and thick earth slabs. The logs were not securely connected to the walls, instead they only placed between some masonry elements which created roller support. Considering the vertical load case only, it can be said that heavy roofs impose high vertical loads and increase the compression stresses thus increase the friction between the masonry elements. This seems to be positive contribution to the walls but roof itself is adversely affected because of the inadequate connection at the ends which enables the ends to translate or rotate under high vertical distributed loads. The main adverse effect is seen in earthquake loading since in this case the great mass of the roof vibrates and this vibration forces the so-called beams of wooden logs in lateral direction. The wooden logs force the walls to displace out-of-plane direction provided that the friction at the end connections is adequate (Fig. 13a). In this case two possible

(a) Wall deformations caused from roof displacements

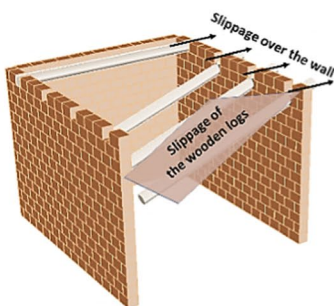
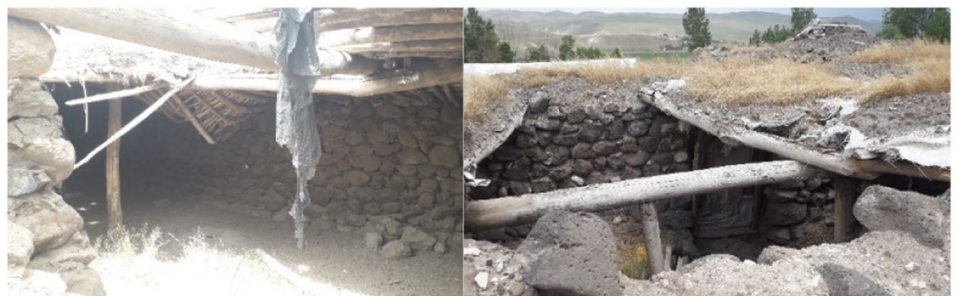
(b) Partial or total collapse of the roof
