# January 24, 2020 Sivrice-Elazığ (Türkiye) Earthquake: The Seismic Assessment of the Earthquake Territory, Geotechnical Findings and Performance of Masonry Buildings

## Abstract

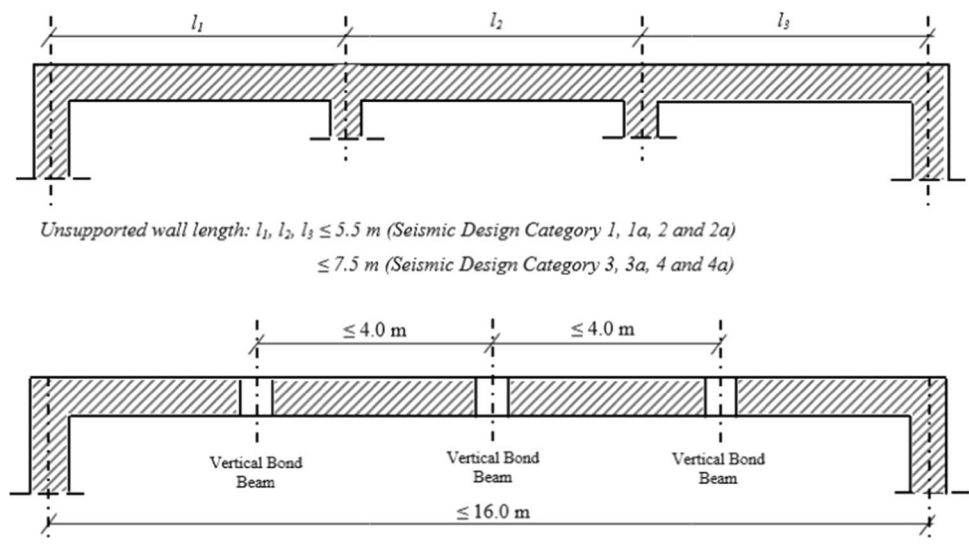
**Fig. 13** Limits of unsupported wall length for load-bearing wall (TBEC 2018)

In order to prevent these damages in masonry buildings, the unsupported length of a wall should be limited by using perpendicular walls and vertical bond beams. Regulation rules for this situation are quite clear. In the TBEC (2018), some rules are given for the maximum unsupported lengths of load-bearing walls and distances between vertical bond beams in unreinforced and confined masonry buildings (Fig. 13).

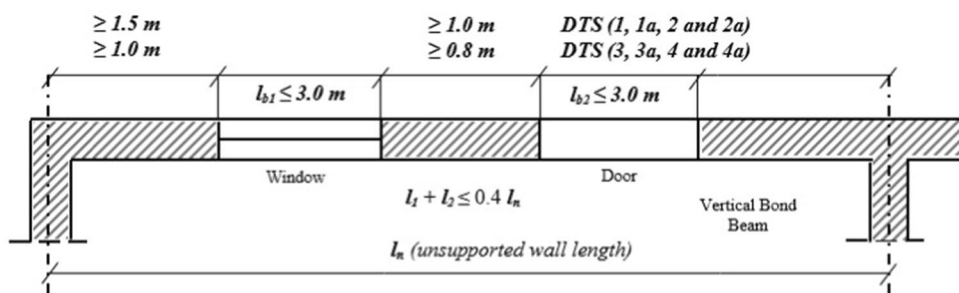
**Fig. 16** Specified requirements for window and door openings (TBEC 2018)

In order to prevent such damages, TBEC (2018) has specified the necessary rules about the dimensions of the door and window openings and the lintel lengths. Reinforced concrete lintels will be built above the door and window spaces. The length of the parts of the lintels that rest on the wall shall not be less than 200 mm. The lintel height shall not be less than 150 mm. The rules given in Fig. 16 shall be complied with in the door and window spaces to be left on the load-bearing walls.

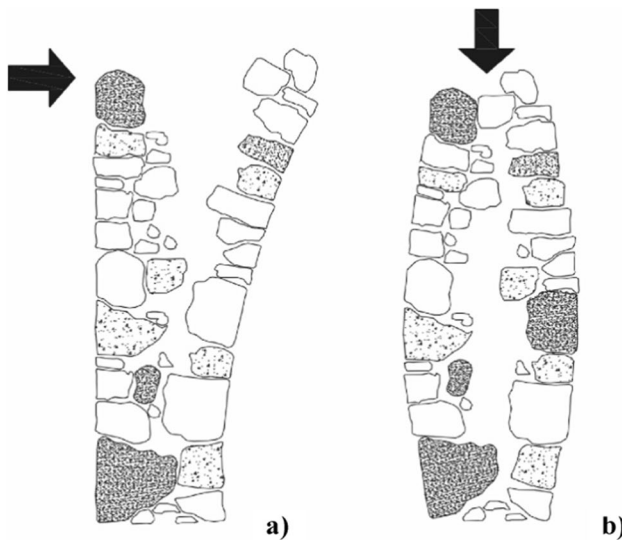
masonry leaves connected with a considerably weaker, filler material, usually made of rubble and mortar and have a high percentage of voids. However, connections of these multi-leaf walls are weak generally. This weak joint results in the two leaves working almost independently, which may bring about their separation and therefore subsequent failure Valluzzi et al. (2001) under combined lateral and axial loading (Fig. 19). During the field survey, masonry structures damaged as a result of this weak connection were encountered (Fig. 20).

**Fig. 19** **a** Failure mechanism of a double-leaf wall panel subjected to a horizontal load. **b** Failure mechanism of a panel subjected to a compression vertical load (Corradi et al. 2017)

The middle layer between multi-layer walls as shown in Fig. 25 is typically composed of rubble stones of low quality and binding material that primarily serve as fillers. Transversal anchorage systems prevent the separation of two layers during an earthquake and significantly increase the strength of the structure by providing a connection between the two surfaces.

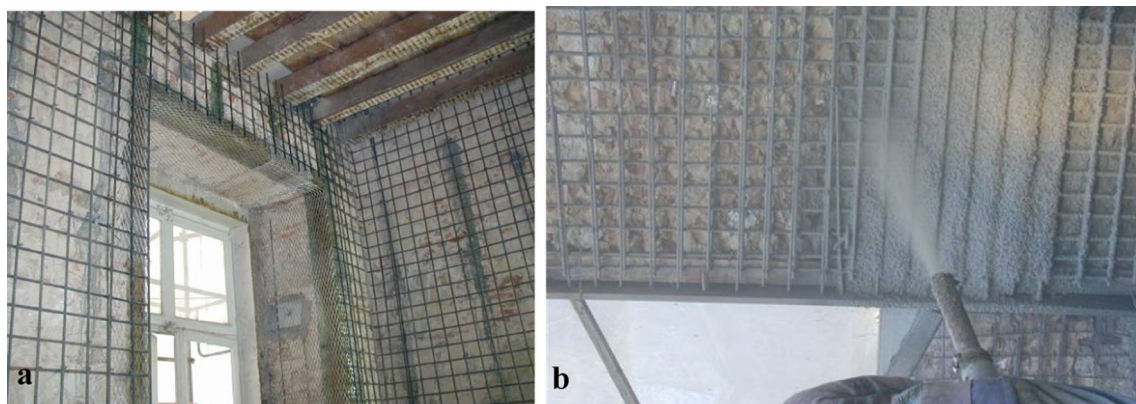
Fig. 21 a Masonry wall from the inside with steel mesh, b spraying of the cement grout into the wall (Adopted from Appleton 2009)

In this retrofitting case (Fig. 21), one places thin (less than 10 cm) layers of coating of cement reinforced with steel on masonry walls. The coating increases the wall's strength and ductility. It can be placed on the outside or the inside or both, depending on the most accessible areas. To enable the behavior of both elements (existing and new) to work together one places steel connectors on the wall.

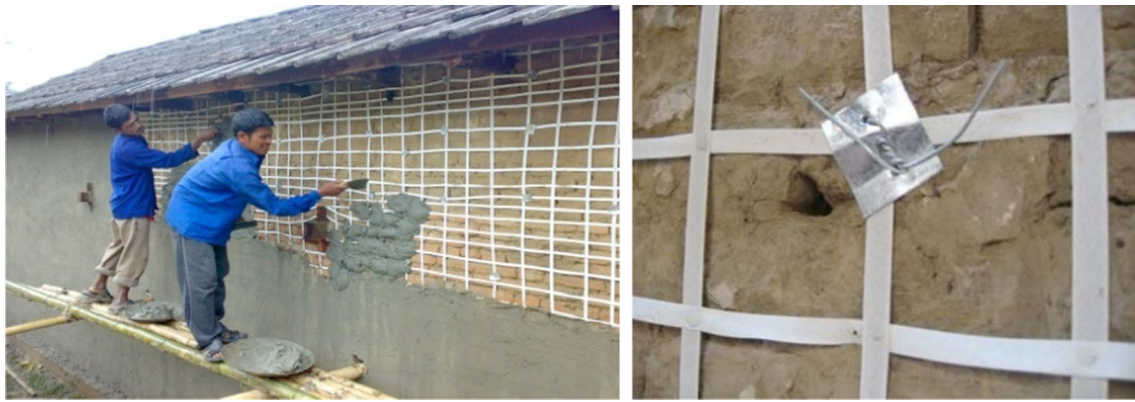
**Fig. 22** Implementation of the PP band method of retrofitting in Kathmandu Valley (left) and anchorage throughout the wall (right) (Adopted from Shrestha et al. 2012)

Polypropylene (PP) mesh used in reinforced masonry buildings has been applied in Nepal, Pakistan and recently in China. PP retrofitting is used to encase masonry walls (Fig. 22), preventing both collapse and the escape of debris during earthquakes. This method is low-cost and easiest to implement in reinforcing conventional masonry buildings.

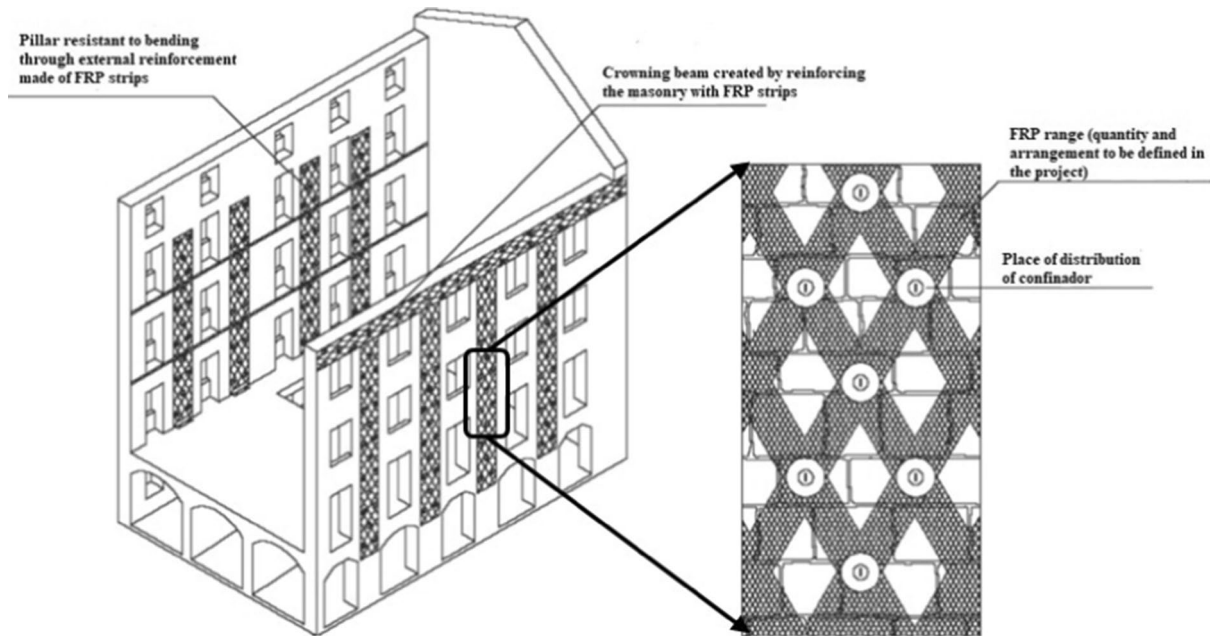
**Fig. 23** Application of CFRP/GFRP on a building wall (Adopted from Henriques et al. 2011)

Another method used in the reinforcement of masonry buildings is the reinforcement of walls with composite materials, such as carbon fiber-reinforced polymer (CFRP) and glass fiber-reinforced polymer (GFRP). Figure 23 shows the application of CFRP/GFRP on a building wall. In this method, there can be placed also connectors, especially on walls, so that the material is well bonded to the masonry.

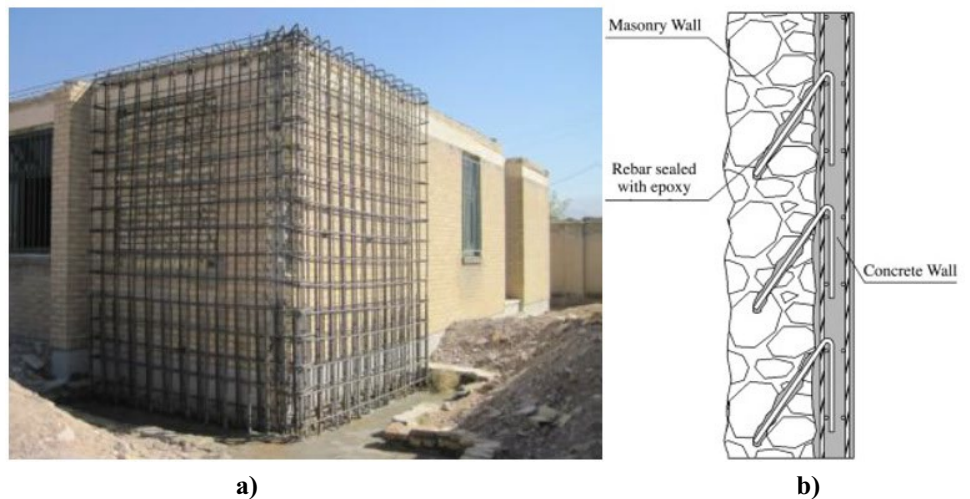
**Fig. 24 a** Application of RC concrete shear wall (Adopted from Mahdizadeh et al. 2012) **b** sectional view (Adopted from Branco and Guerreiro 2011)

In this method, the masonry wall is reinforced with a reinforced concrete shear wall (Fig. 24a). For the system to behave together, the shear wall and the masonry wall are connected with a sufficient number of anchors (Fig. 24b). Thus, the overall rigidity of the system can increase the lateral strength and control the slips between floors.

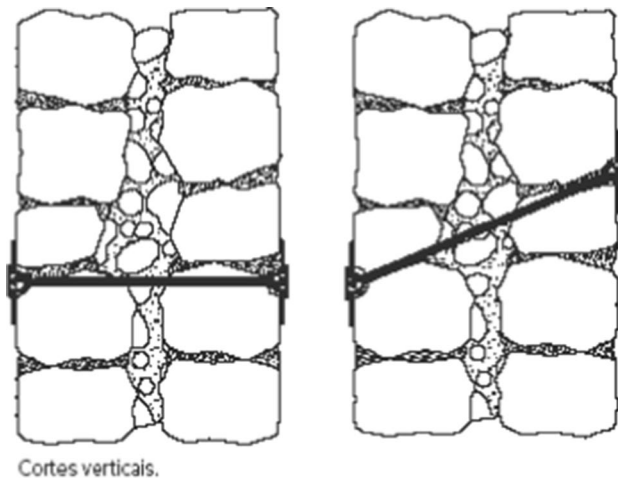
**Fig. 25** Transversal anchorage system in multi-layer masonry walls (Adopted from Meireles and Bento 2013)

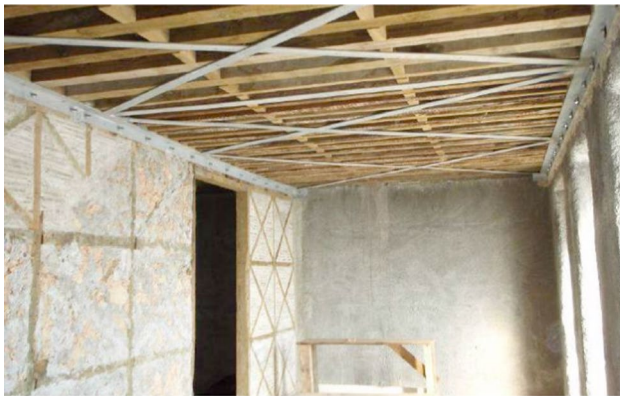
**Fig. 26** Transversal anchorage system in multi-layer masonry walls (Adopted from Meireles and Bento 2013)

Under earthquake effects, adding a horizontal buttress made of diagonally arranged steel ties to the wooden floor will make a positive contribution. With L-shaped steel plates, the connection between the ground and the masonry wall will be strengthened, so that the entire wall will meet the earthquake load, not pointwise (Fig. 26).
