Surface deformations of 24 January 2020 Sivrice (Elazığ)–Doğanyol (Malatya) earthquake ($M_w = 6.8$) along the Pütürge segment of the East Anatolian Fault Zone and its comparison with Turkey's 100-year-surface ruptures

Orhan Tatar¹ · Hasan Sözbilir^{2,3} · Fikret Koçbulut¹ · Erdin Bozkurt^{4,5} · Ercan Aksoy⁶ · Semih Eski³ · Bülent Özmen⁷ · Hüseyin Alan^{8,9} · Yüksel Metin¹⁰

Received: 31 July 2020 / Revised: 27 September 2020 / Accepted: 30 September 2020 / Published online: 27 October 2020
© Springer Nature Switzerland AG 2020

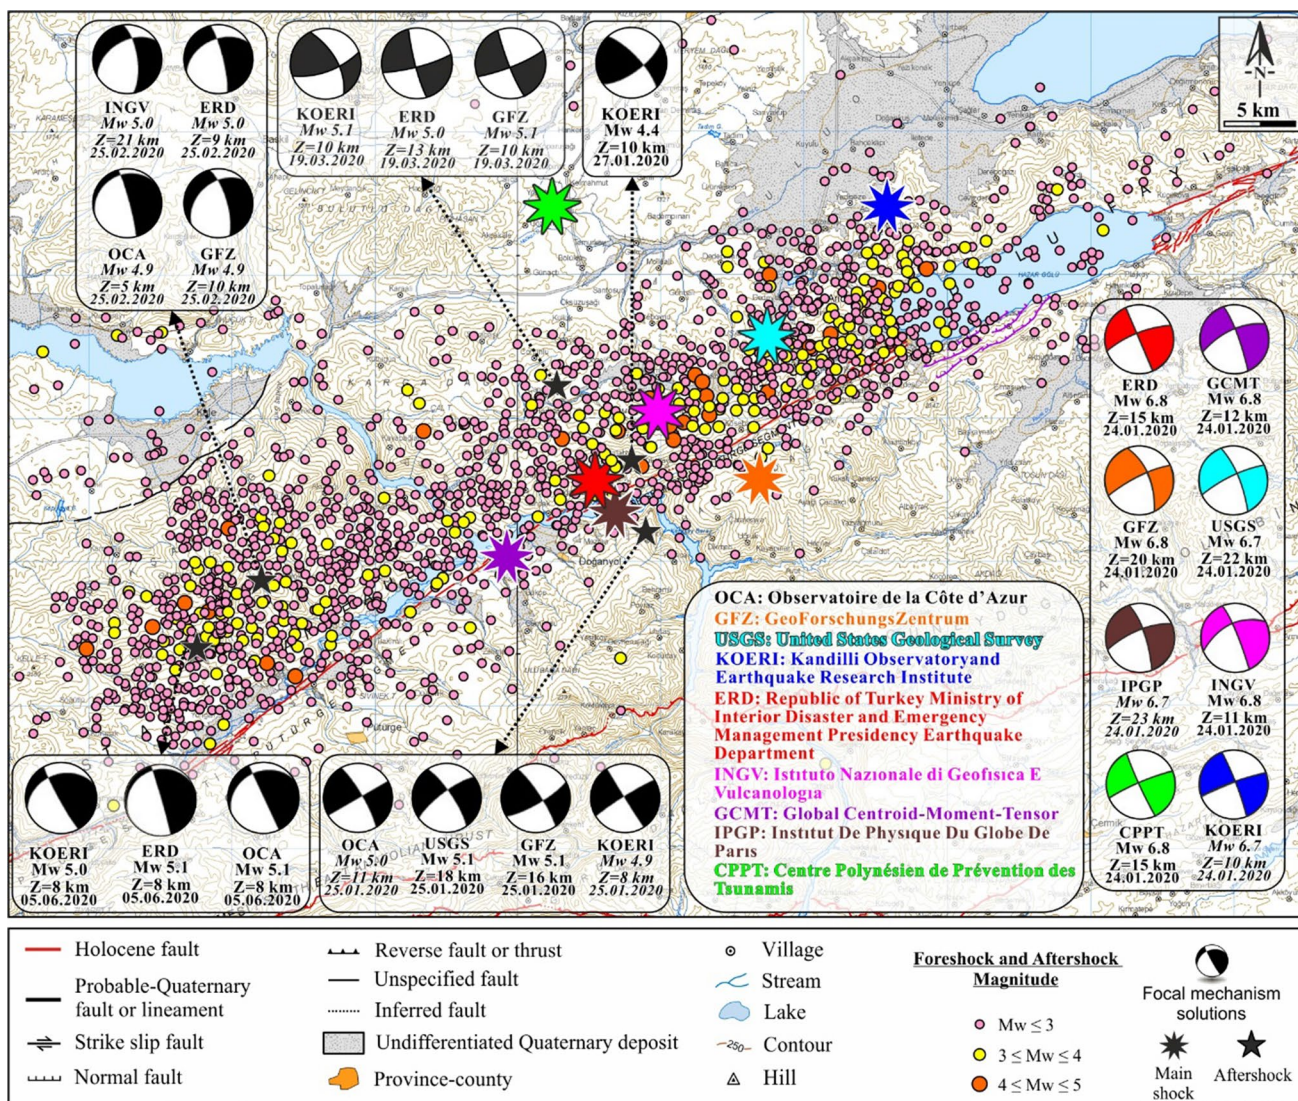
The last one, a moderate size earthquake occurred at 20:55:11 local time (17:55 UTC) on Friday, January 24, 2020 in Sivrice (Elazığ) and Doğanyol (Malatya) area. Turkish Republic Ministry of Interior, The Disaster and Emergency Management Presidency of Turkey (AFAD) Earthquake Department announced magnitude of the earthquake 6.8 (M_w), focal depth as 8.06 km and epicenter as Çevrimtaş village (0.81 km south of Sivrice). According to Bogaziçi University Kandilli Observatory and Earthquake Research Institute (KOERI), the magnitude, focal depth and epicenter of the earthquake are M_I : 6.6 (M_w : 6.5), 5 km and Çevrimtaş village (Sivrice). On the other hand, these parameters are 6.7, 11 km and Kalaba village (11 km NNE of Doğanyol) according to USGS (Fig. 3).

Fig. 3 A seismotectonic map showing the distribution of main and aftershocks of the 24.02.2020 Sivrice (Elazığ)–Doğanyol (Malatya) earthquake (Mw = 6.8). The active fault map is from Emre et al. (2011)

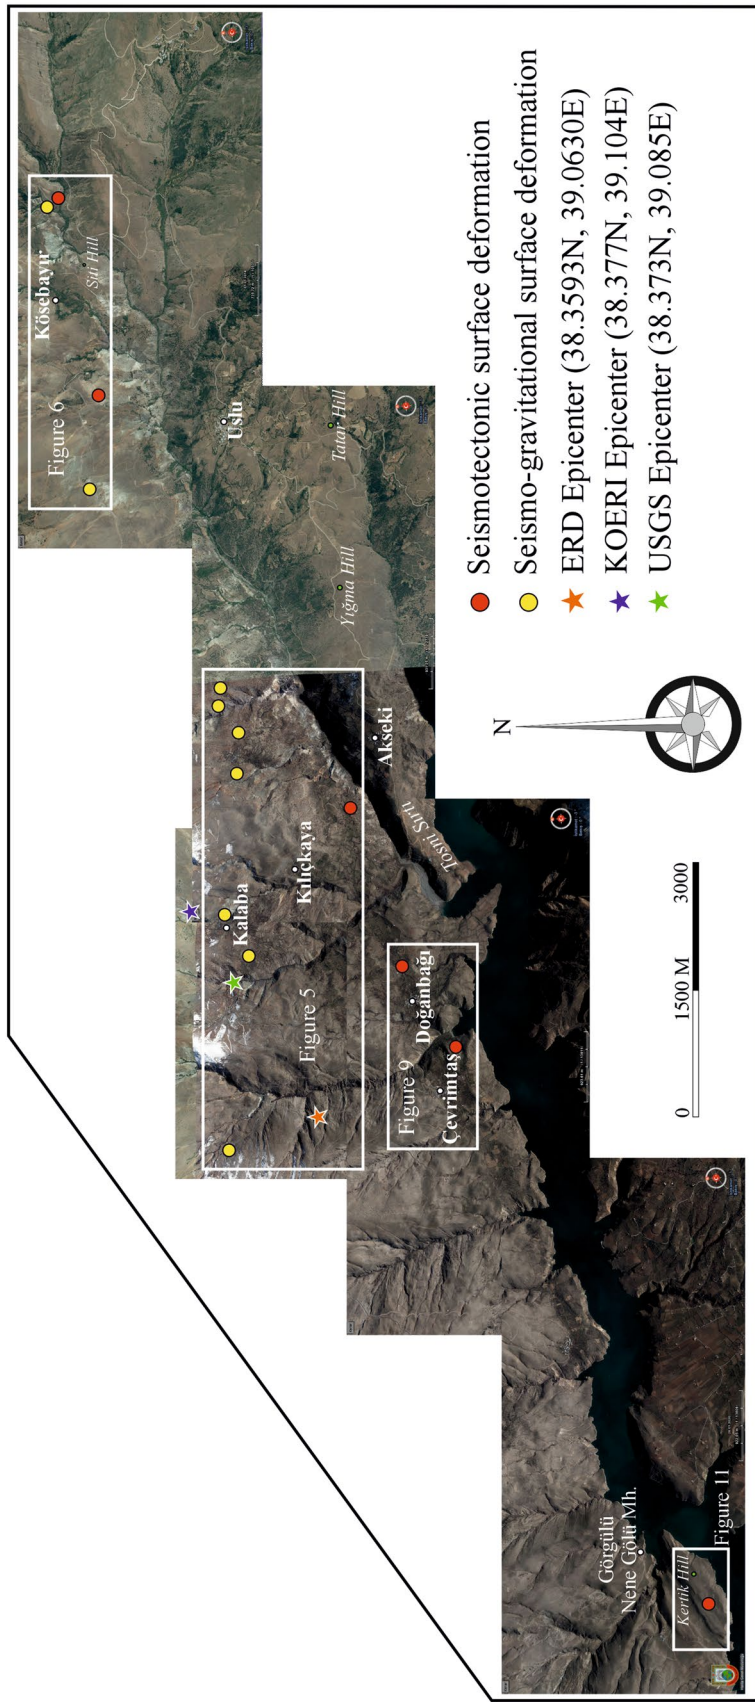
Surface deformation features occur along a ca. 30-km-long zone between Sivrice and Ormaniçi village and covers an area of up to 2 km in some places. This zone also forms the main part of the Pütürge segment. The 12-km left-lateral displacement of the Fırat River is also located within the central part of this deformation zone (Fig. 4).

Fig. 4 HGM Küre map showing the location of surface deformation features that occurred in January 24, 2020 Sivrice (Elazığ)–Doğanyol (Malatya) earthquake. The red dots indicate the areas of the surface fracture, the yellow dots, areas where surface deformations are observed, and the blue, green and orange dots, the epicenter of the main shock given by KOERI, USGS and ERD, respectively

Detailed observations around villages of Kösebayır, Kılıçkaya, Doğanbağı, Çevrimtaş and Ilıncak located to the southwest of Sivrice district (Fig. 4) reveal that most deformational structures are seismo-gravitational in origin, and that dense network of capillary cracks are common structures along the road between Kösebayır and Kalaba villages.

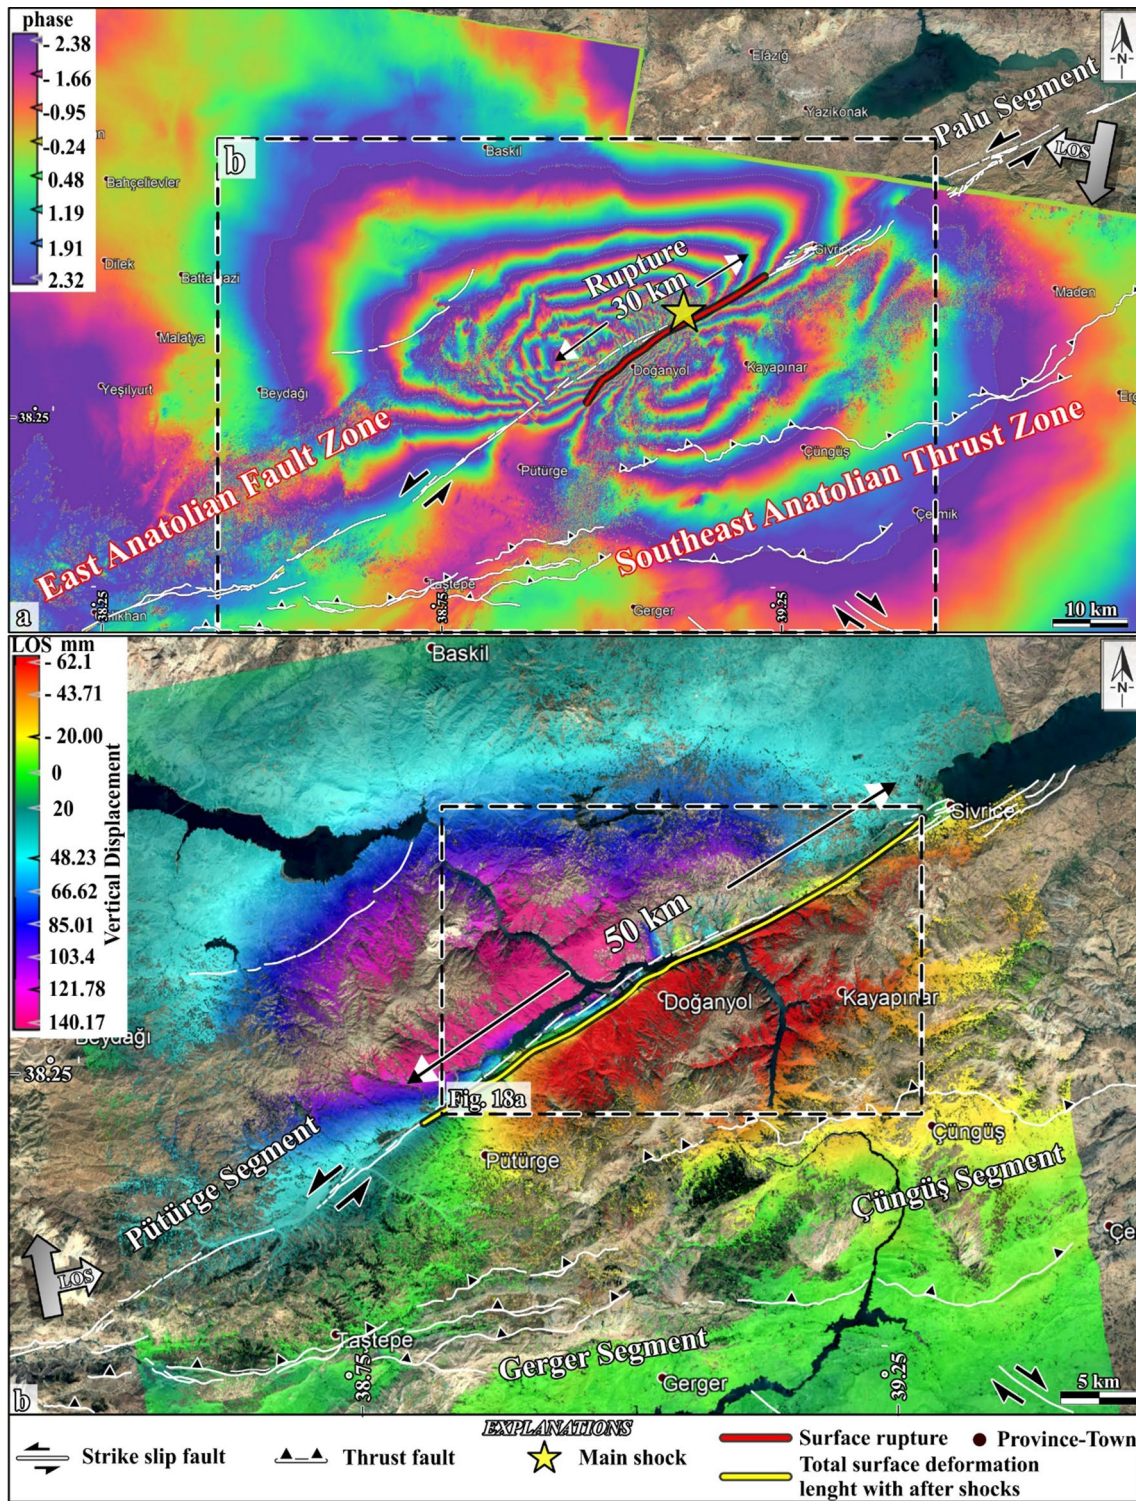
The January 24, 2020 Sivrice (Elazığ)—Doğanyol (Malatya) earthquake represents the largest seismic event affecting surface ever observed with modern DInSAR techniques. Co-seismic measurements allow us to estimate vertical displacement and to prepare a deformation maps (Fig. 16). Surface deformation after the earthquake is visible in the phase map (Fig. 16a) and we find mean 10 cm uplift on NW block and maximum—6 cm subsidence on SE block (Fig. 16b). The line, which is clearly evident between the subsidence and uplift block, corresponds to the area where the surface rupture may form. The 30-km-long surface rupture starts from the SW of Sivrice and continues along the Fırat River, ends between the Pütürge and the Doğanyol (Fig. 16b). The distribution of surface deformation features, such as landslides, tension cracks, etc. caused by aftershocks, occur in a zone that reaches to length of about

50 km (Fig. 16b). In many published articles, data on horizontal deformations were obtained using optical, InSAR, and geodetic data. If we briefly talk about these studies; modeling of geodetic data by Cheloni and Akıncı (2020) obtained from the geodetic inversion shows left-lateral strike-slip with up to 2.3 m of slip. Pousse-Beltran et al. (2020) investigated horizontal surface deformation using an optical image correlation (OIC) of pre-earthquake and post-earthquake maps. Displacement measurement uncertainties are ~ 0.75 m in the east-west component and ~ 1.0 m in the north-south component, whereas WSW of the epicenter, after slip decreases rapidly to $\sim 2\text{--}3$ cm and the locking depth diminishes to near 0, indicating post-seismic surface rupturing (Pousse-Beltran et al. 2020). Jamalreyhani et al. (2020) estimated a uniform slip of 1.6 ± 0.2 m, within 68% of confidence. Melgar et al. (2020) mapped LOS displacements from InSAR showing 45-cm left-lateral sense of slip.

Fig. 16 Co- and post-seismic interferogram maps from the descending tracks. **a** Phase map between 16–28/01/2002 dates and **b** vertical LOS displacement map between 21–27/01/2020 dates. Faults are from Duman et al. (2017); yellow star shows main shock location

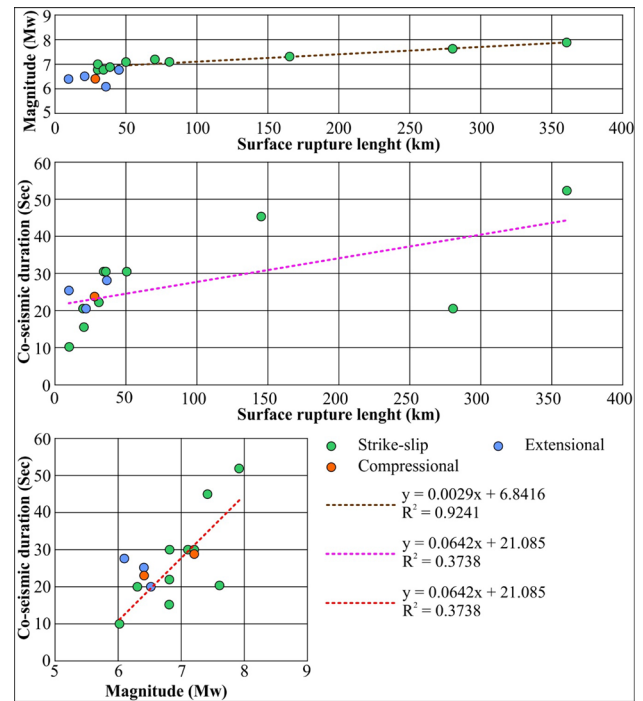
In this section, classification of surface deformations developed during the instrumental earthquakes in Turkey will be presented and their relation to co- to post-seismic events will be discussed (Table 4; Fig. 17).

Fig. 17 a and b Relationship between surface rupture length and magnitude/co-seismic duration and c magnitude and co-seismic duration of strike slip/compressional/extensional earthquakes that developed during the last hundred years in Turkey
